HISTORIC STRUCTURES/SITES REPORT

**15 CHAPALA STREET
VILLA ROSA INN
SANTA BARBARA, CALIFORNIA
APN: 033-101-006**

October 17, 2016

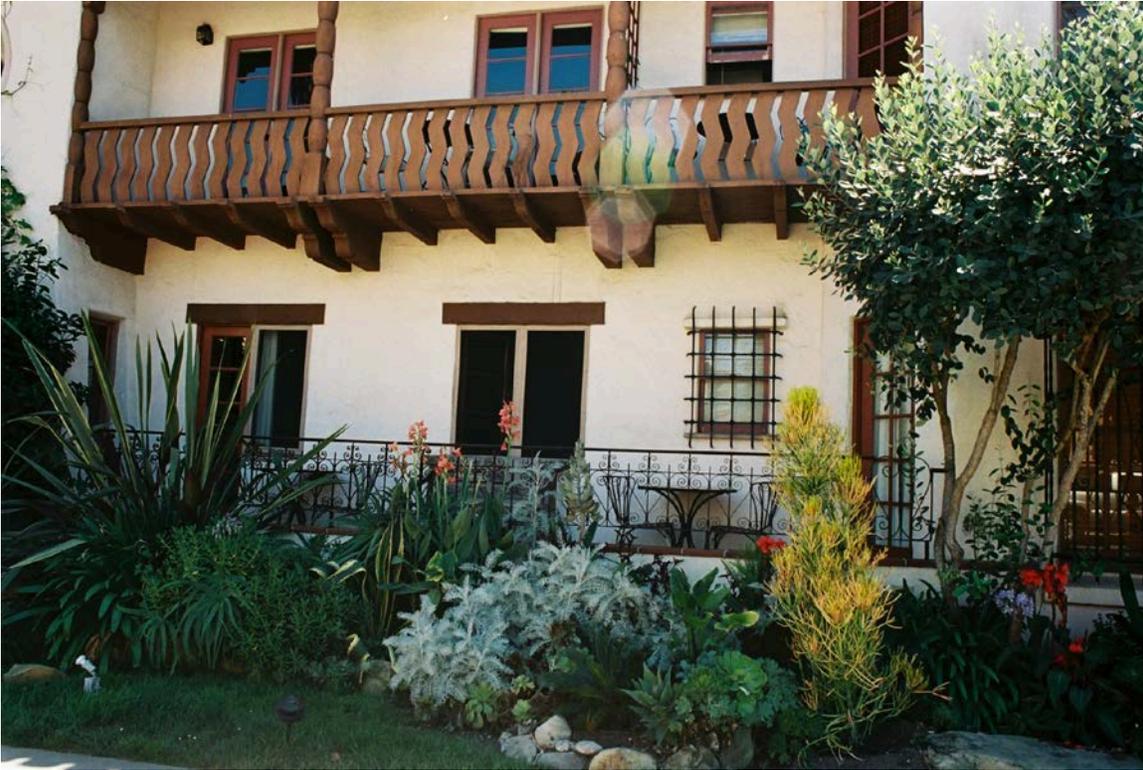
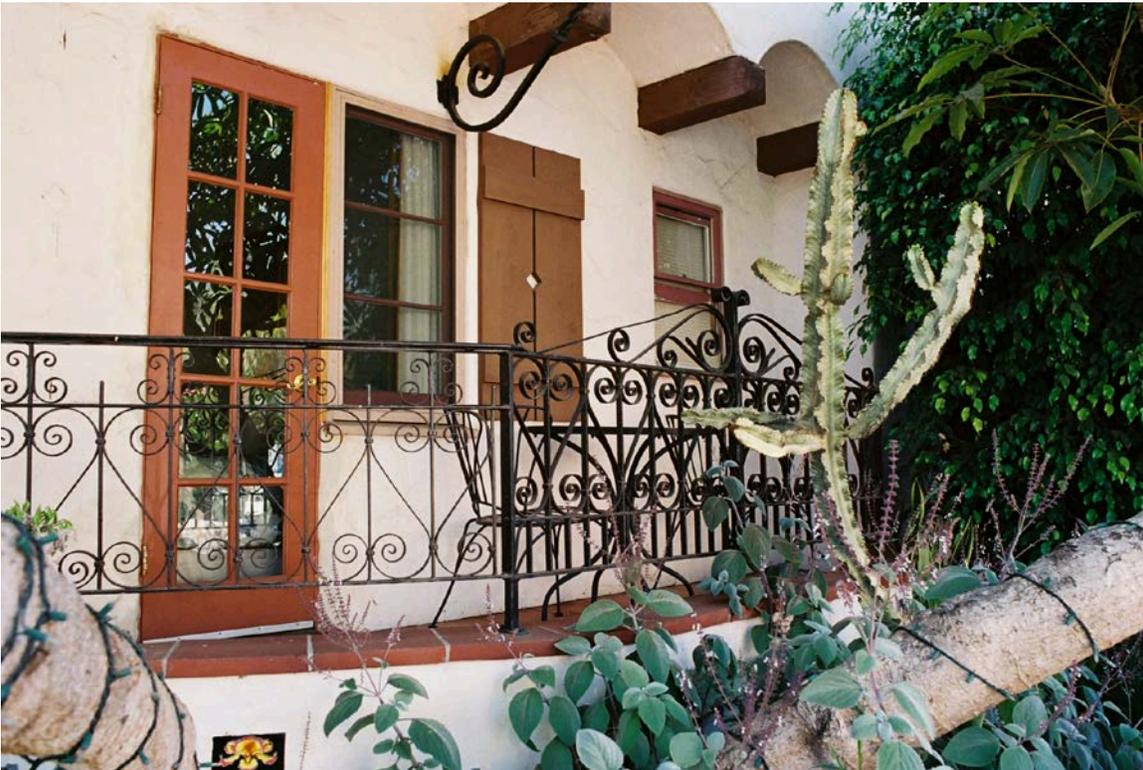
**Standards Photo D top: patio deck to right of entrance, meets Standards.
Standards Photo E bottom: patio deck to left of main entrance; meets Standards.**

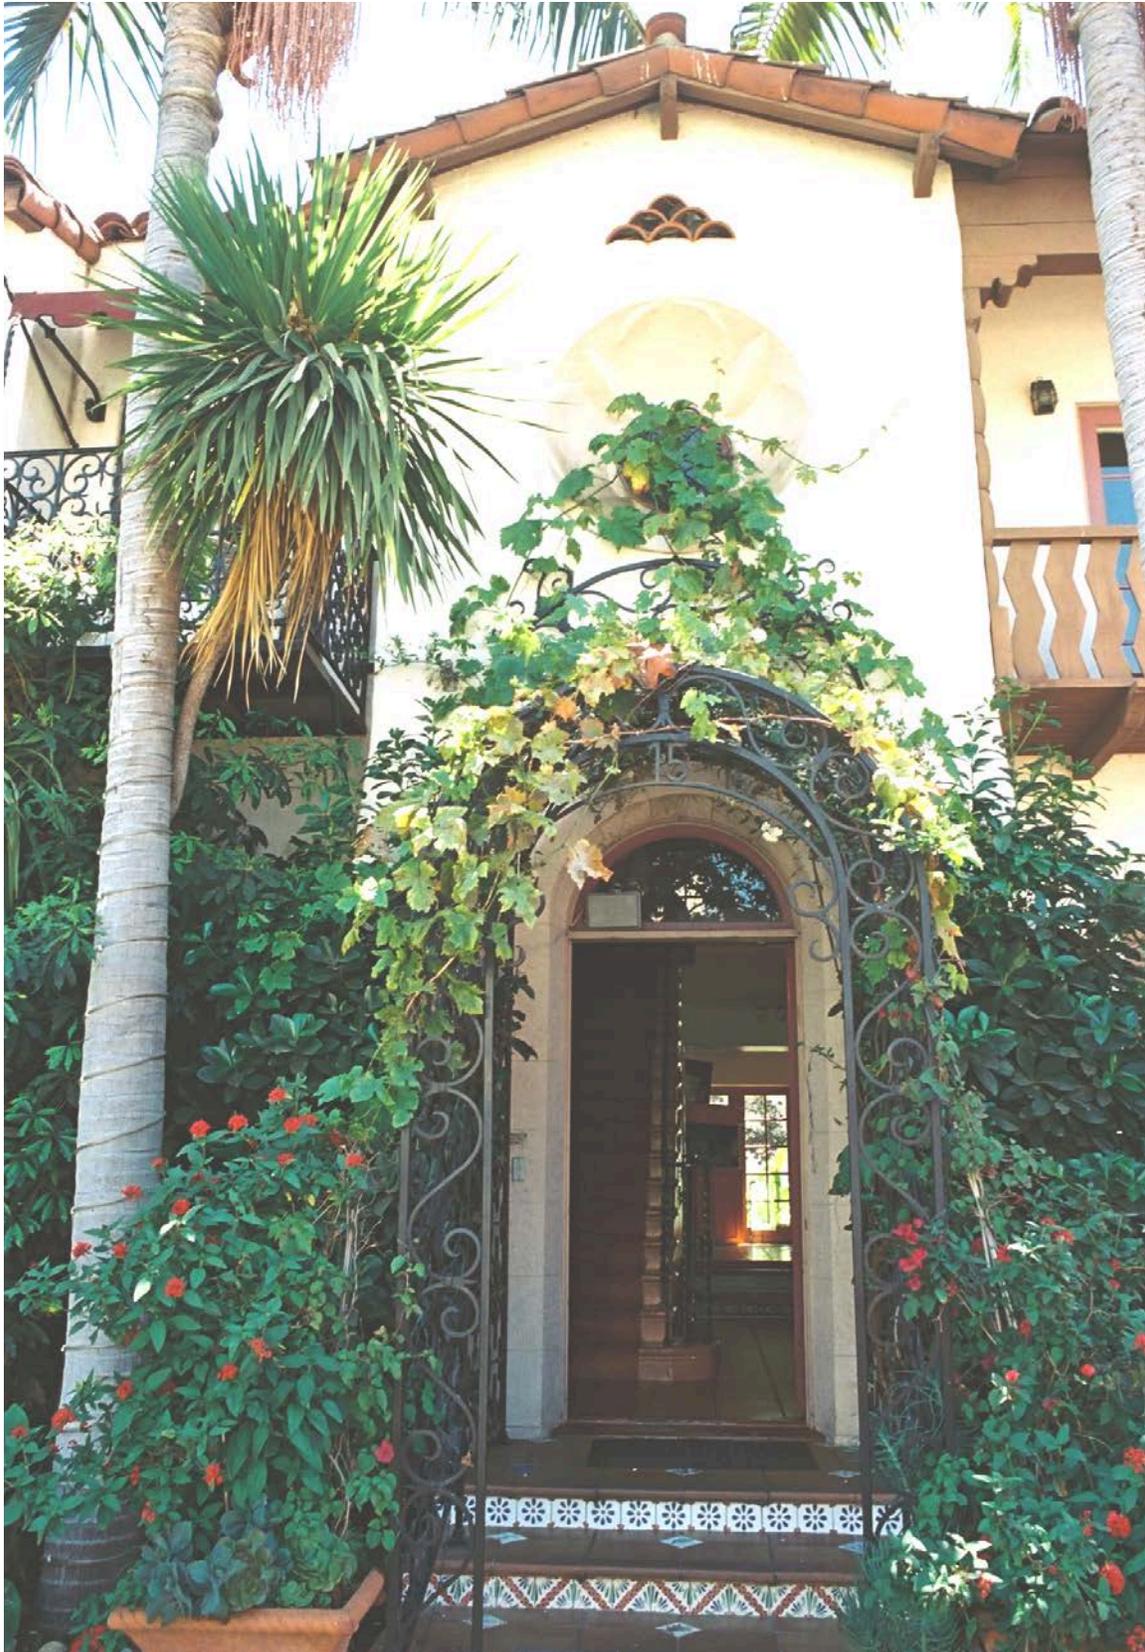
Standards Photo F: small as-built second floor balcony left of main entrance; meets Standards. Arbor over entryway does not meet Standards, to be removed.

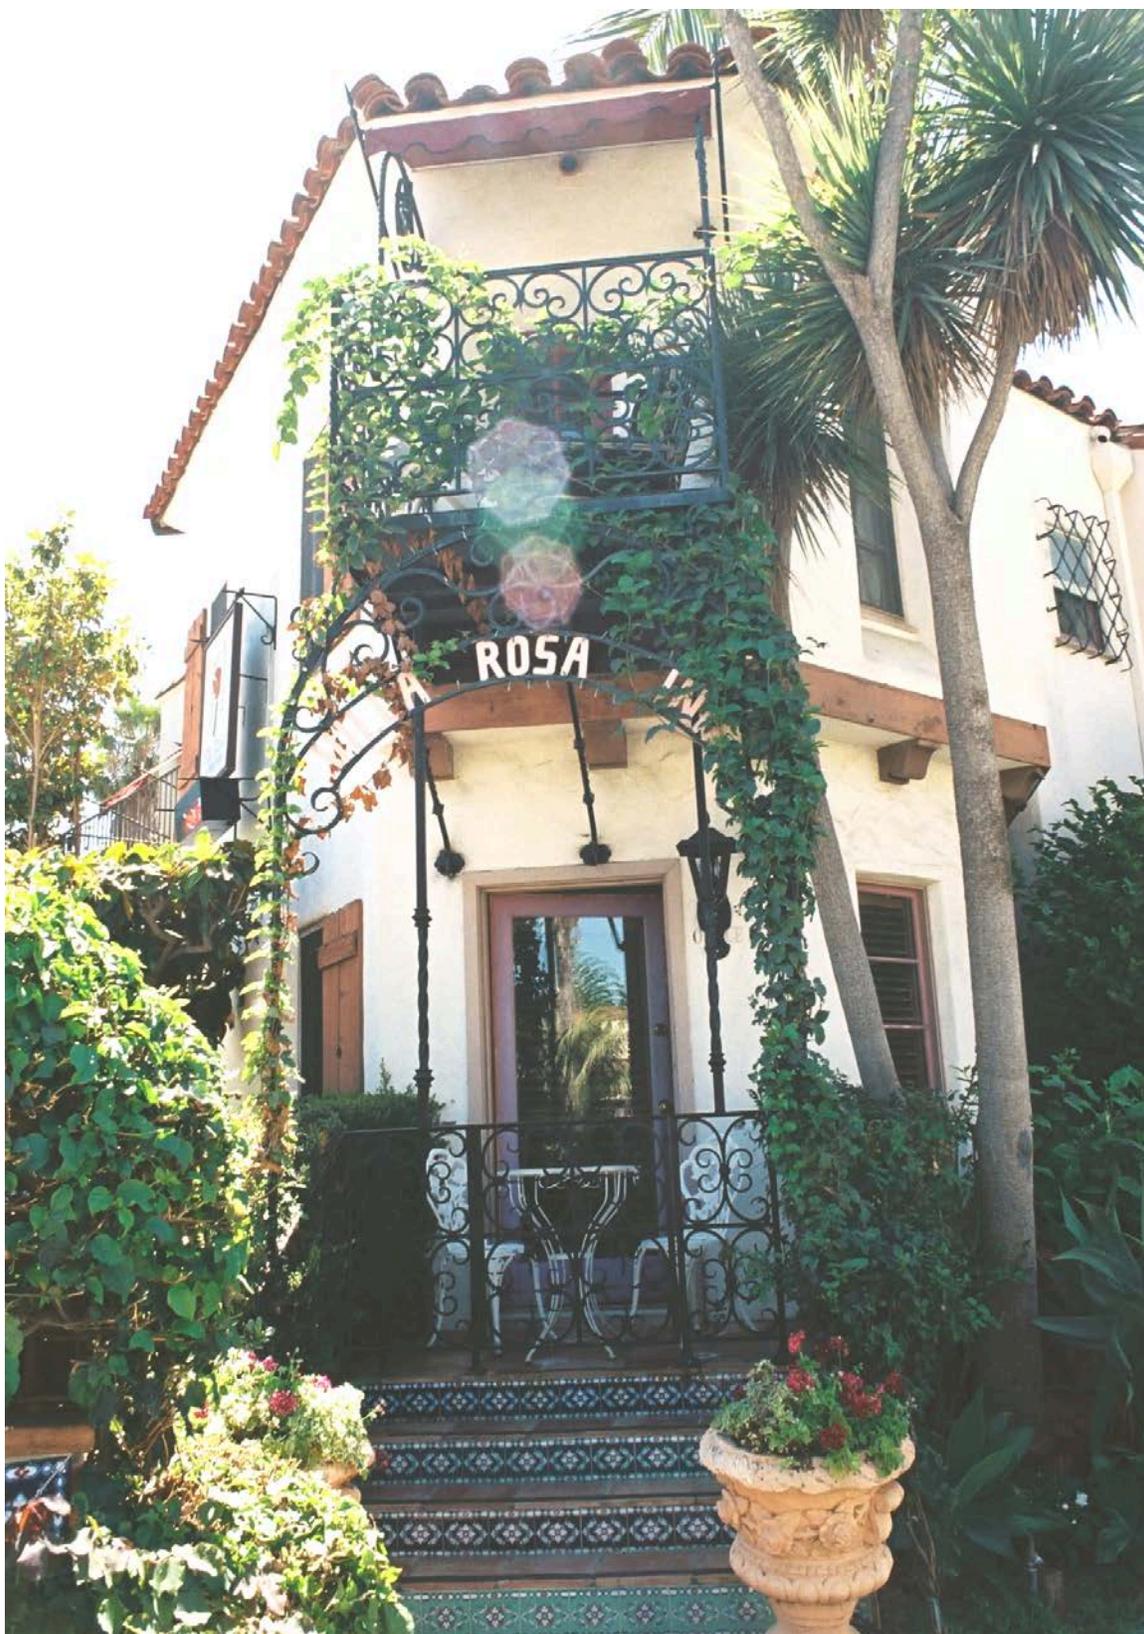
**Standards Photo G: first floor railing, meets Standards.
Arbor and second floor balcony do not meet Standards, need to be removed.**

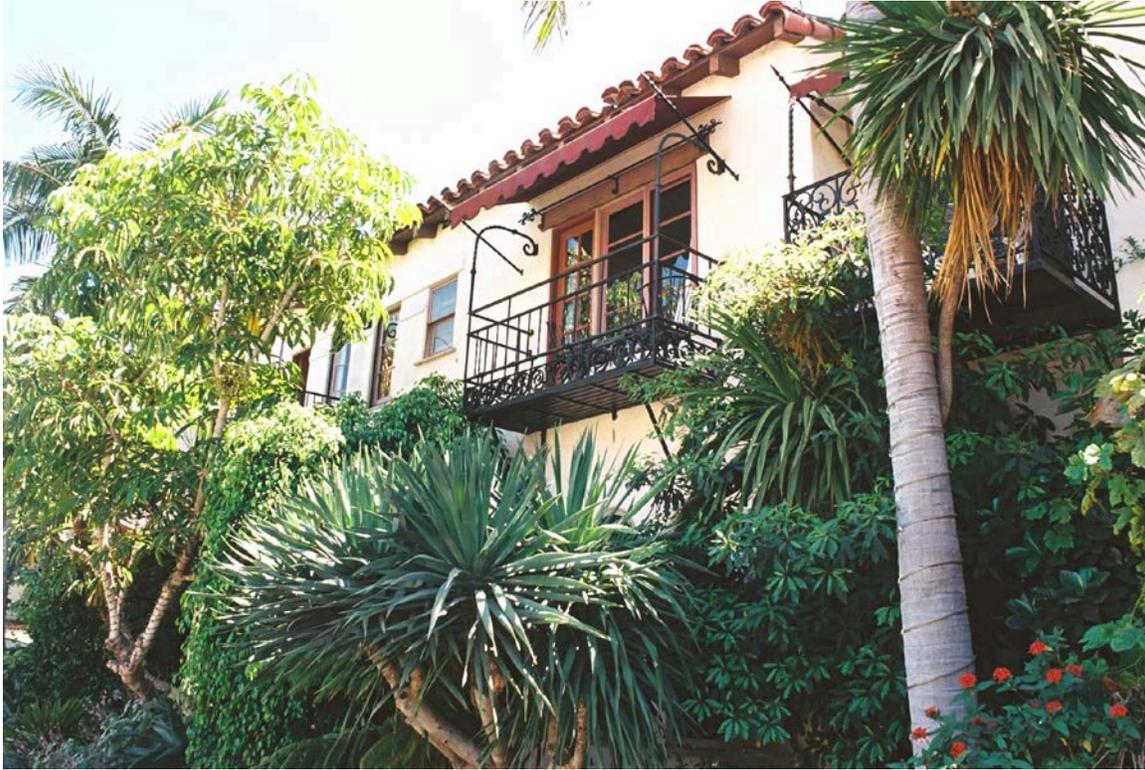
Standards Photo H: second floor balconies left of main entrance; small one on right behind palm meets standards; larger one in center could be modified to meet standards. (Note: balcony behind tree at far left is shown in Standards Photo I below; it could be modified to meet Standards.)

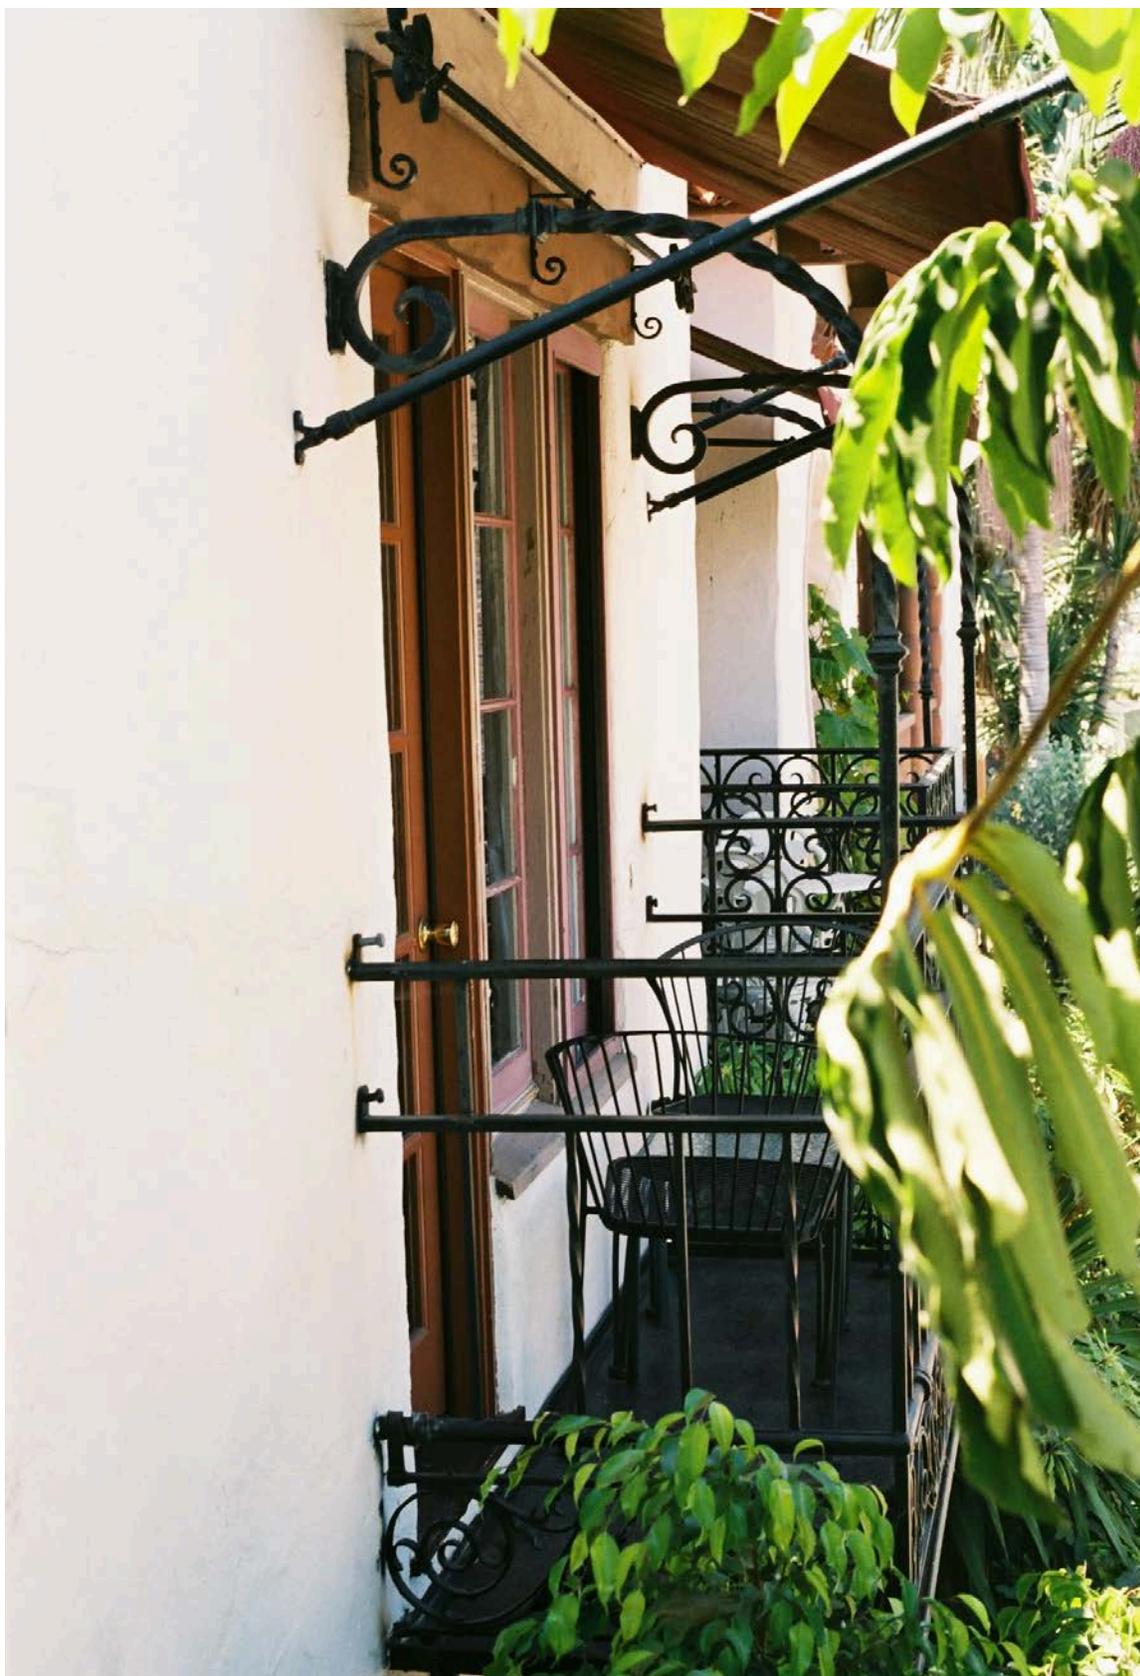
Standards Photo I: second balcony, left of main entrance, that could be modified to meet Standards.

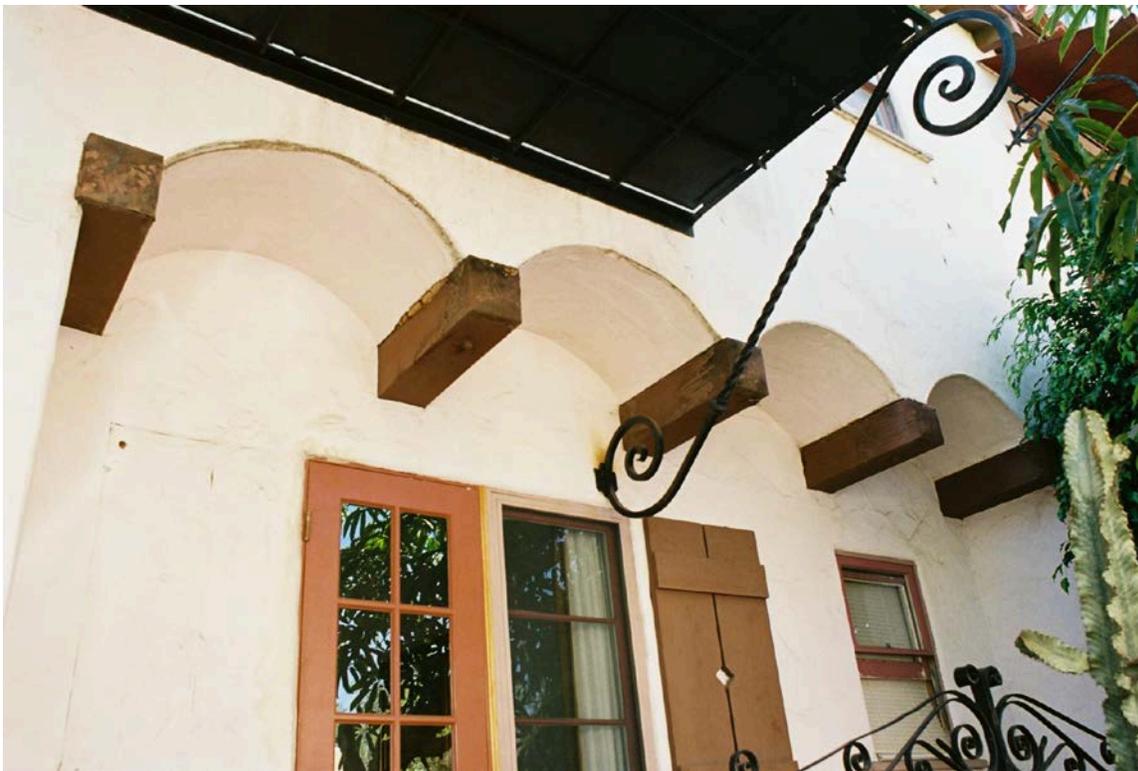
Standards Photo J: second floor balcony of Photo I, showing inappropriate wrought iron support; could be modified to meet Standards.

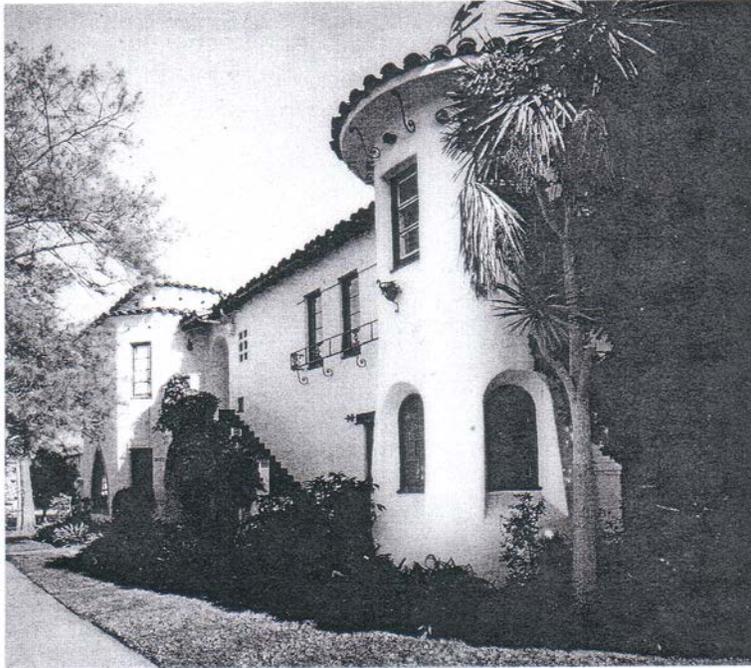
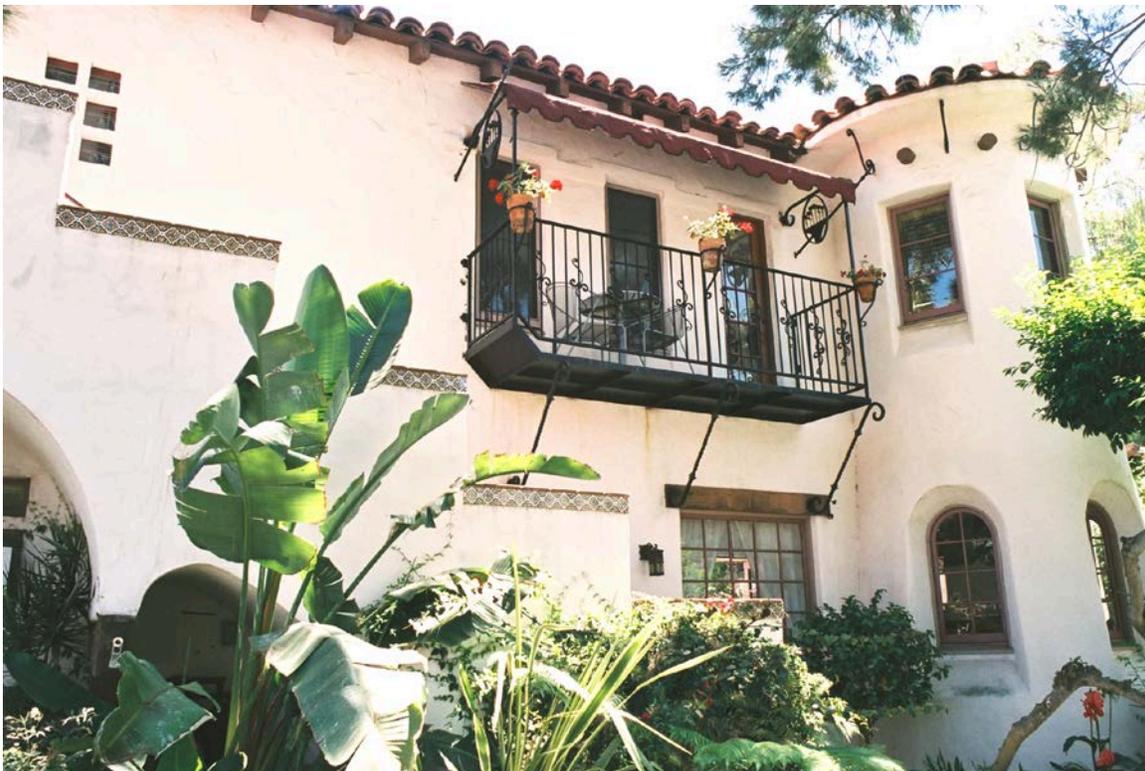
**Standards Photo K top: West Mason elevation, showing original wrought iron balcony, 1995.
Standards Photo L bottom: as-built balcony that could be modified to emulate historic balcony shown in photo K.**

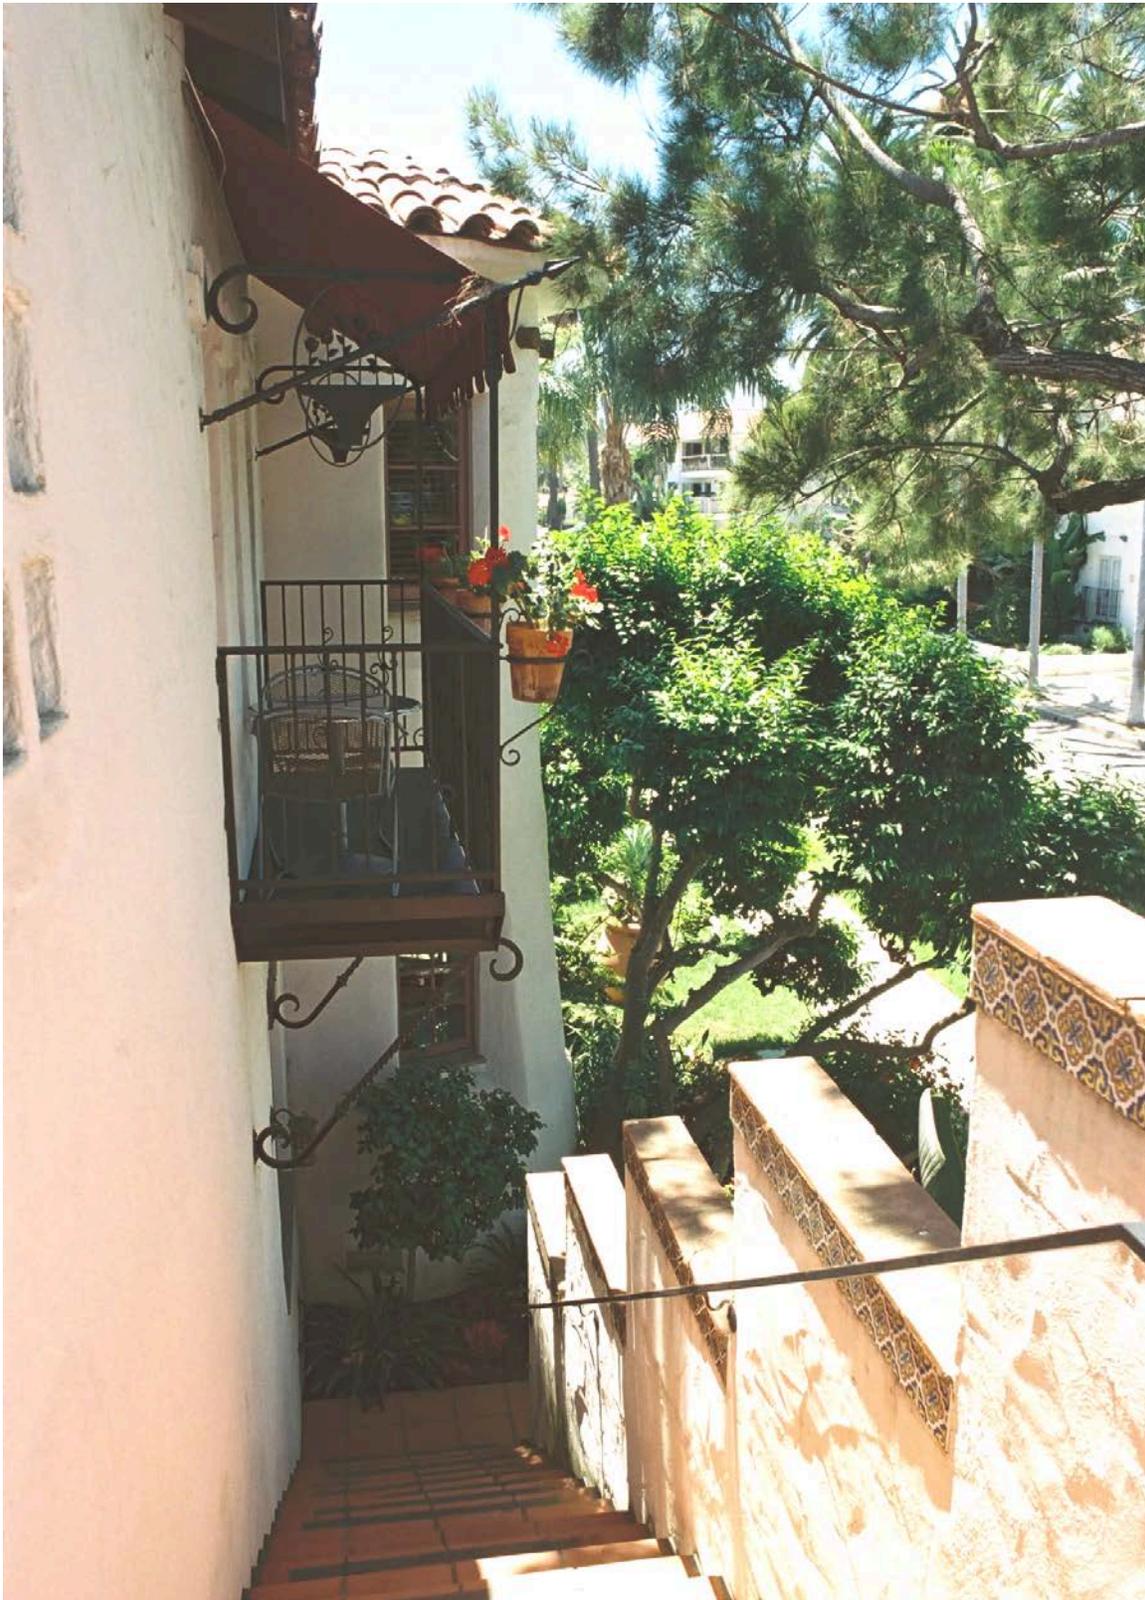
Standards Photo M: as-built balcony of photo L showing how it crowds stairway spatial relationship.

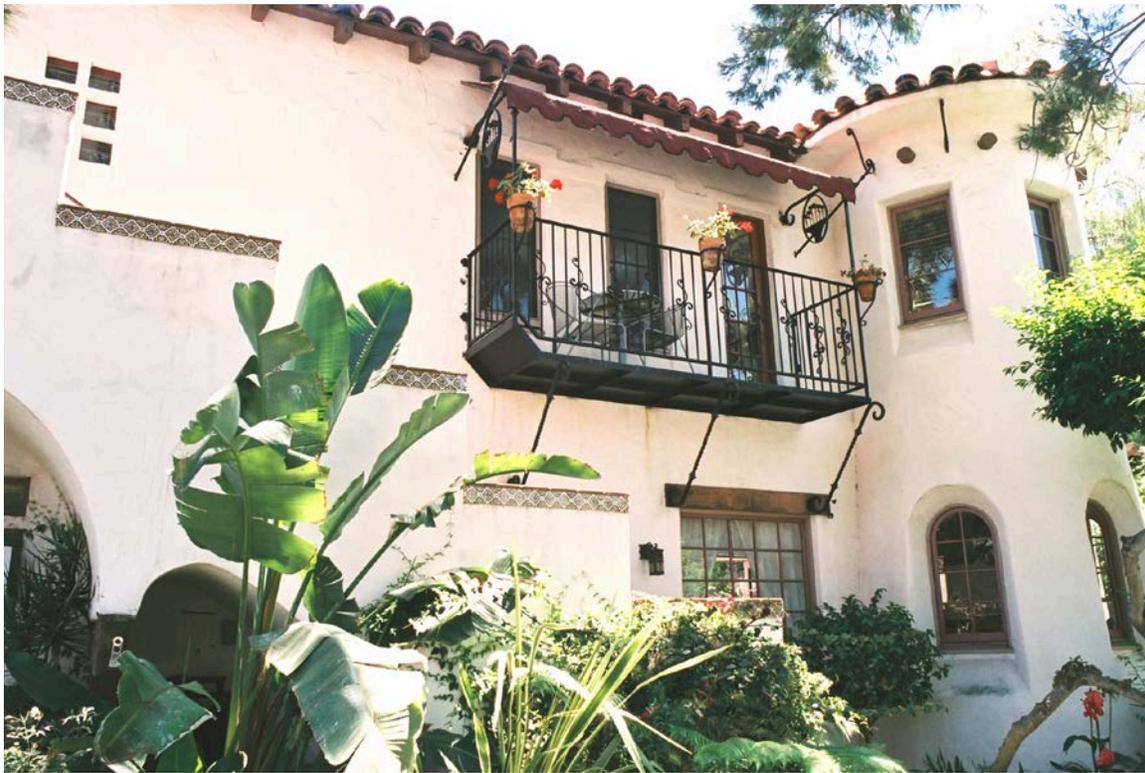
Plate 21: as-built second floor balcony with supports resting on window below; facing southwest.

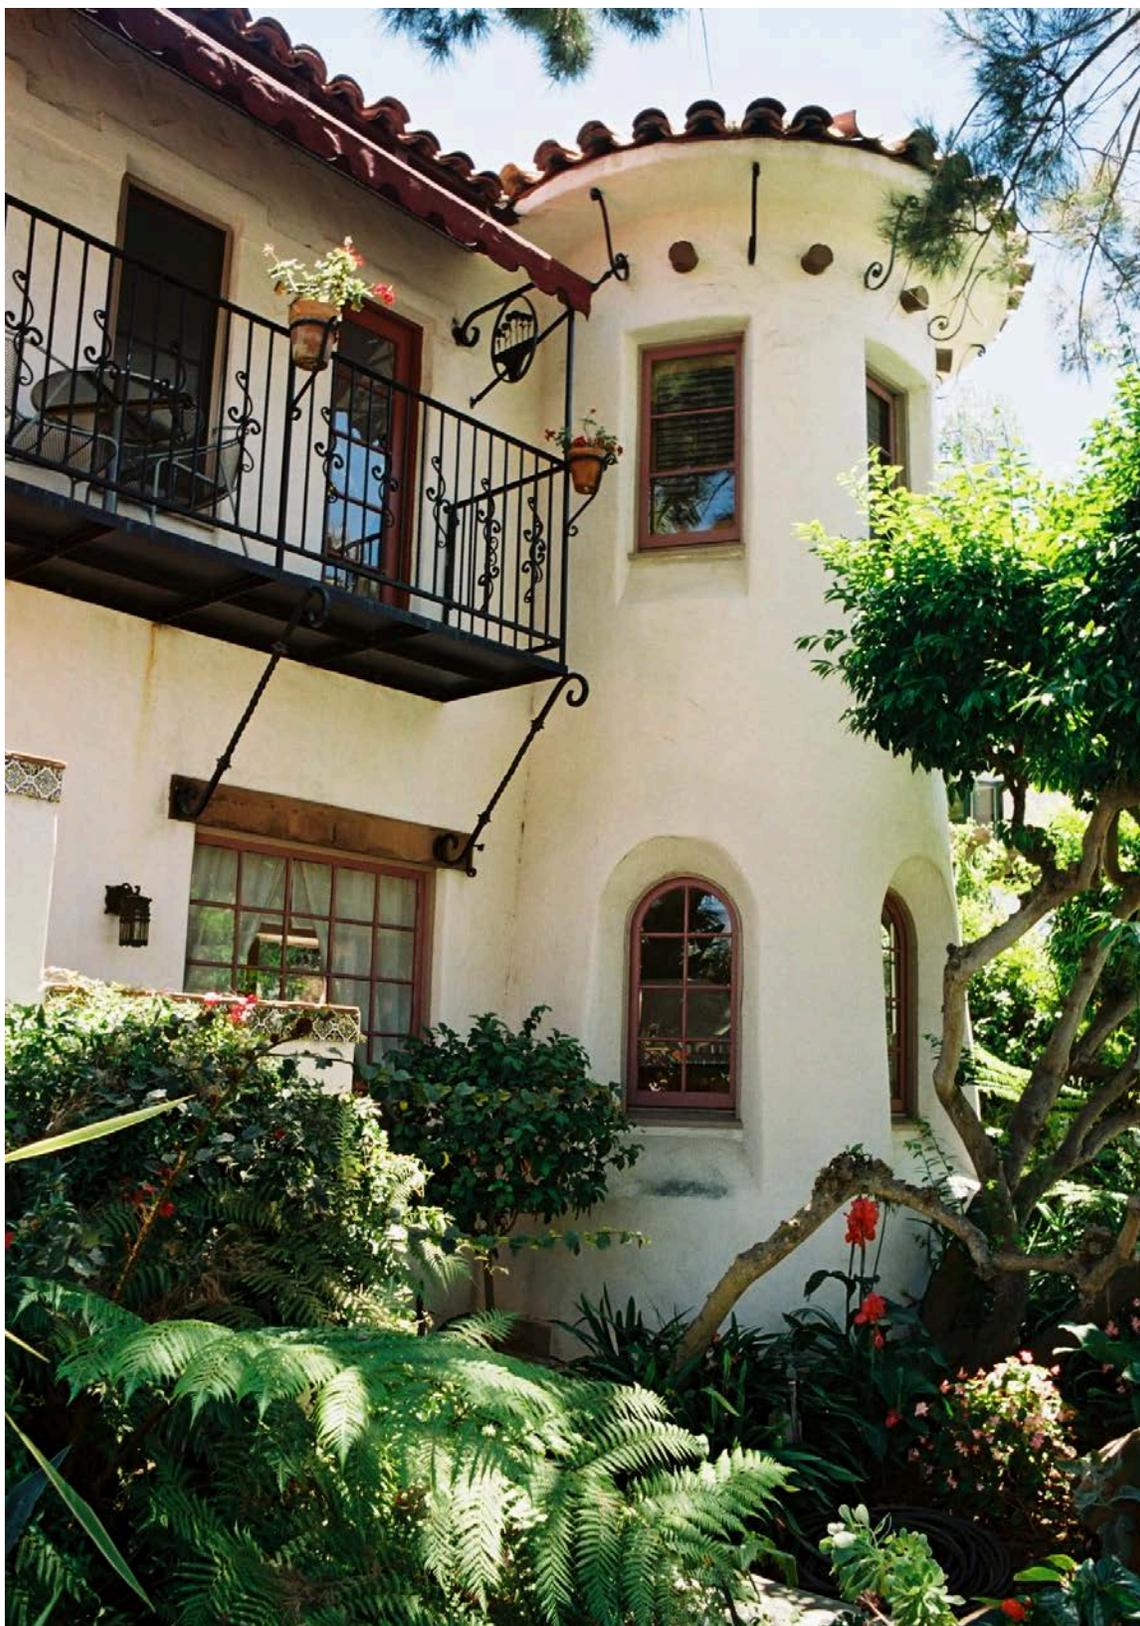
Plate 23: as-built balcony in relation to turret and window below; facing west.
