City of Santa Barbara
Planning Division

SUBJECT: Review of Proposed Mills Act Program Ten-Year Restoration Plan

ADDRESS: 403 Loma Alta Drive

MILLS ACT PROGRAM TEN-YEAR RESTORATION PLAN

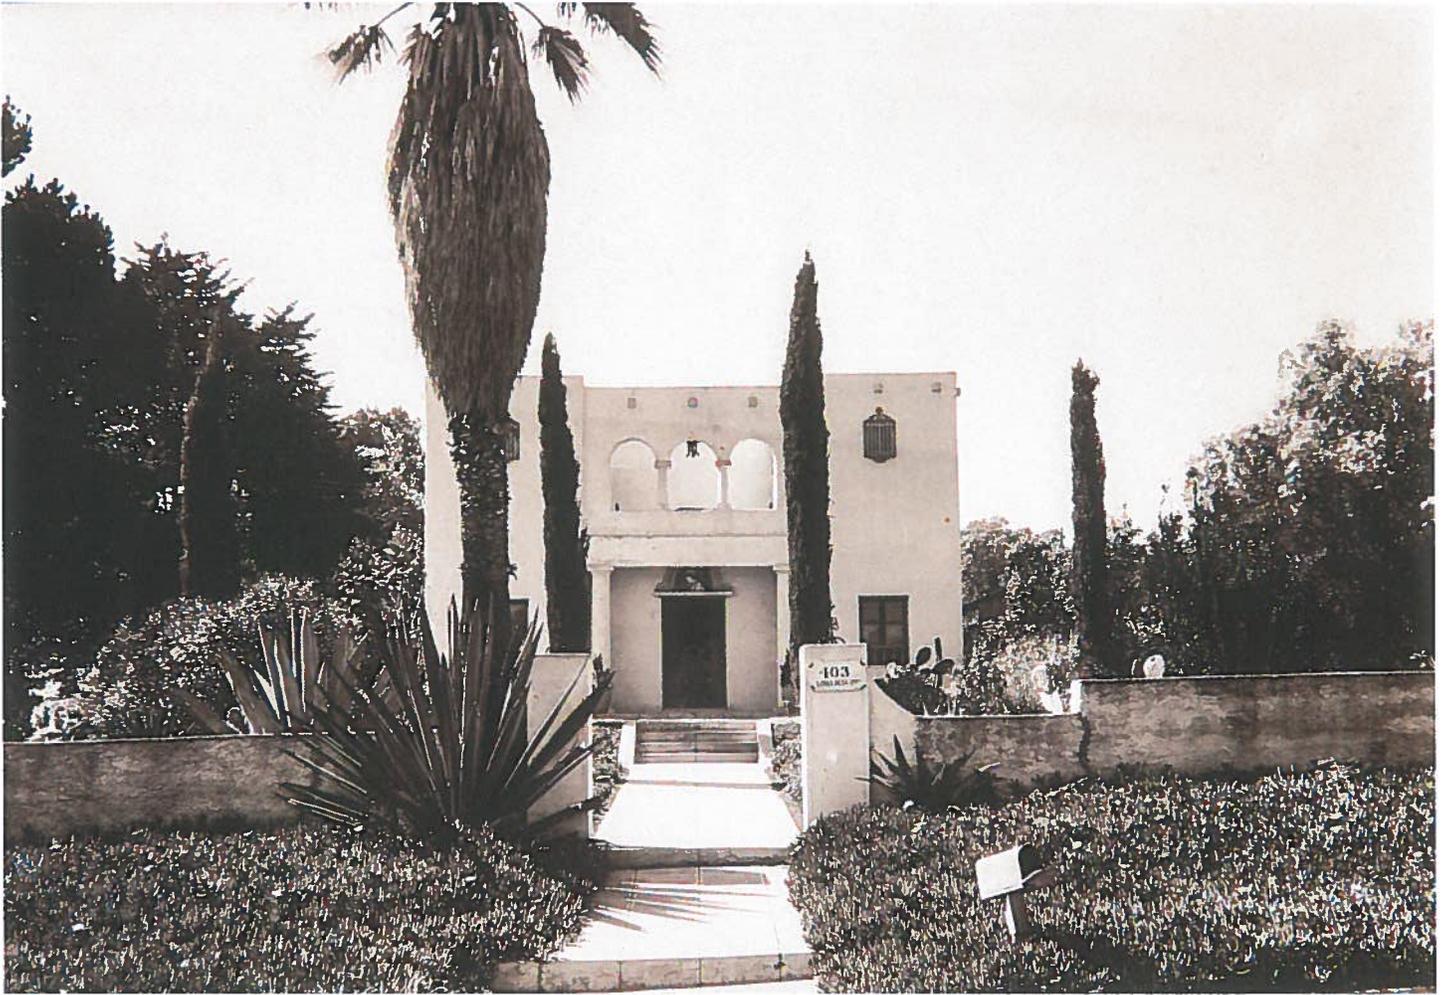
Front Facade

This early photograph shows the original site walls and front elevation, obscured by the current landscape. The original windows at the second level have been filled in and original light fixtures were replaced.

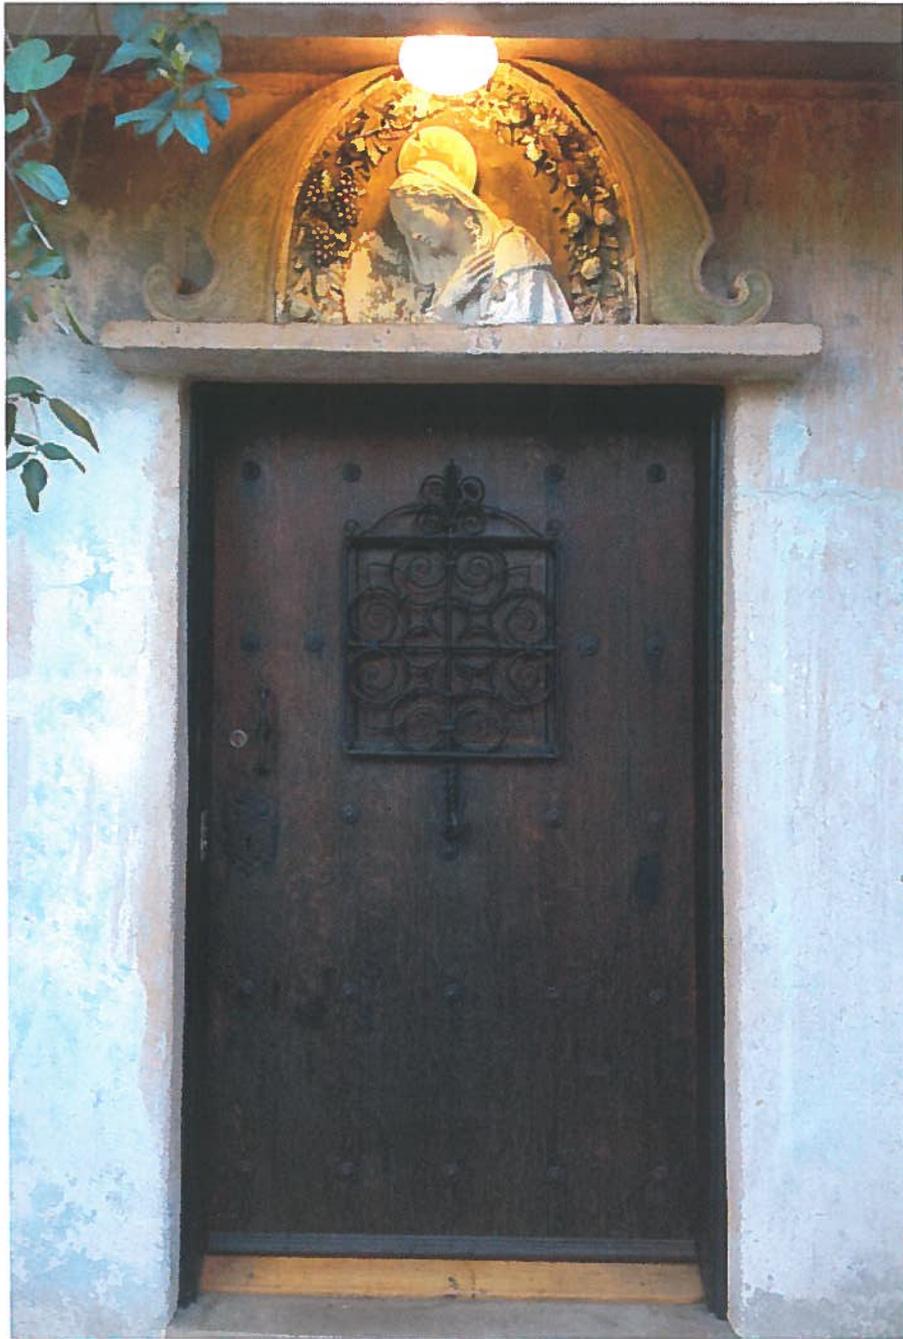
Front Door and Plaster Relief

The front entry door and surround are exposed to morning sun. The wood door, wrought iron grille and plaster Della Robbia plaster relief are weathered and need restoration.

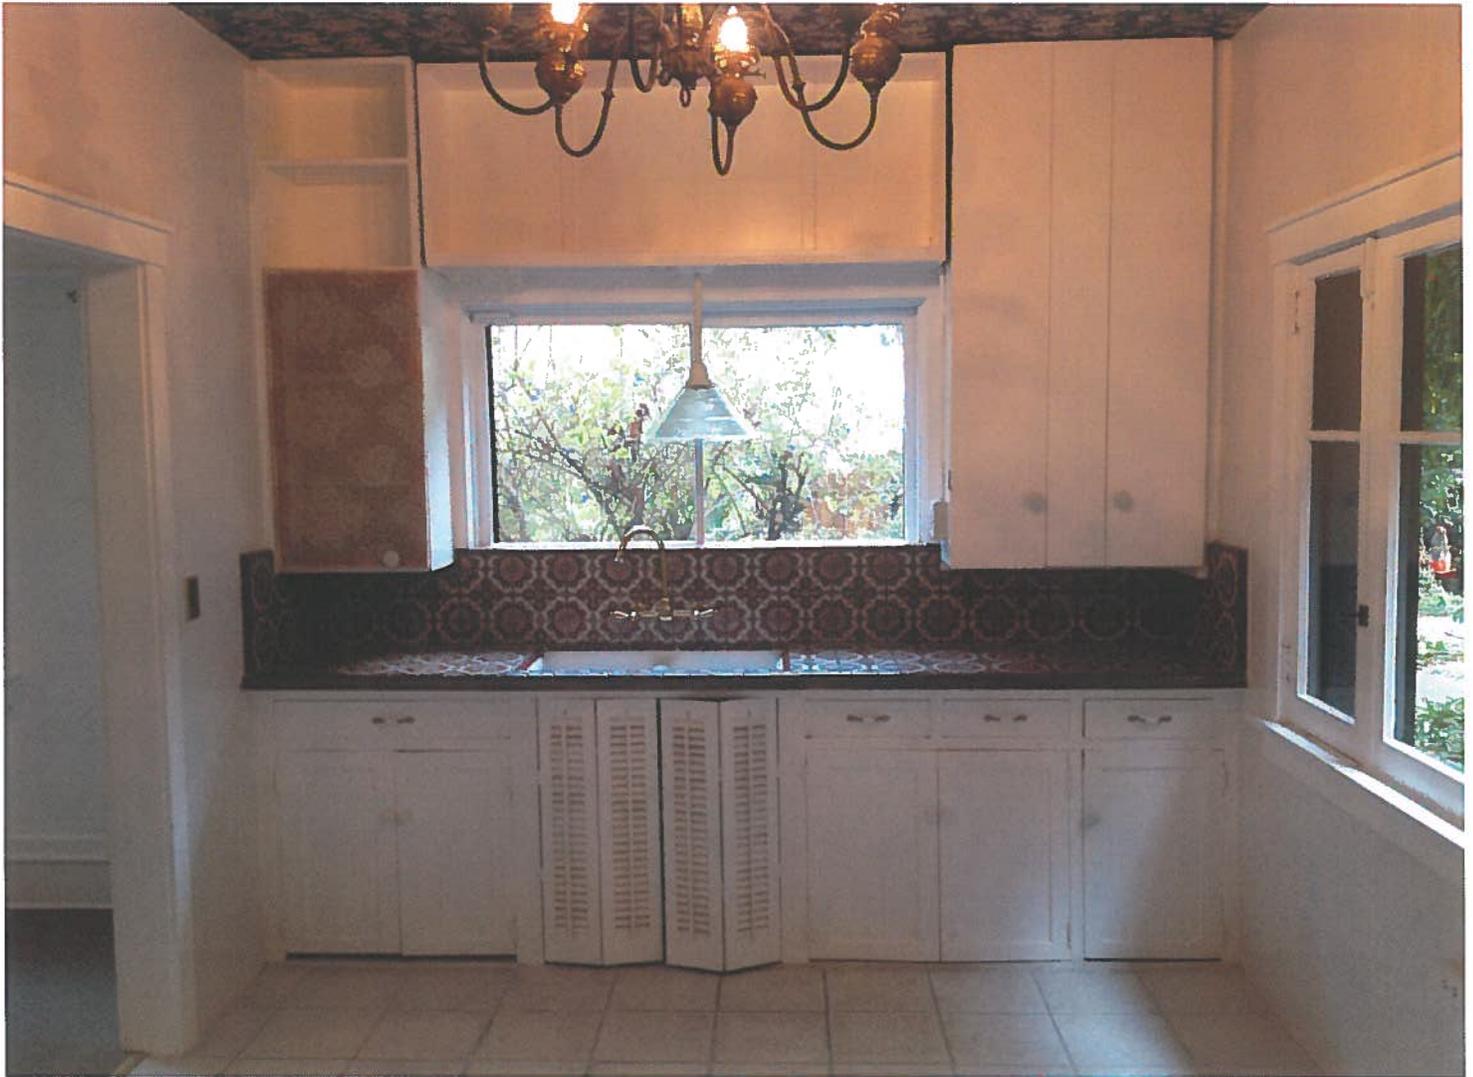
Existing kitchen Cabinets

The kitchen cabinets are in disrepair, the cabinets combine additions and alterations to the original construction. The tile covering the counter and backsplash is from the late sixties, new ceramic tile covers the wood floor. Windows, walls and door trim are in good condition.

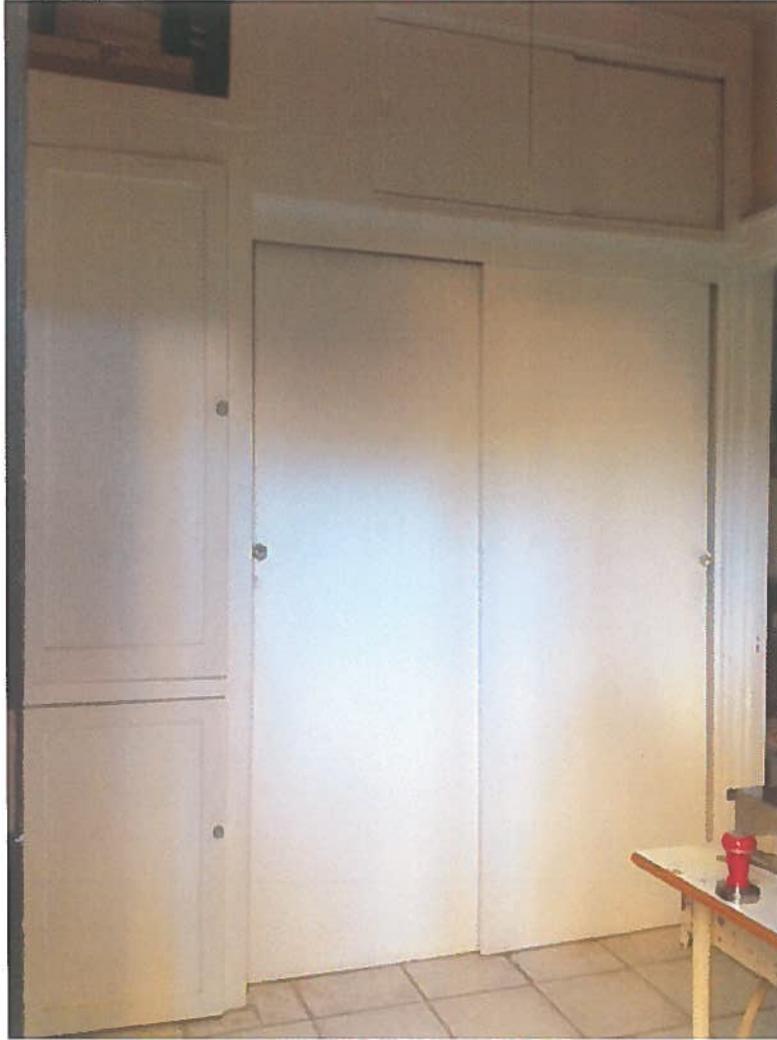
Existing Pantry Cabinets

The existing pantry cabinets are not original to the home. They are poorly constructed of inferior materials and some of the hardware is worn or broken and does not function. The area also has obsolete electrical panels located within the cabinets. The wiring and cabinets need to be rebuilt.

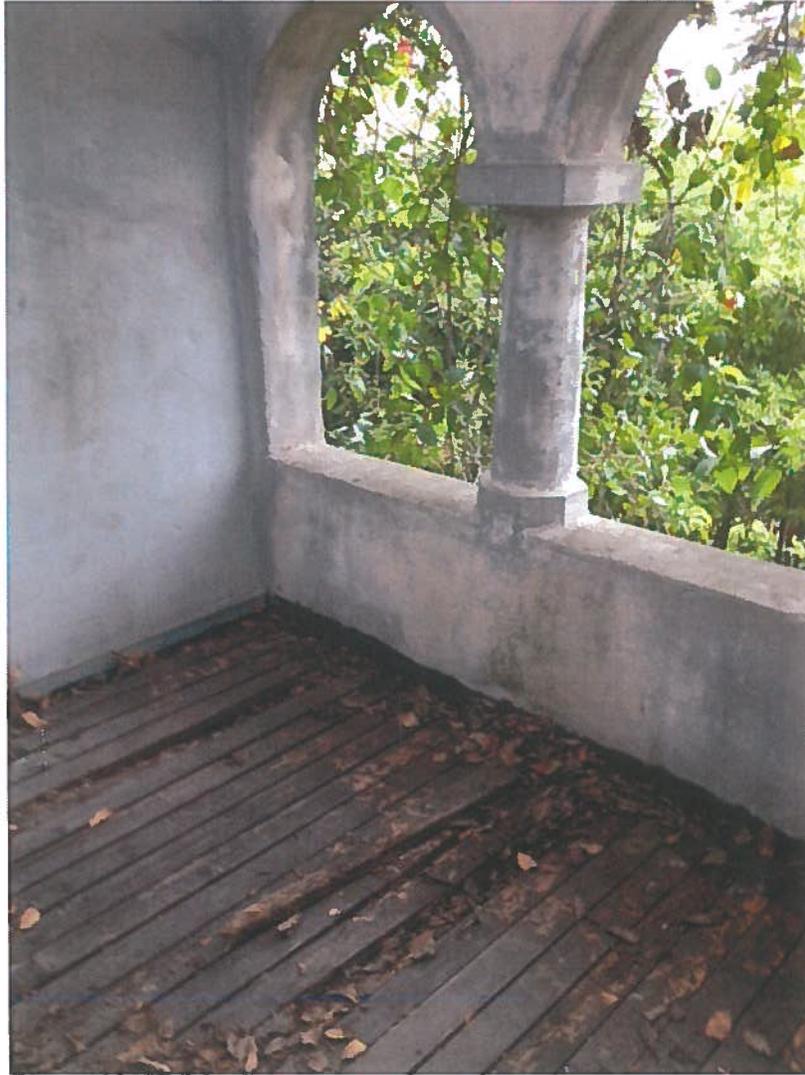
Loggia and Deck

The Loggia is missing the original lighting fixtures and the deck is in disrepair. Repair of the substructure, new waterproofing, new decking and new electrical to the loggia are necessary.

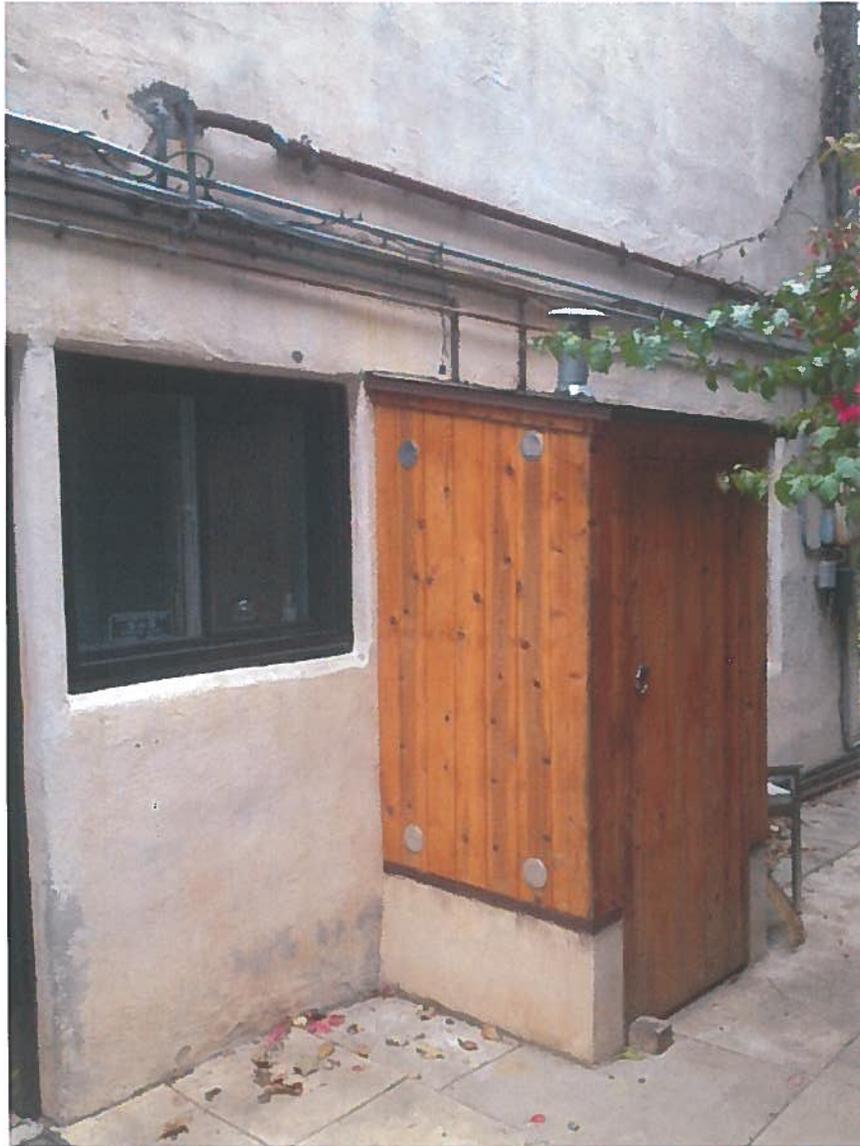
Existing Water Heater and Plumbing

The water heater is located outside the kitchen in a simple wood enclosure. The addition is not compatible with the historic exterior design and the location compromises the function of the patio. A tankless system would replace the shed element and restore the aesthetics and use of the back patio.

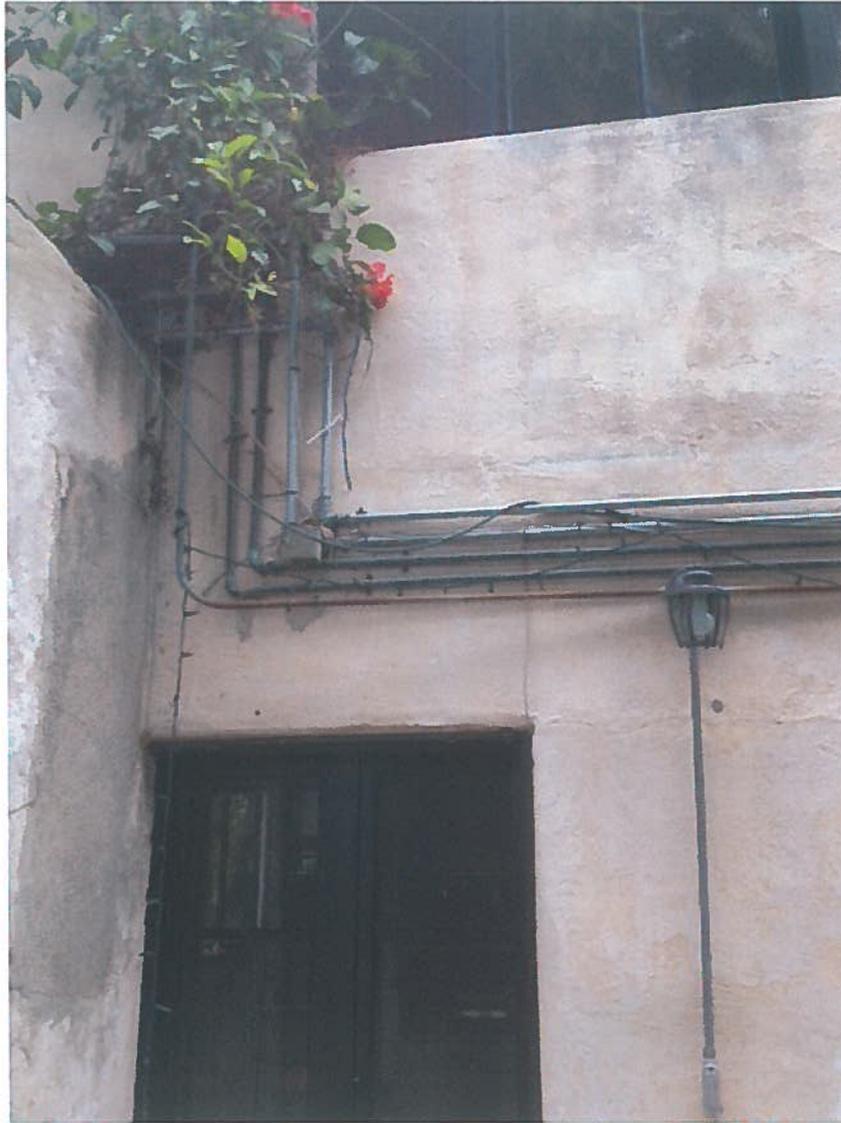
Exterior Electrical and Plumbing

The house has exposed electrical runs and plumbing on the sides and rear of the house. The installation is not to code and needs upgraded.

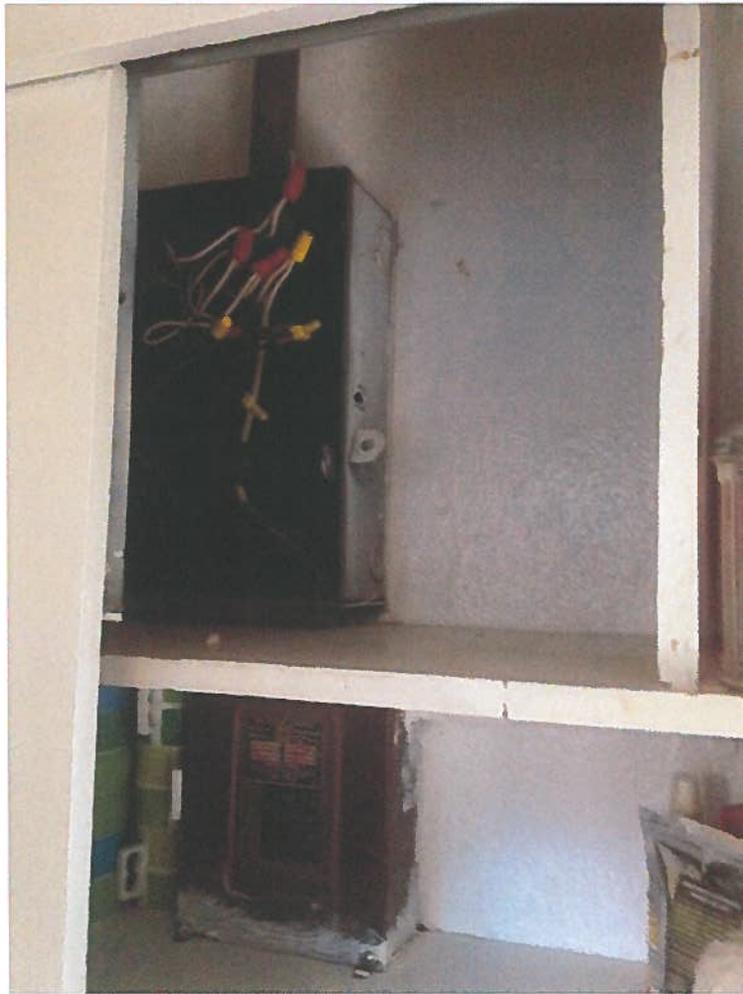
Electrical Service

The electrical service was expanded in piecemeal fashion over time. There is original knob and tube and surface mount wiring with several fuse boxes. A complete analysis of the existing circuits and upgrade or replacement of the substandard circuits is needed .

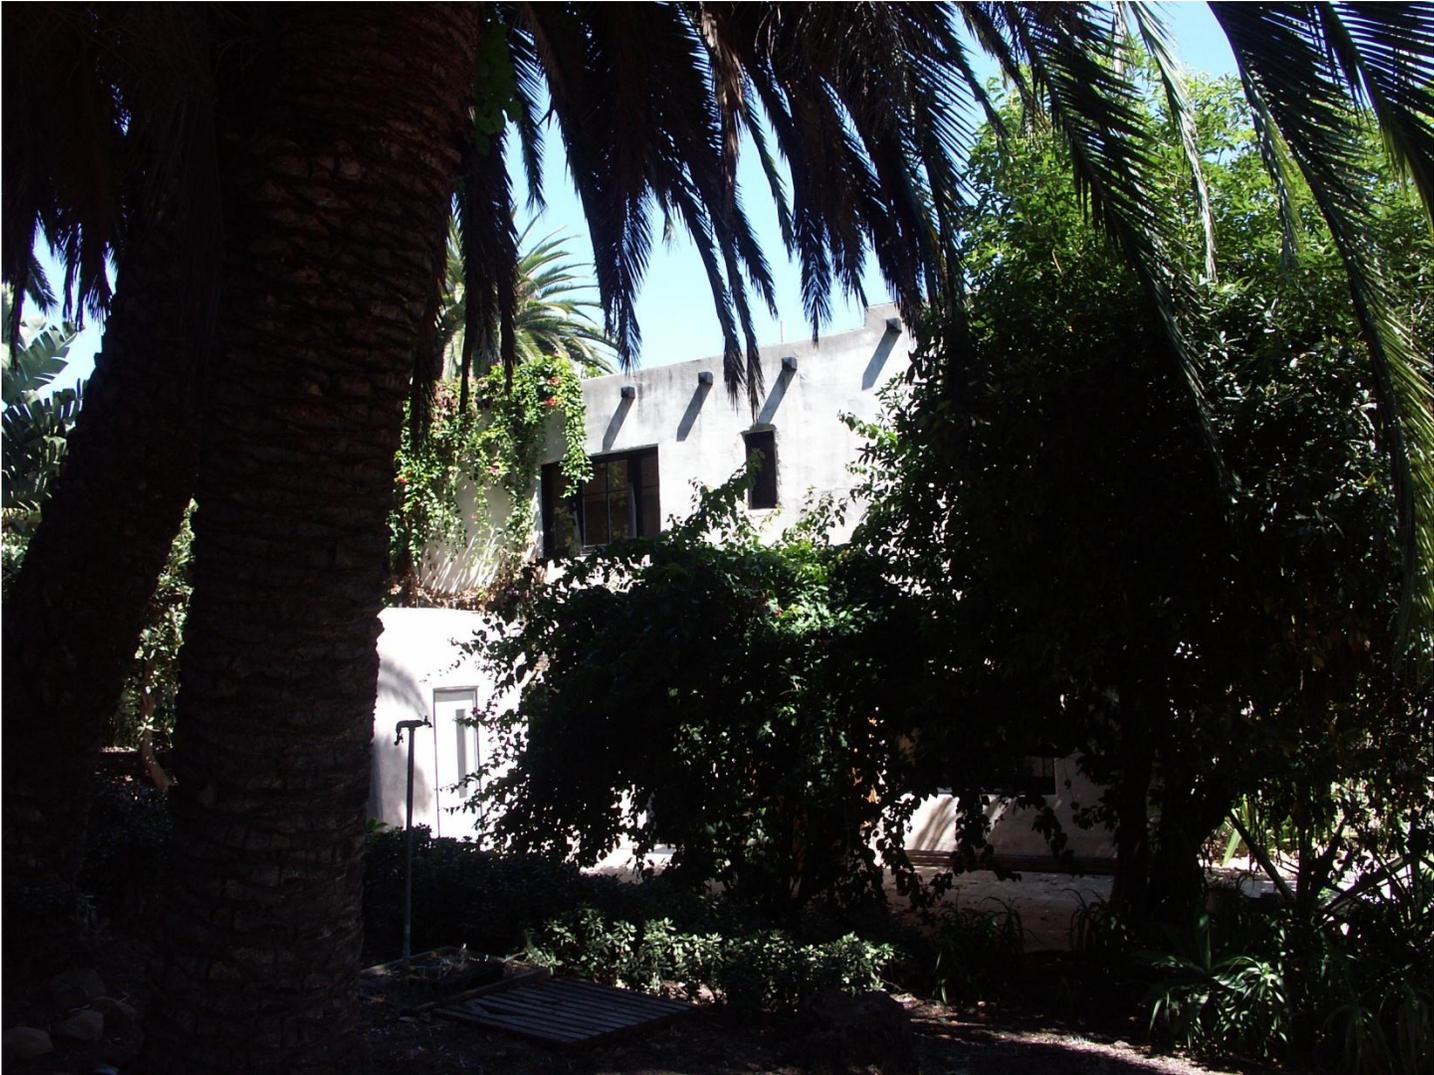
Landscape Irrigation

The half acre site has several distinct landscape environments with rare plantings. The grounds include a succulent garden, palm grove, cactus garden, bamboo maze and citrus trees.
