State of California — The Resources Agency
 DEPARTMENT OF PARKS AND RECREATION
PRIMARY RECORD

2015 **Quinientos Street Bridge Replacement:** Consistency of Historical Resources Evaluation Report (HRER) with the *City of Santa Barbara Master Environmental Assessment (MEA) Guidelines for Archaeological Resources and Historic Structures and Sites* (January 2002), Historic Structures/Sites Report Requirements. Applied EarthWorks, Inc., Lompoc, California. Prepared for the City of Santa Barbara Department of Public Works and Community Development.

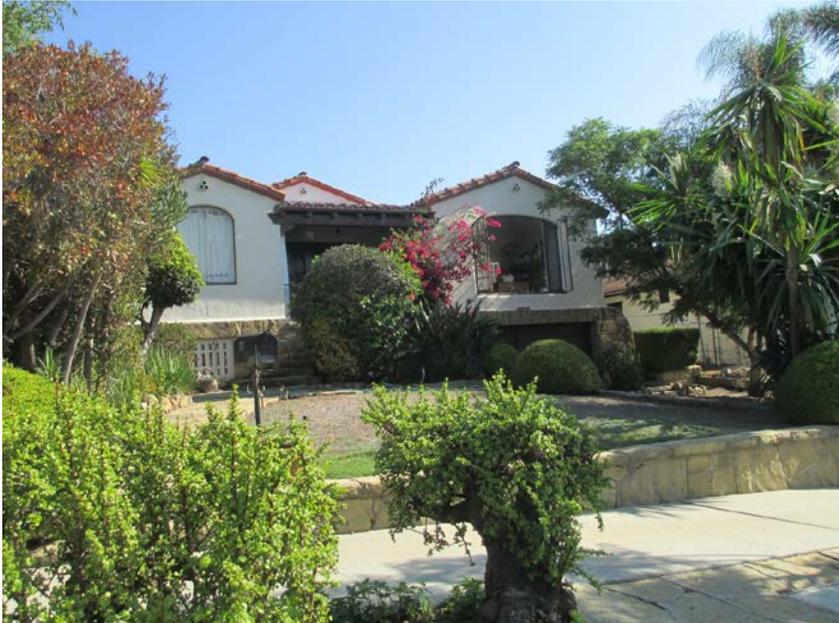
*P5a. **Photograph**

*P3a. **Description:** The subject property is located in the Casitas Tract, a subdivision created in 1922. In February 1933, owner/contractor Arcangelo Goggia applied for a building permit to construct a single family dwelling with a garage beneath on the undeveloped parcel (Building Permit # A-7728). Based on a review of digitized building permits and the windshield survey conducted in 2015, this Spanish Colonial Revival style dwelling appears unaltered. Property owner Arcangelo Goggia is identified as a masonry contractor in the 1994 Noticias "Rock of Ages" article and his work includes "William P. Gould's olive mill and the walls of the Edward Ryerson estate" (Cleek 1994:17). Goggia resided in the subject dwelling from 1933 until his death in 1967.

The subject property has not been exhaustively researched or formally evaluated for historical significance. As the property appears to be a good example of a middle class dwelling constructed in the Spanish Colonial Revival architectural style, a style important to the unique identity and heritage of the city of Santa Barbara, it is recommended for further research and eligibility consideration as a Structure of Merit. The subject property may also be significant for its association with stone mason Arcangelo Goggia.

*P5b. **Description of Photo:** Looking east at the street-facing west façade.

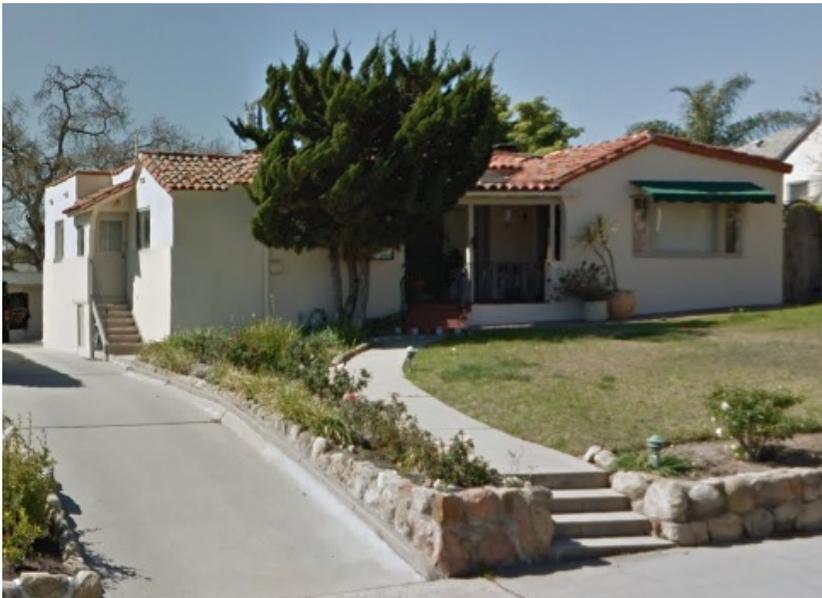
*P5a. **Photograph**

*P3a. **Description:** The subject property is located in the Casitas Tract, a subdivision created in 1922. Based on Santa Barbara County Assessor records, the dwelling was constructed in 1925. In November 1930, owner/contractor Henry Paulson applied for a building permit to construct a single car garage at the rear of the parcel (Building Permit # A-6347). Based on the windshield survey and a review of digitized building permits, the Spanish Colonial Revival style building has undergone some modifications including the addition of a skylight in the front porch roof, replacement of exterior doors, replacement of windows on the south façade, and the extension of the exterior kitchen wall. At this time, the modifications do not appear to significantly diminish the overall integrity of the property.

The subject property has not been exhaustively researched or formally evaluated for historical significance. As the property appears to be a good example of a middle class dwelling constructed in the Spanish Colonial Revival architectural style, a style important to the unique identity and heritage of the city of Santa Barbara, it is recommended for further research and eligibility consideration as a Structure of Merit.

*P5b. **Description of Photo:** Looking west at the south and east (street-facing) façades.

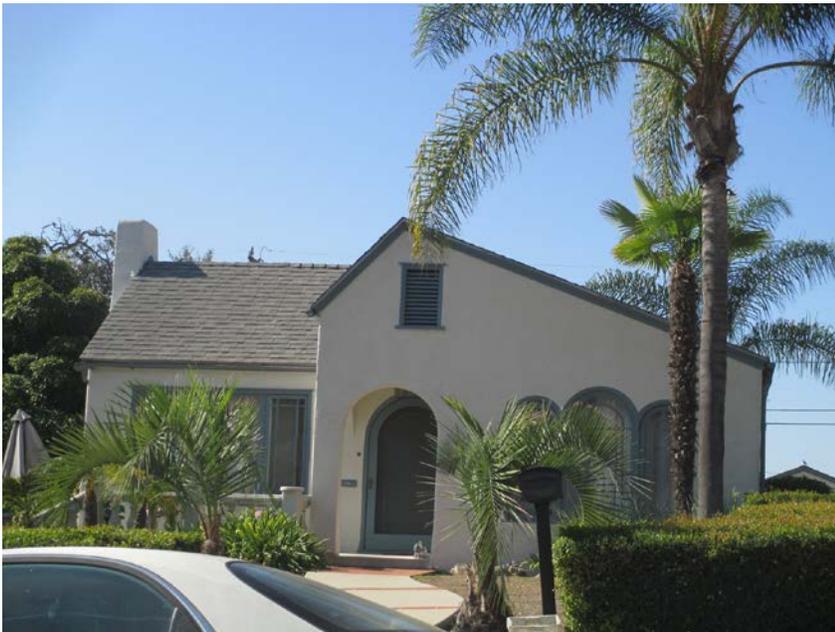
*P5a. **Photograph**

*P3a. **Description:** The subject property is located in the Casitas Tract, a subdivision created in 1922. Based on Santa Barbara County Assessor records, the Spanish Colonial Revival style dwelling was constructed in 1923. The 1923 city directory lists Charles and Pansy Woods as residing on the subject property. In June 1931, owner Charles D. Wood applied for a building permit to add a room to the rear west façade (Building Permit # A-6811). In 1984, an enclosed spa room was added to the rear west façade. The rear additions do not diminish the integrity of the property and the character-defining features of the dwelling remain unaltered.

The subject property has not been exhaustively researched or formally evaluated for historical significance. As the property appears to be a good example of a middle class dwelling constructed in the Spanish Colonial Revival architectural style, a style important to the unique identity and heritage of the city of Santa Barbara, it is recommended for further research and eligibility consideration as a Structure of Merit.

*P5b. **Description of Photo:** Looking west at the east (street-facing) façade.

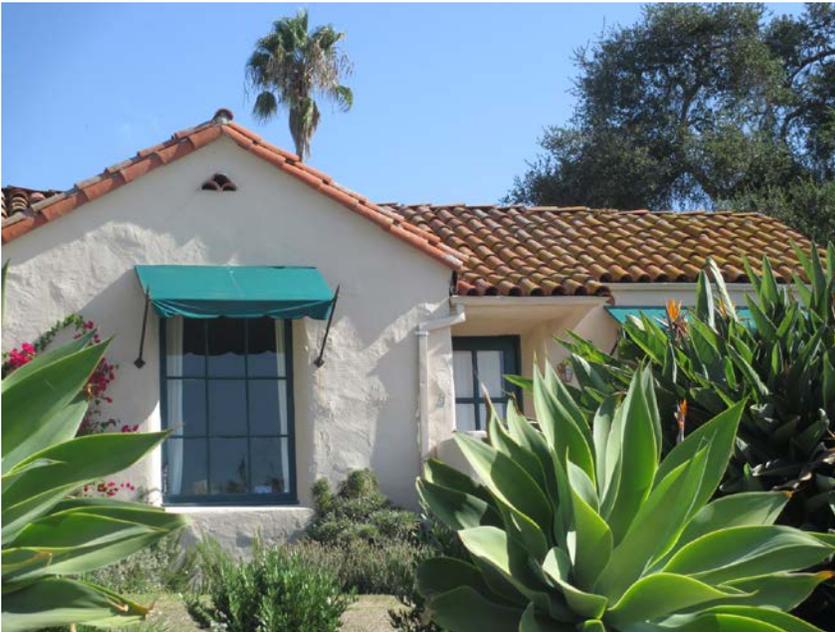
*P5a. Photograph

*P3a. Description: The subject property is located in the Casitas Tract, a subdivision created in 1922. In January 1926, owner/contractor John A. Malloy applied for a building permit to construct a dwelling and garage on the undeveloped parcel (Building Permit # A-1392). Although the only other building permits on file are for roof work, it appears that some of the windows have been replaced at an unknown time. The alteration does not appear to significantly diminish the integrity of the property.

The subject property has not been exhaustively researched or formally evaluated for historical significance. As the property appears to be a good example of a middle class dwelling constructed in the Spanish Colonial Revival architectural style, a style important to the unique identity and heritage of the city of Santa Barbara, it is recommended for further research and eligibility consideration as a Structure of Merit.

*P5b. Description of Photo: Looking east at the west (street-facing) façade.

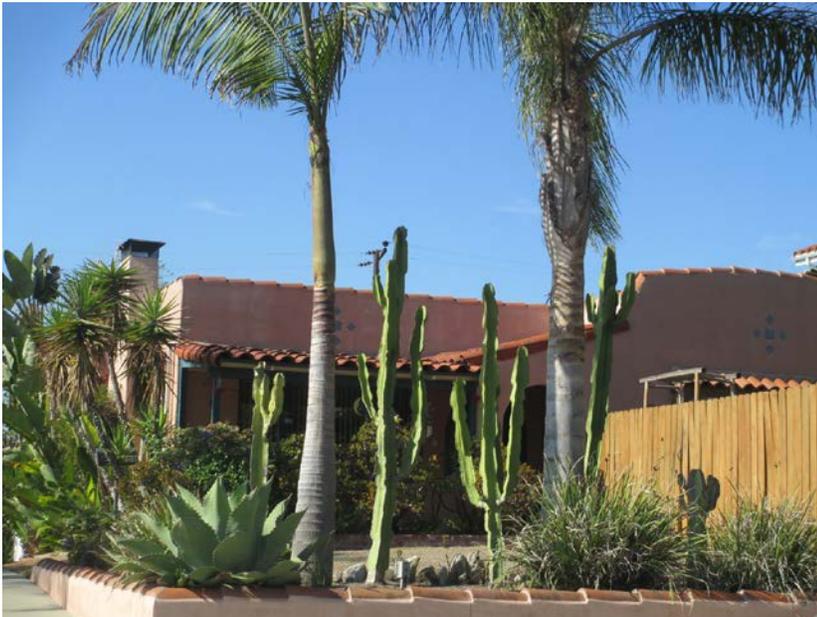
*P5a. **Photograph**

*P3a. **Description:** The subject property is located in the Casitas Tract, a subdivision created in 1922. Based on City Directories, the subject dwelling was constructed by 1923. Lawrence Colby Mollett and his wife Grace are residing on the property in that year but moved to another property by 1924. In November 1957, owner Lester Buell applied for a building permit to convert the dwelling into a duplex with a large addition to the rear of the dwelling (Building Permit # F-6162). The rear addition does not significantly diminish the integrity of the property and the character-defining features of the Spanish Colonial Revival dwelling appear unaltered.

The subject property has not been exhaustively researched or formally evaluated for historical significance. As the property appears to be a good example of a middle class dwelling constructed in the Spanish Colonial Revival architectural style, a style important to the unique identity and heritage of the city of Santa Barbara, it is recommended for further research and eligibility consideration as a Structure of Merit.

*P5b. **Description of Photo:** Looking west at the east (street-facing) façade.

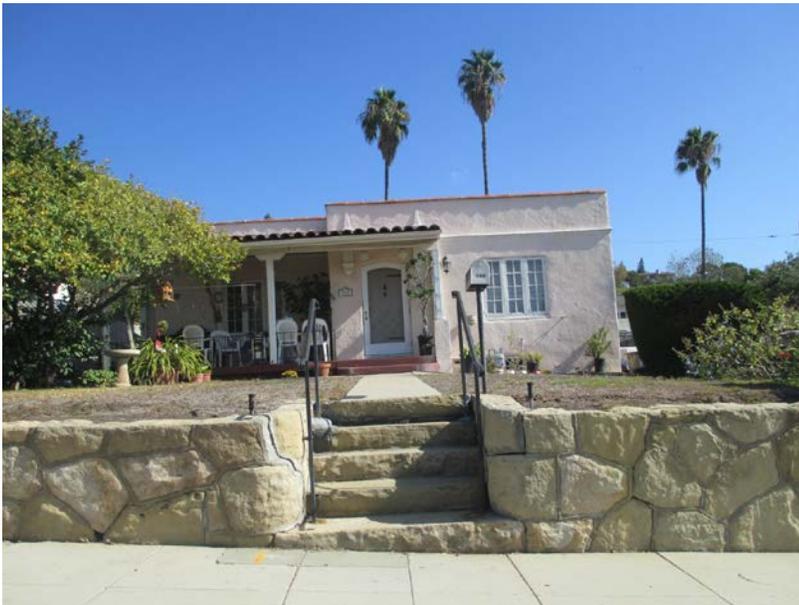
***P5a. Photograph**

*P3a. Description: The subject property is located in the Casitas Tract, a subdivision created in 1922. Based on City Directories and Santa Barbara County Assessor records, the subject dwelling was constructed in 1923. John O'Malley and his wife Elizabeth resided on the property from 1923 to 1938. John O'Malley worked as a plaster contractor and likely applied the decorative plaster work above the front entrance door. The current entrance porch roof partially conceals the decorative feature. Subsequent property owners Anthony and Grace Della added the masonry retaining wall along the west parcel boundary in 1938 (Building Permit # B-3038). The character-defining features of the original dwelling are unaltered and the entrance porch, if removed, would reveal the decorative plaster work. As such, the porch does not significantly diminish the integrity of the property.

The subject property has not been exhaustively researched or formally evaluated for historical significance. As the property appears to be a good example of a middle class dwelling constructed in the Spanish Colonial Revival architectural style, a style important to the unique identity and heritage of the city of Santa Barbara, it is recommended for further research and eligibility consideration as a Structure of Merit.

P5b. Description of Photo: Looking east at the west (street-facing) façade.

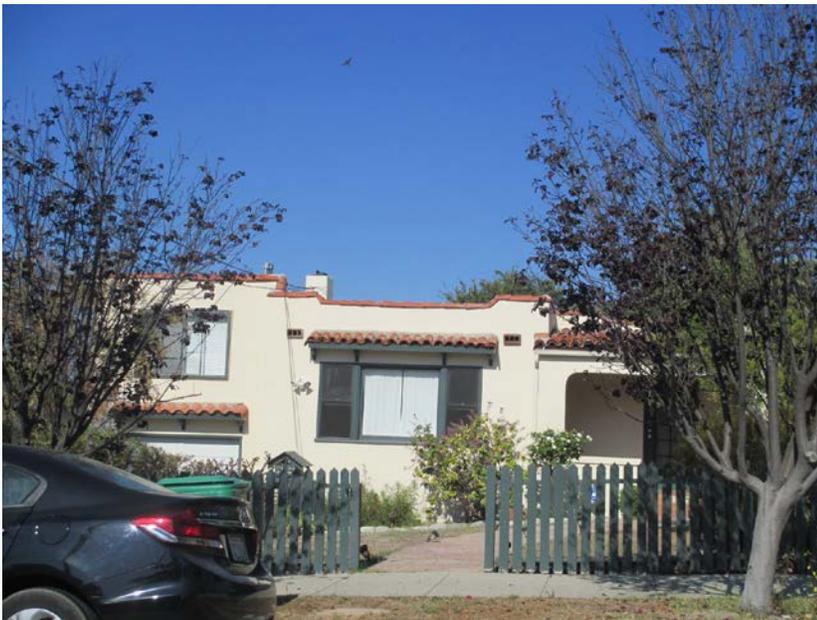
*P5a. **Photograph**

*P3a. **Description:** The subject property is located in the Casitas Tract, a subdivision created in 1922. Based on City Directories, the subject dwelling was constructed in 1925. Amos H. Wheeler and his wife Rose are identified as the residents in 1926. In September 1955, Peter and Delfino Jordano applied for a building permit to add a study and bathroom to the rear of the dwelling (Building Permit # F-3645). In 1986, the City issued a permit to add a family room, bathroom, and breakfast nook to the rear of the dwelling. A dining room addition was added to the rear of the 1955 addition in 1992. The dwelling appears to have other minor alterations not identified in building permits on file. The alterations do not appear to significantly diminish the integrity of the property.

The subject property has not been exhaustively researched or formally evaluated for historical significance. As the property appears to be a good example of a middle class dwelling constructed in the Spanish Colonial Revival architectural style, a style important to the unique identity and heritage of the city of Santa Barbara, it is recommended for further research and eligibility consideration as a Structure of Merit.

*P5b. **Description of Photo:** Looking north at the south (street-facing) façade.

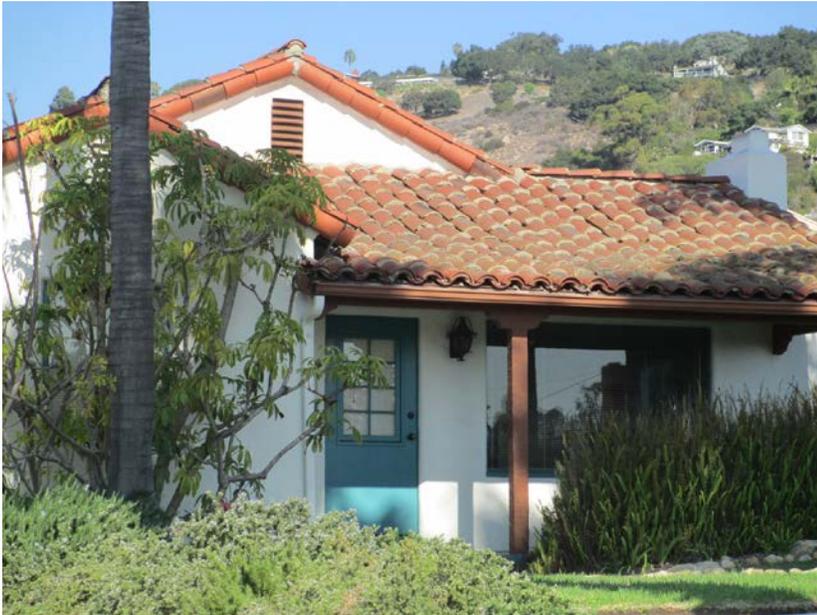
*P5a. **Photograph**

*P3a. **Description:** The subject property is located in the Casitas Tract, a subdivision created in 1922. In April 1930, owner Habid E. Arbagey and contractor Alex D'Alfonso applied for a building permit to construct a single family dwelling and garage on the undeveloped parcel (Building Permit # A-5690). Based on a review of digitized building permits and the windshield survey conducted in 2015, the Spanish Colonial Revival style dwelling appears to retain its character-defining features. In 1987, the City issued a permit for the construction of two, 2-story dwellings with ground floor garages and second floor balconies on the rear of the parcel. The additional buildings are moderately concealed behind the original dwelling and do not appear to significantly diminish the integrity of the older dwelling.

The subject property has not been exhaustively researched or formally evaluated for historical significance. As the property appears to be a good example of a middle class dwelling constructed in the Spanish Colonial Revival architectural style, a style important to the unique identity and heritage of the city of Santa Barbara, it is recommended for further research and eligibility consideration as a Structure of Merit. The subject property may also be significant for its association with building contractor Alex D'Alfonso.

*P5b. **Description of Photo:** Looking north at the south (street-facing) façade.
