City of Santa Barbara California

PLANNING COMMISSION STAFF REPORT

REPORT DATE: June 11, 2015
AGENDA DATE: June 18, 2015
PROJECT ADDRESS: 400 W. Pueblo Street (MST2003-00152)
Santa Barbara Cottage Hospital
TO: Planning Commission
FROM: Planning Division, (805) 564-5470, extension 2687
 Beatriz Gularte, Senior Planner *BGG*
 Suzanne Riegler, Associate Planner *SR*

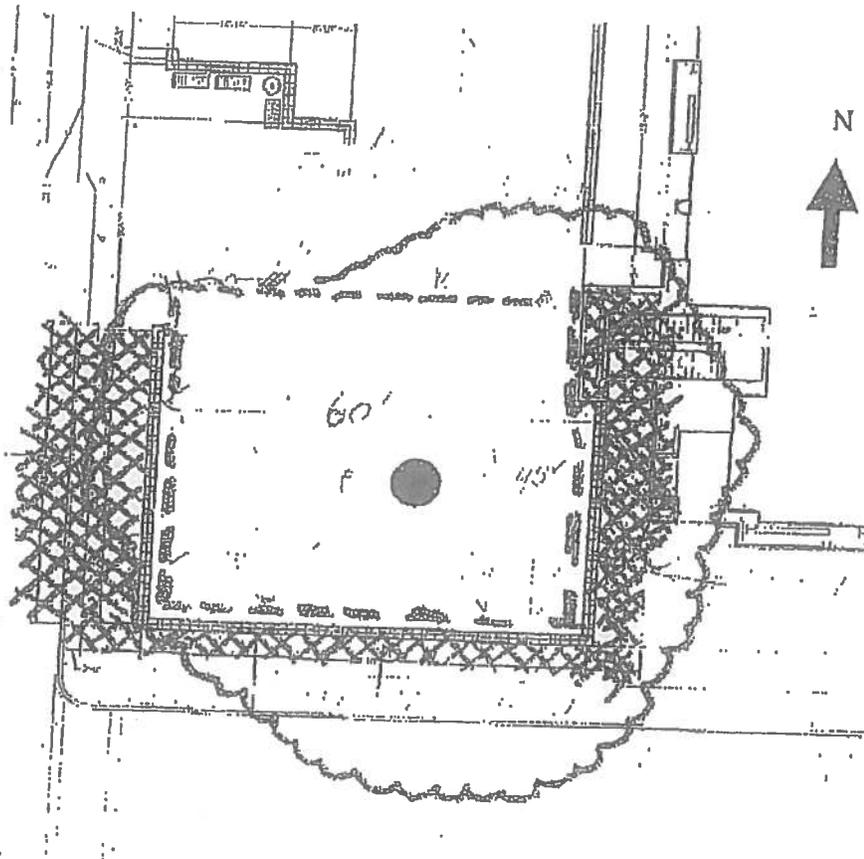
Figure 1: Diagram of tree parameters adapted from the site plan. Hatch marks represent areas where soil and roots will be cut. Bold dashed line is location where tree protection fencing should be installed. Dates indicate when demolition/construction will begin.

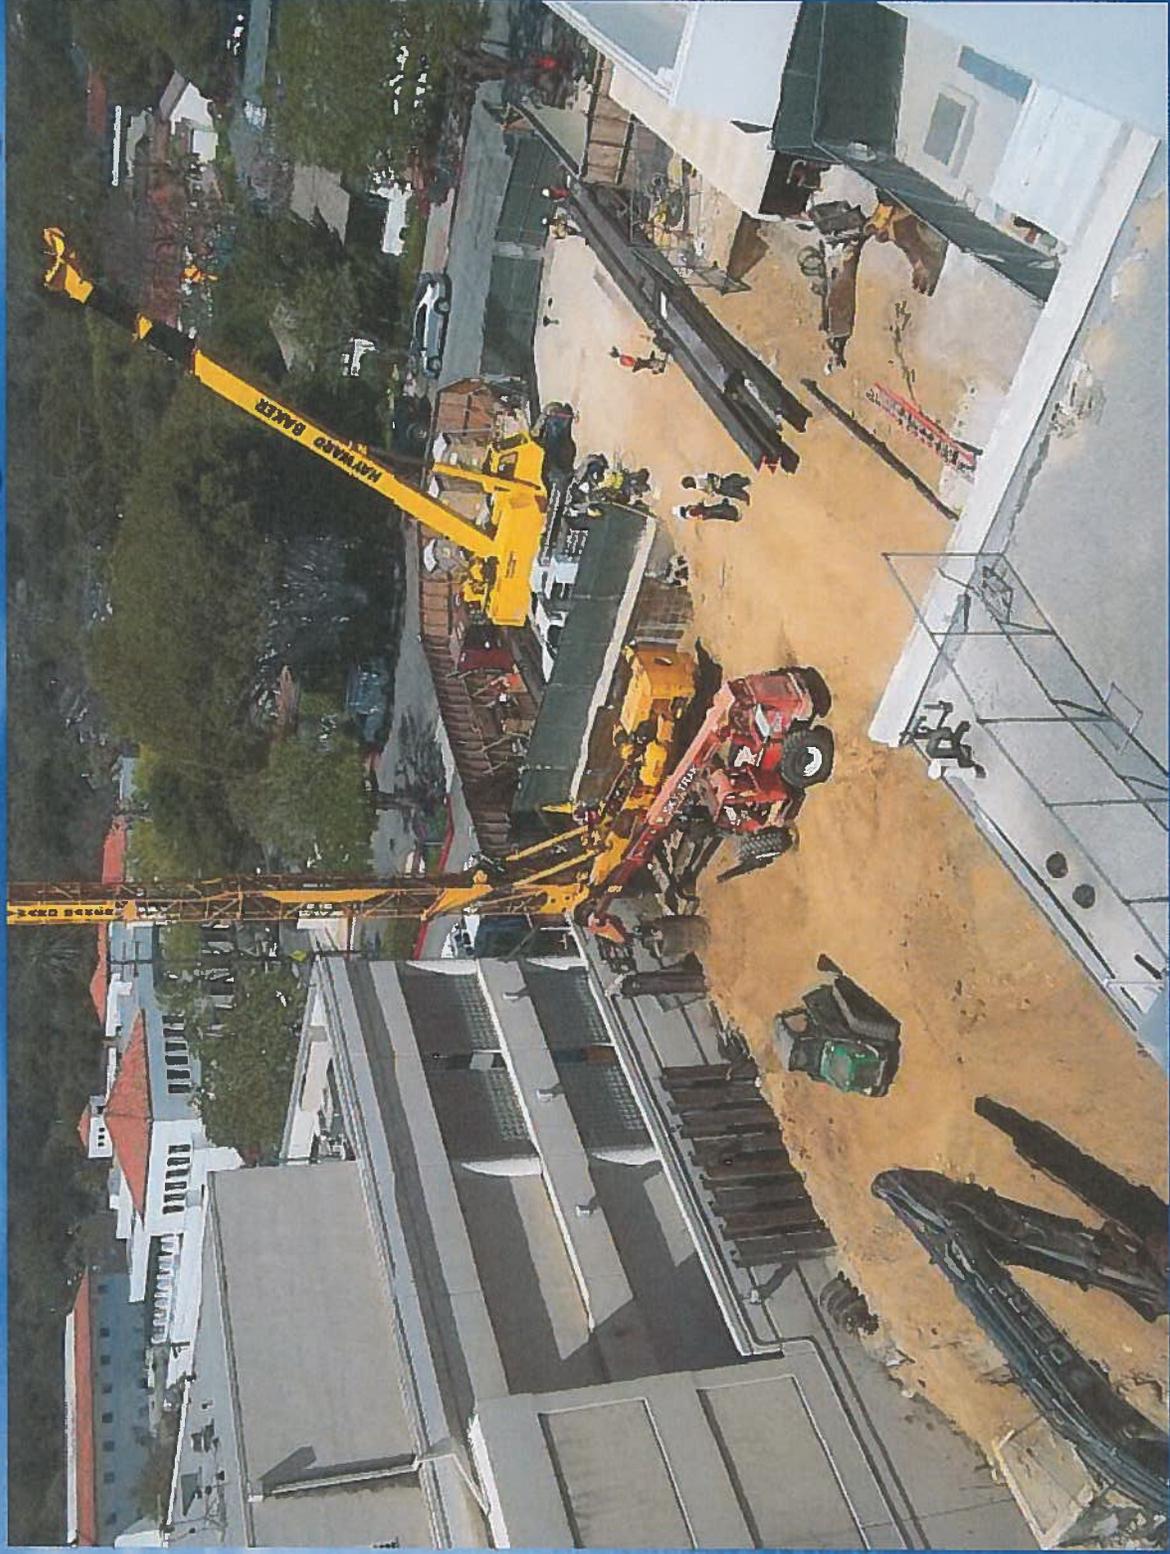
Centennial Wing Shoring

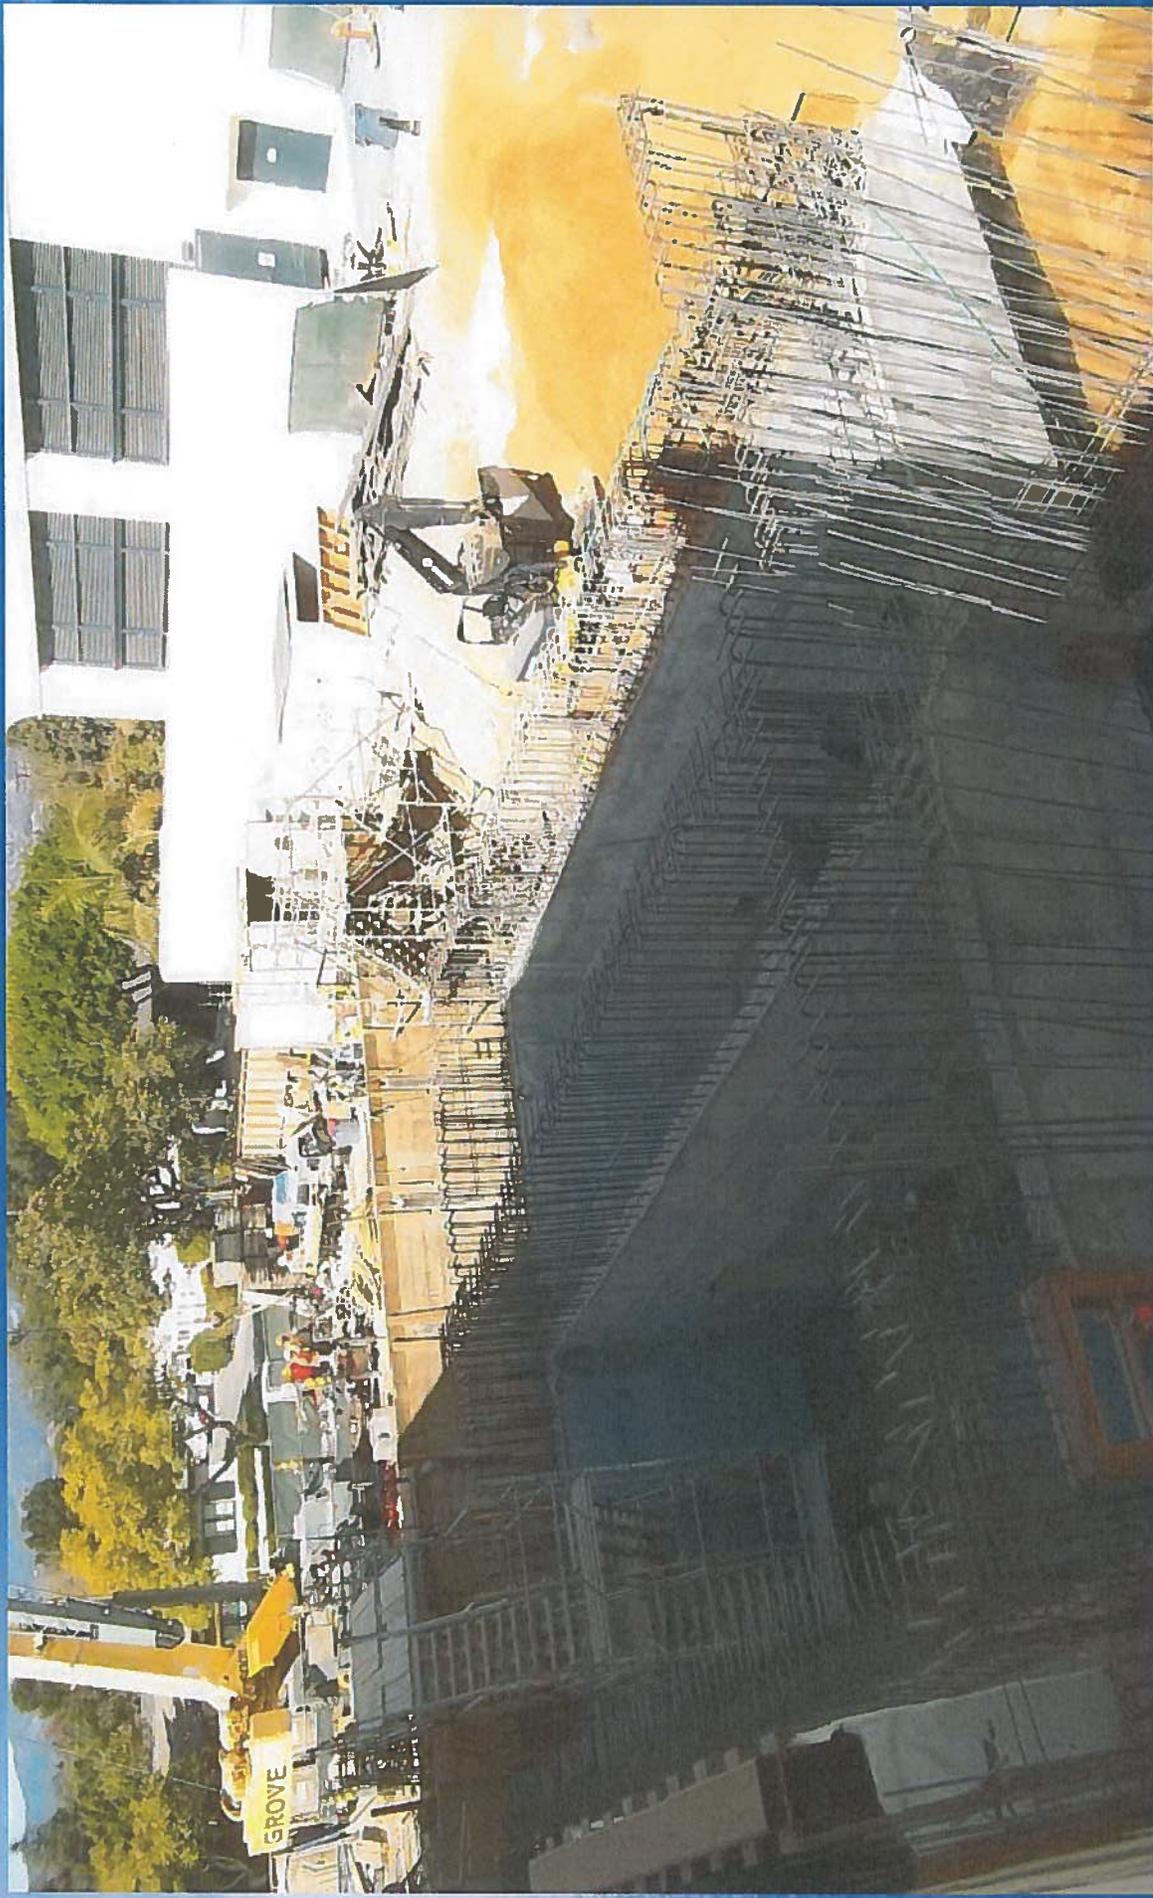
Water Tank Vaults

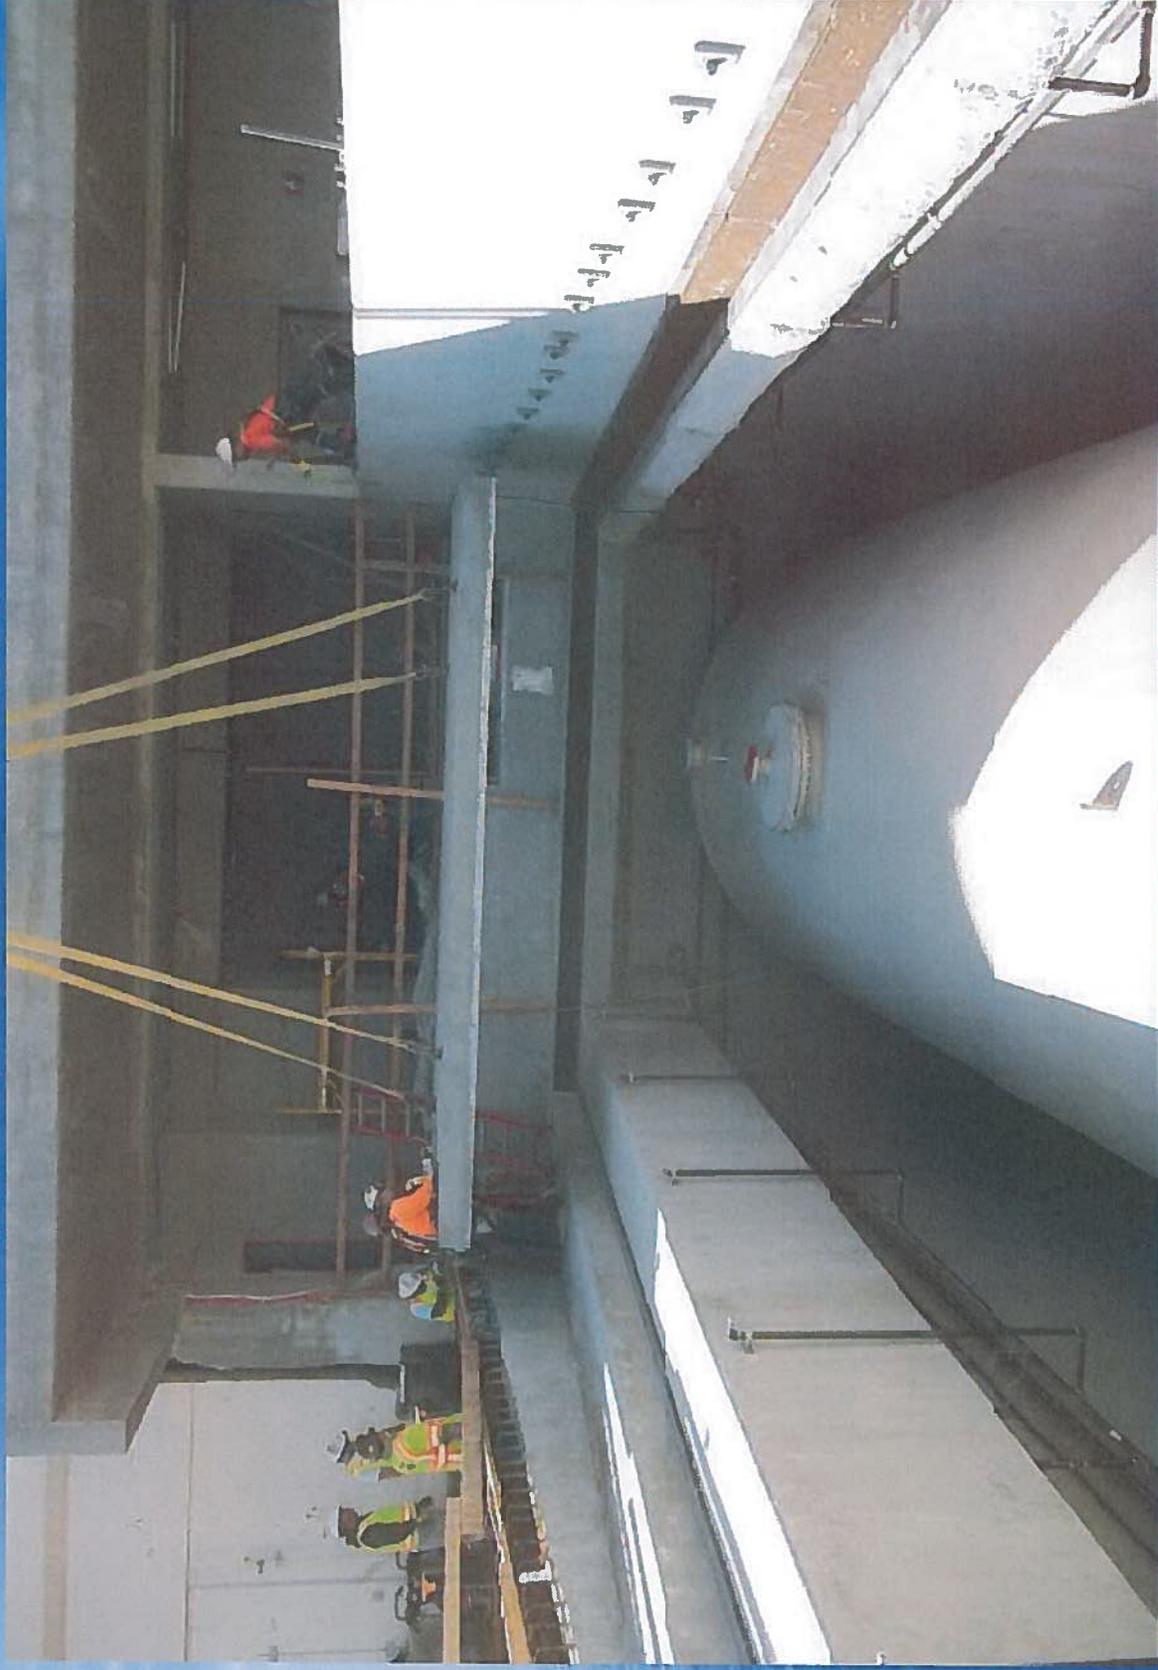
Q2 2014 Setting the Vault Lid

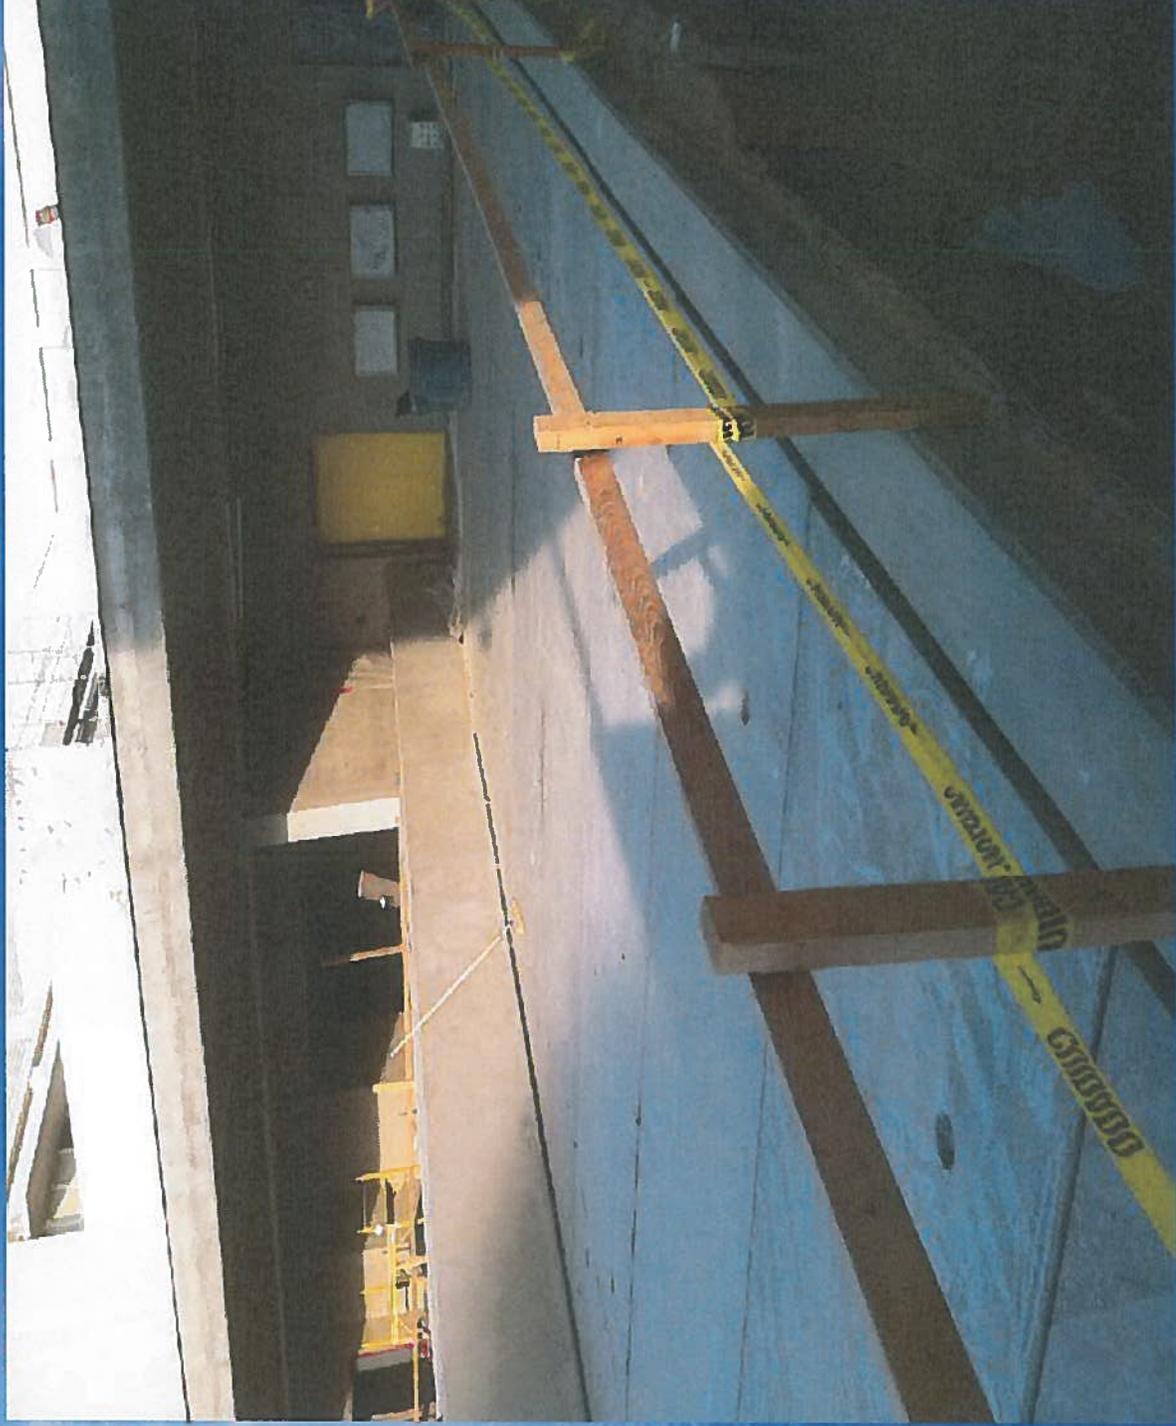
Q2 2014 Vault Lid In Place
