**PHASE 2  
HISTORIC STRUCTURES/SITES REPORT  
FOR THE  
SANTA BARBARA MUSEUM OF NATURAL HISTORY  
MASTER PLAN**

**MST 2014-00116**

**SANTA BARBARA, CALIFORNIA**

Prepared by:  
Post/Hazeltine Associates

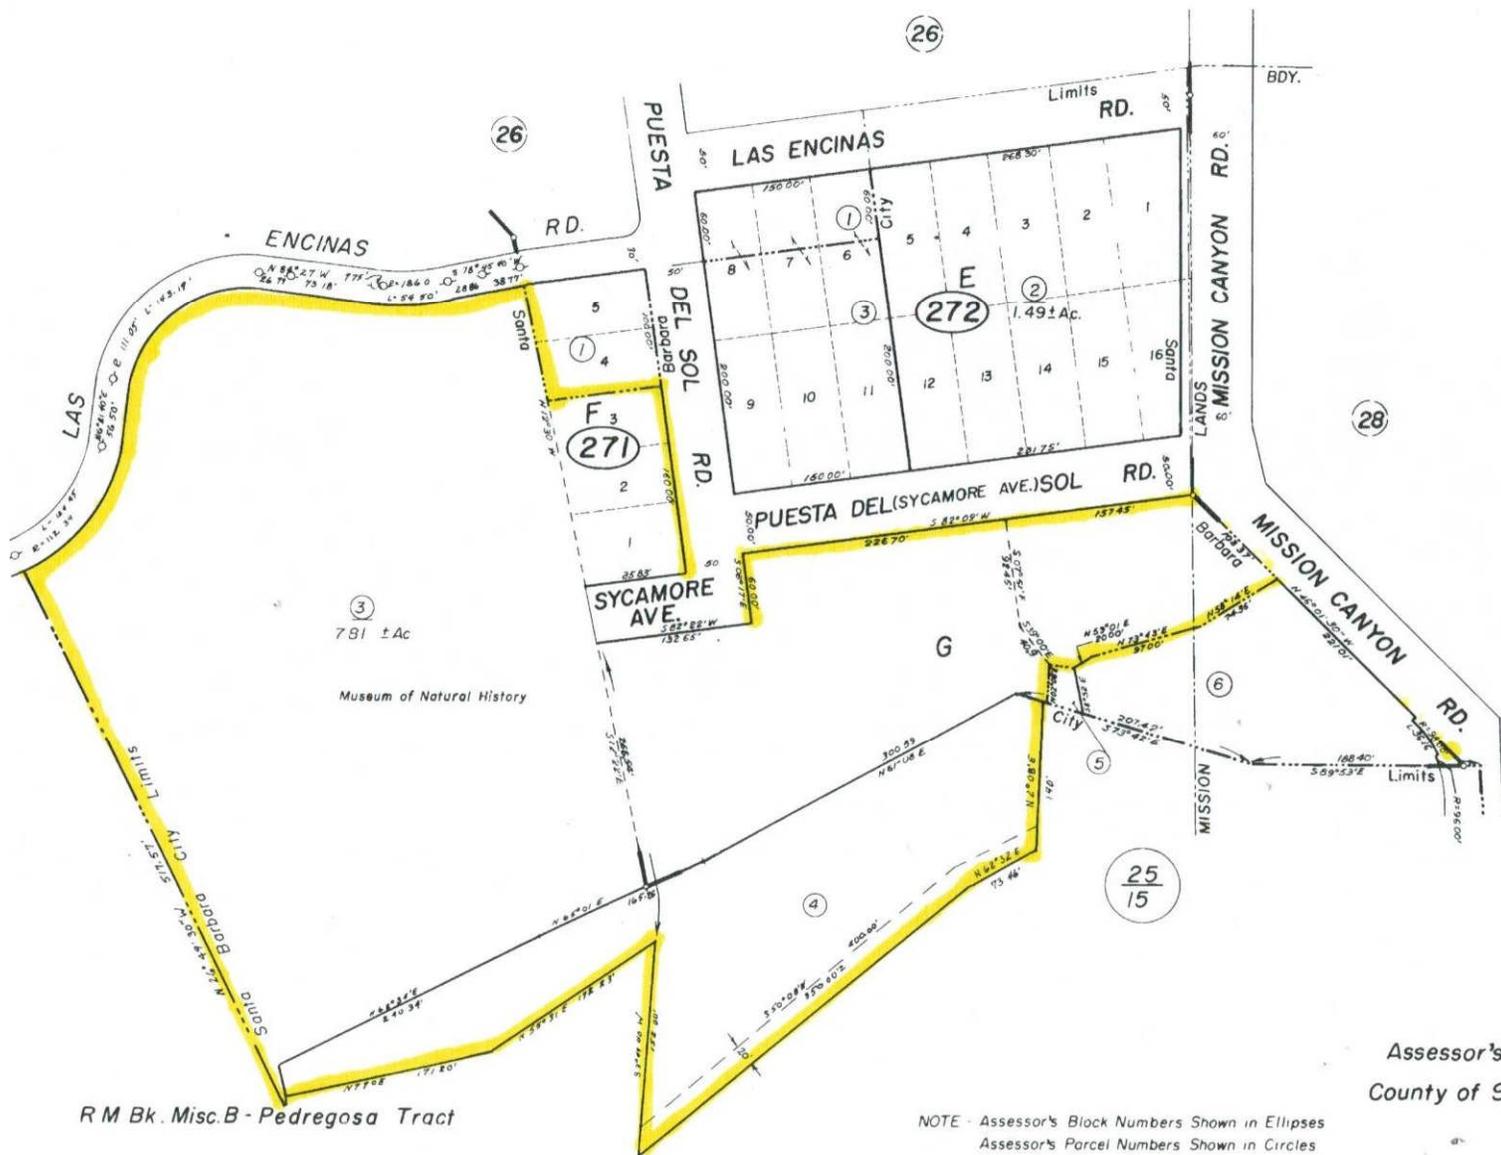
Figure 2  
 Assessor's Parcel Map #2 (yellow outlines Museum parcels)  
 (APN 23-271-003 & APN 23-271-004)  
 Santa Barbara Museum of Natural History  
 (Museum of Natural History Campus)

The applicant proposes to annex to the City of Santa Barbara in Parcel 1 the following three parcels: APN 23-250-066, APN 23-250-068 and APN 23-250-039, which are currently in an unincorporated area of the County of Santa Barbara (but within the City of Santa Barbara's sphere of influence) (see Figure 2). Annexation would allow the SBMNH property to be under a single jurisdiction.

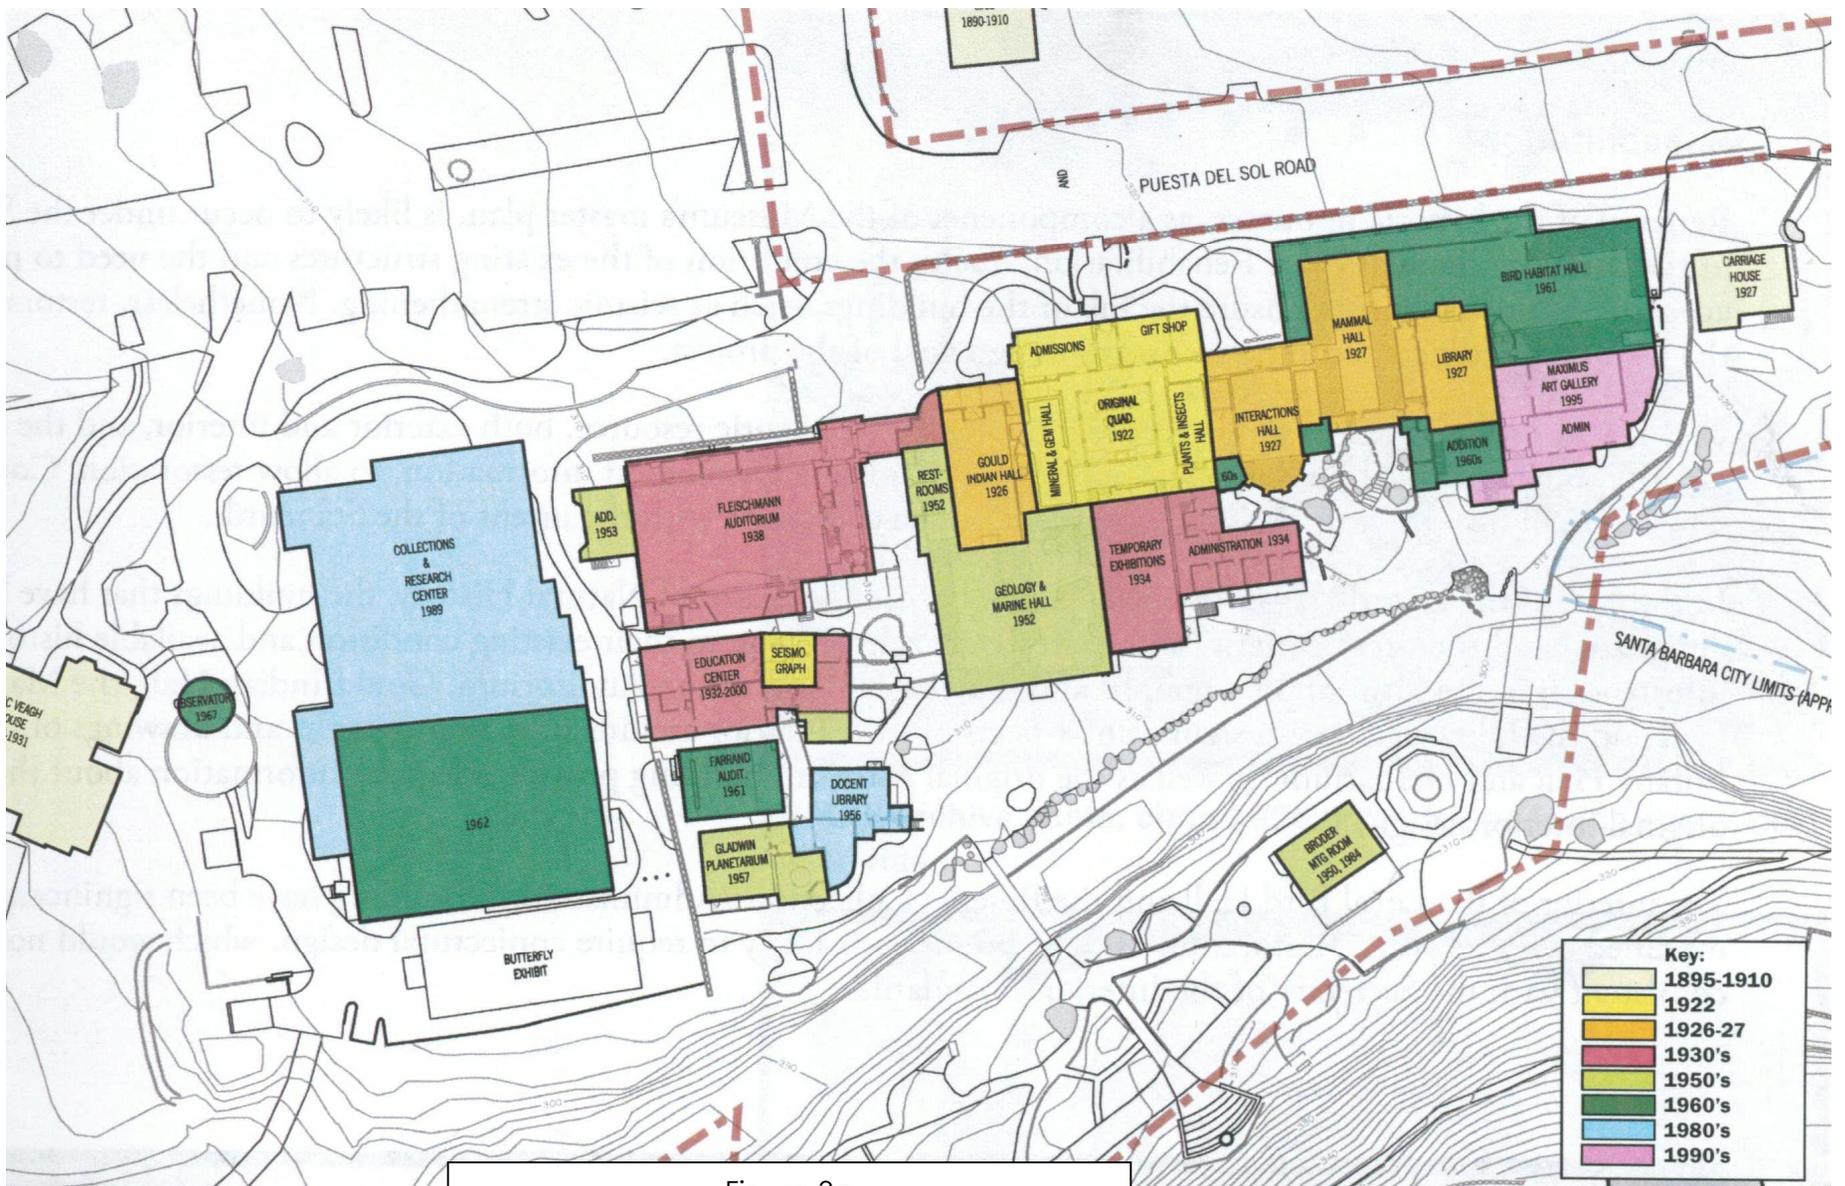
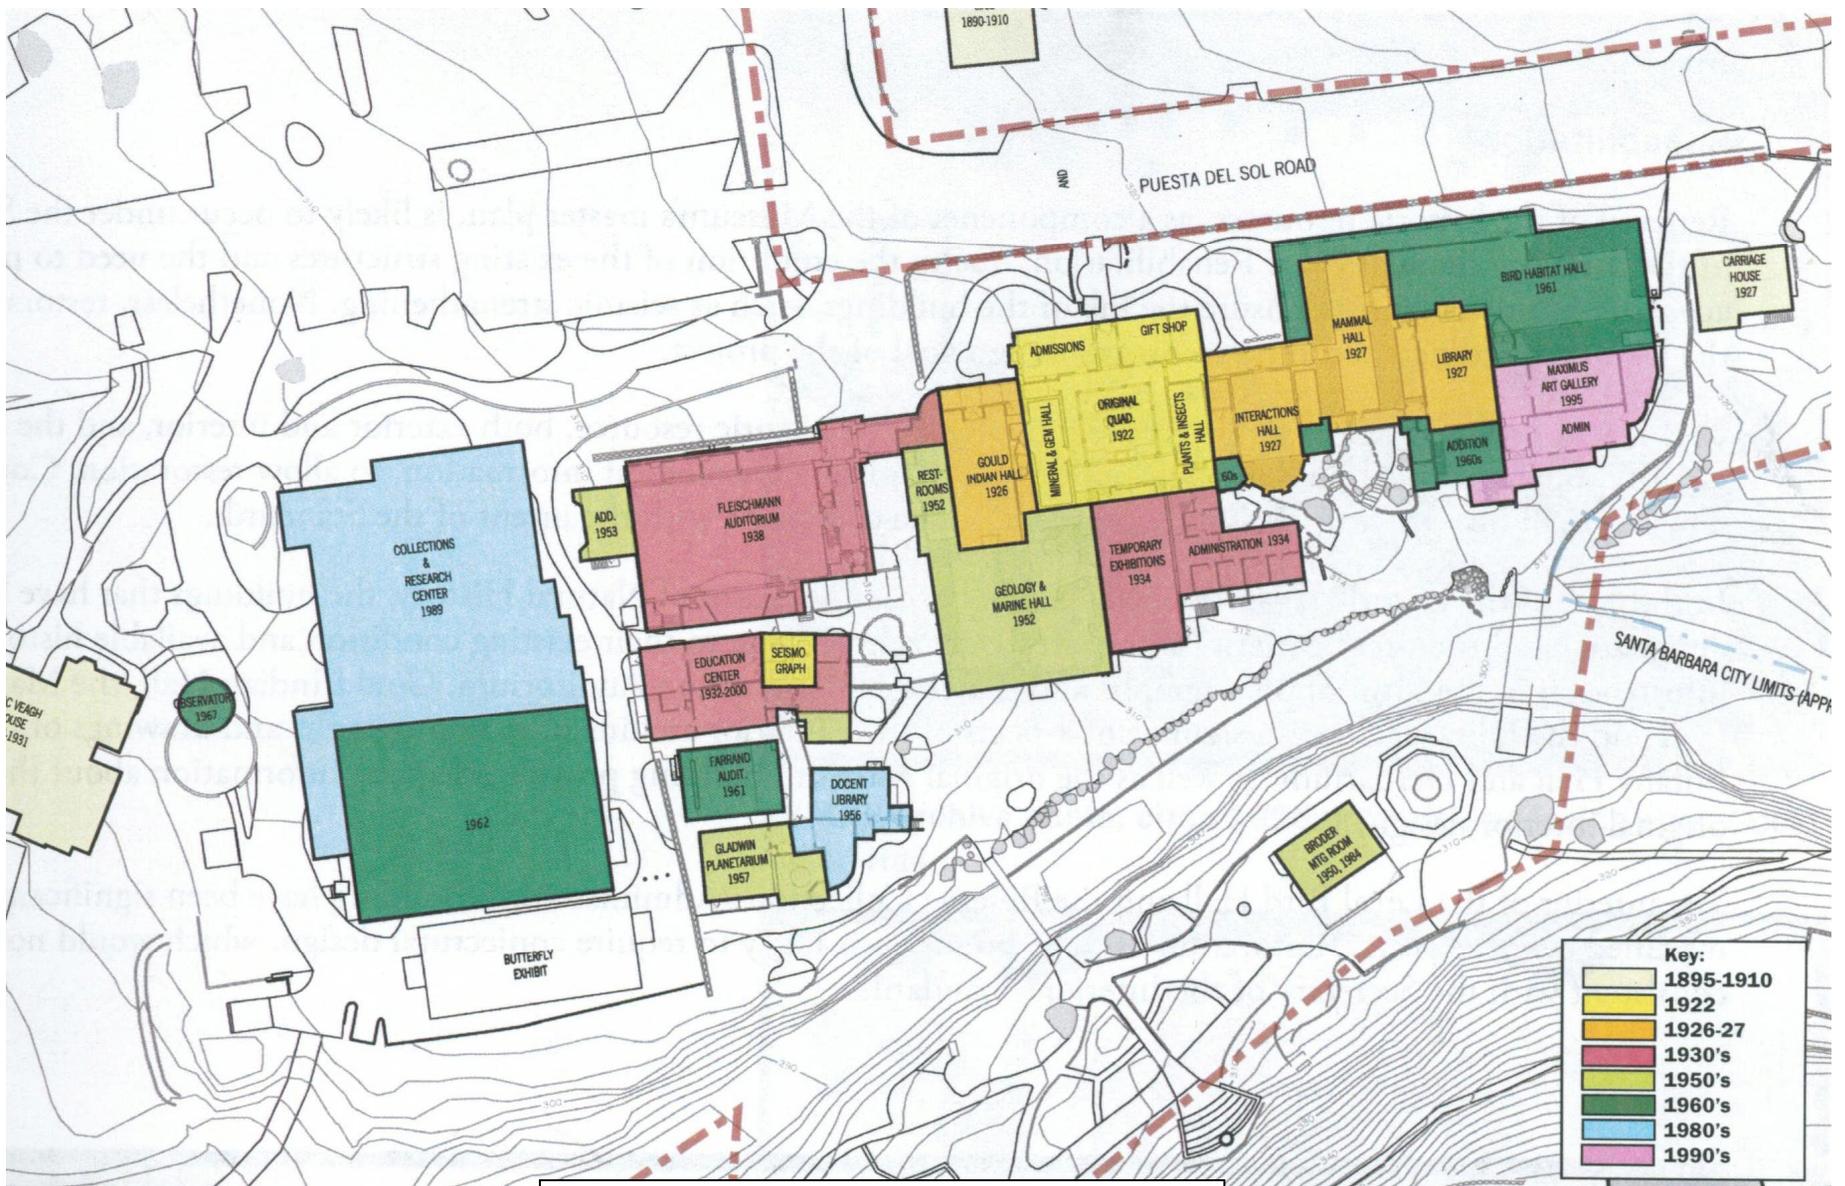
Figure 3a  
 Existing Site Plan Main Museum Complex  
 Santa Barbara, Museum of Natural History  
 (Schacht/Aslani)

Figure 3a  
 Existing Site Plan Main Museum Complex  
 Santa Barbara, Museum of Natural History  
 Schacht/Aslani, 2010

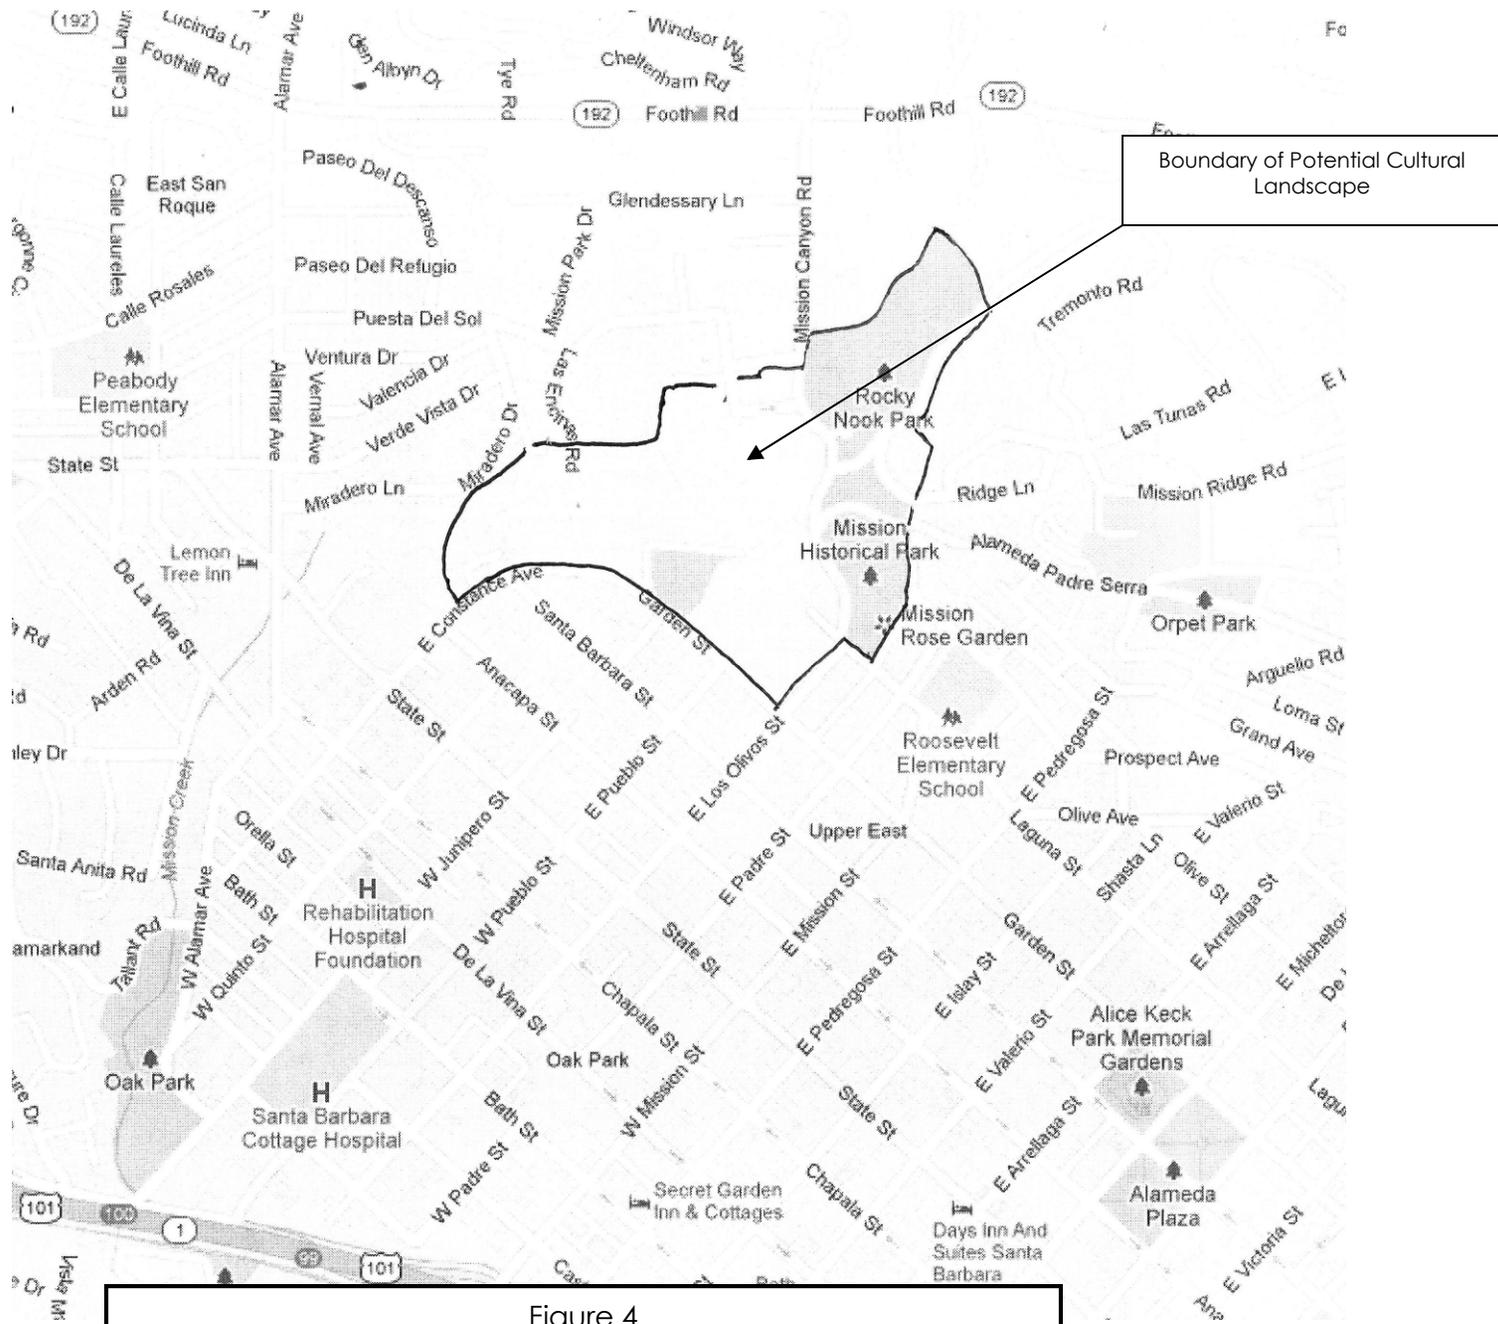
Figure 4  
 Boundary of the potential Cultural Landscape defined in the  
 Phase 1 HSSR

The Phase I HSSR identified a potential significant cultural landscape at the south end of Mission Canyon; its contributing resources are listed below (see Figure 4). The significance of this landscape is derived from its concentration of natural features and vegetation and its inventory of significant historic resources dating from the late 18<sup>th</sup> century through the late 1930s, which range from Mission Santa Barbara and its waterworks to the Santa Barbara Museum of Natural History. Within the project area the streetscape along the 2500 block of Puesta del Sol is a significant contributor to the cultural landscape.

For the purposes of this review the vicinity of the project area is defined as the parcels listed in Figure 4 that contribute to the significant cultural landscape. Only one large-scale project is located in the vicinity of the project area. This is a project currently under construction at 2300 Garden Street to transform the former Saint Anthony's Seminary into the Garden Street Academy, a private school. As proposed the project, which is partially completed, encompasses retrofitting and rehabilitating the existing buildings and alterations to the existing service driveway and landscaping. The project does not encompass substantial changes to the north side of the complex, which faces towards Mission Canyon. An HSSR was prepared in 2009 by Preservation Planning Associates. The report and its subsequent addenda determined that the project was consistent with the Secretary of the Interior's Standards for the Treatment of Historic Properties and that the impact from the implementation of the proposed project was less than significant (Preservation Planning Associates 2009). Other projects in the vicinity of the SBMNH project property are primarily limited to small-scale residential remodeling projects, which do not have the potential for substantially contributing to cumulative impacts to significant historic resources. Approved and pending projects in the vicinity of the project area are either minor in scale or have been determined to have less than significant impacts on significant historic resources. Therefore, the proposed implementation of the Santa Barbara Museum's Master Plan does not have the potential for substantially increasing development in the project vicinity in a manner that would contribute to significant impacts to nearby significant historic resources or the surrounding cultural landscape.

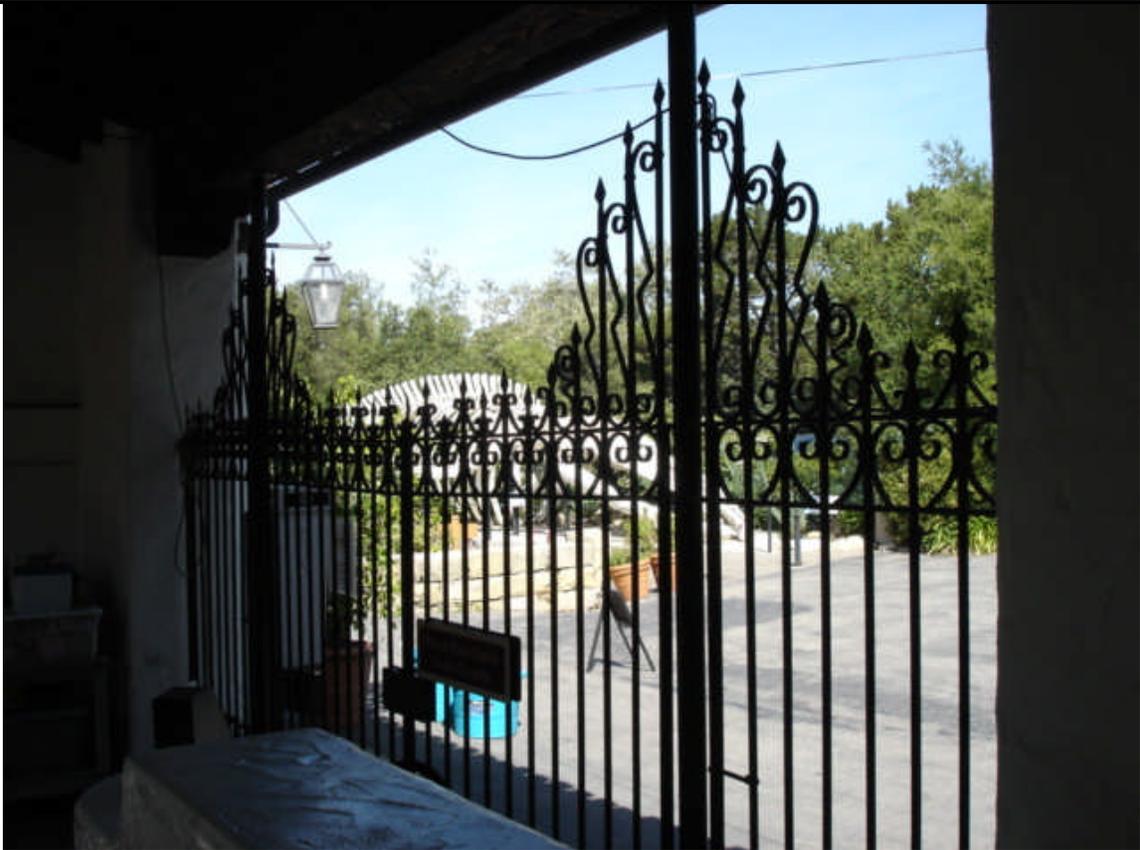
Figure 21  
Detail of wrought iron gates in loggia linking Fleischmann Auditorium to Gould  
Indian Hall (Looking west)

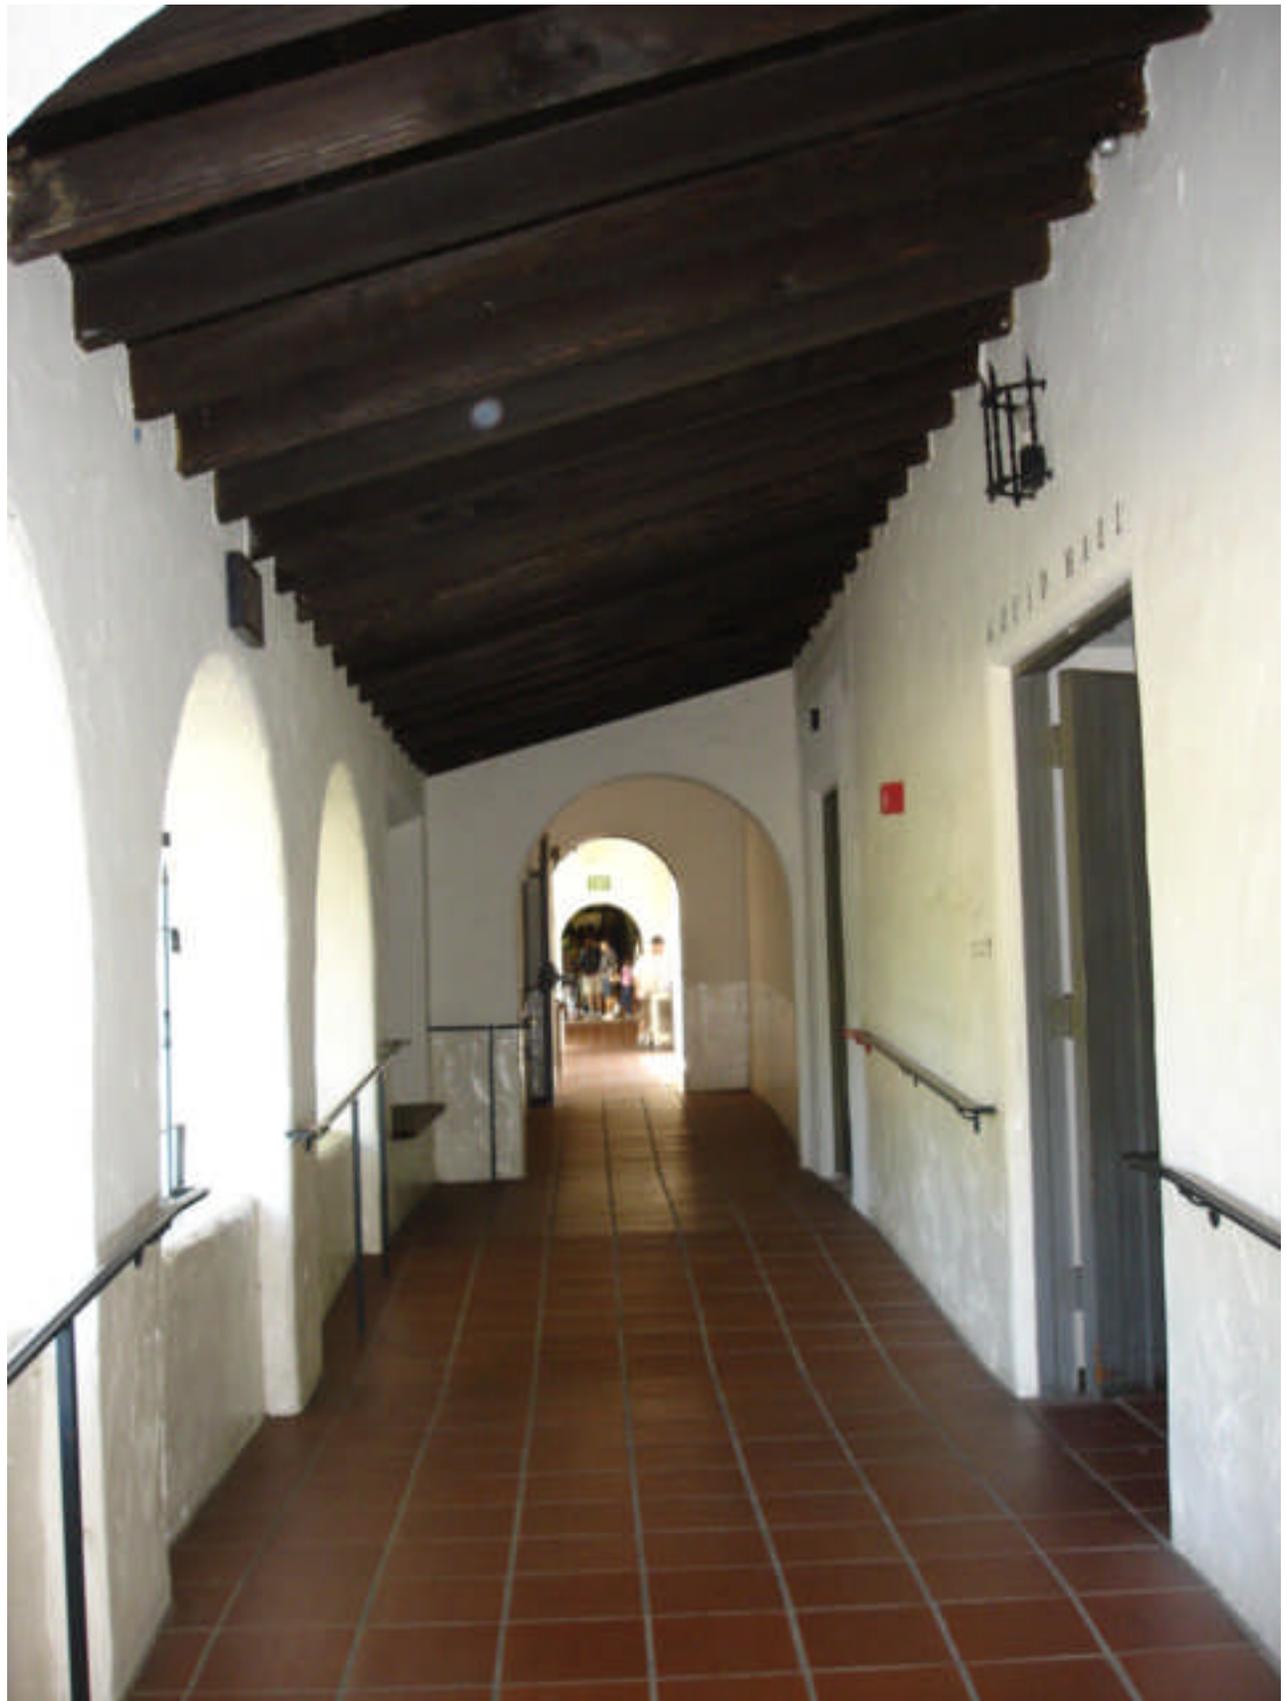
Figure 22  
Detail of arcade showing floor detail, plaster and ceiling detail along façade of  
Gould Indian Hall (looking east)

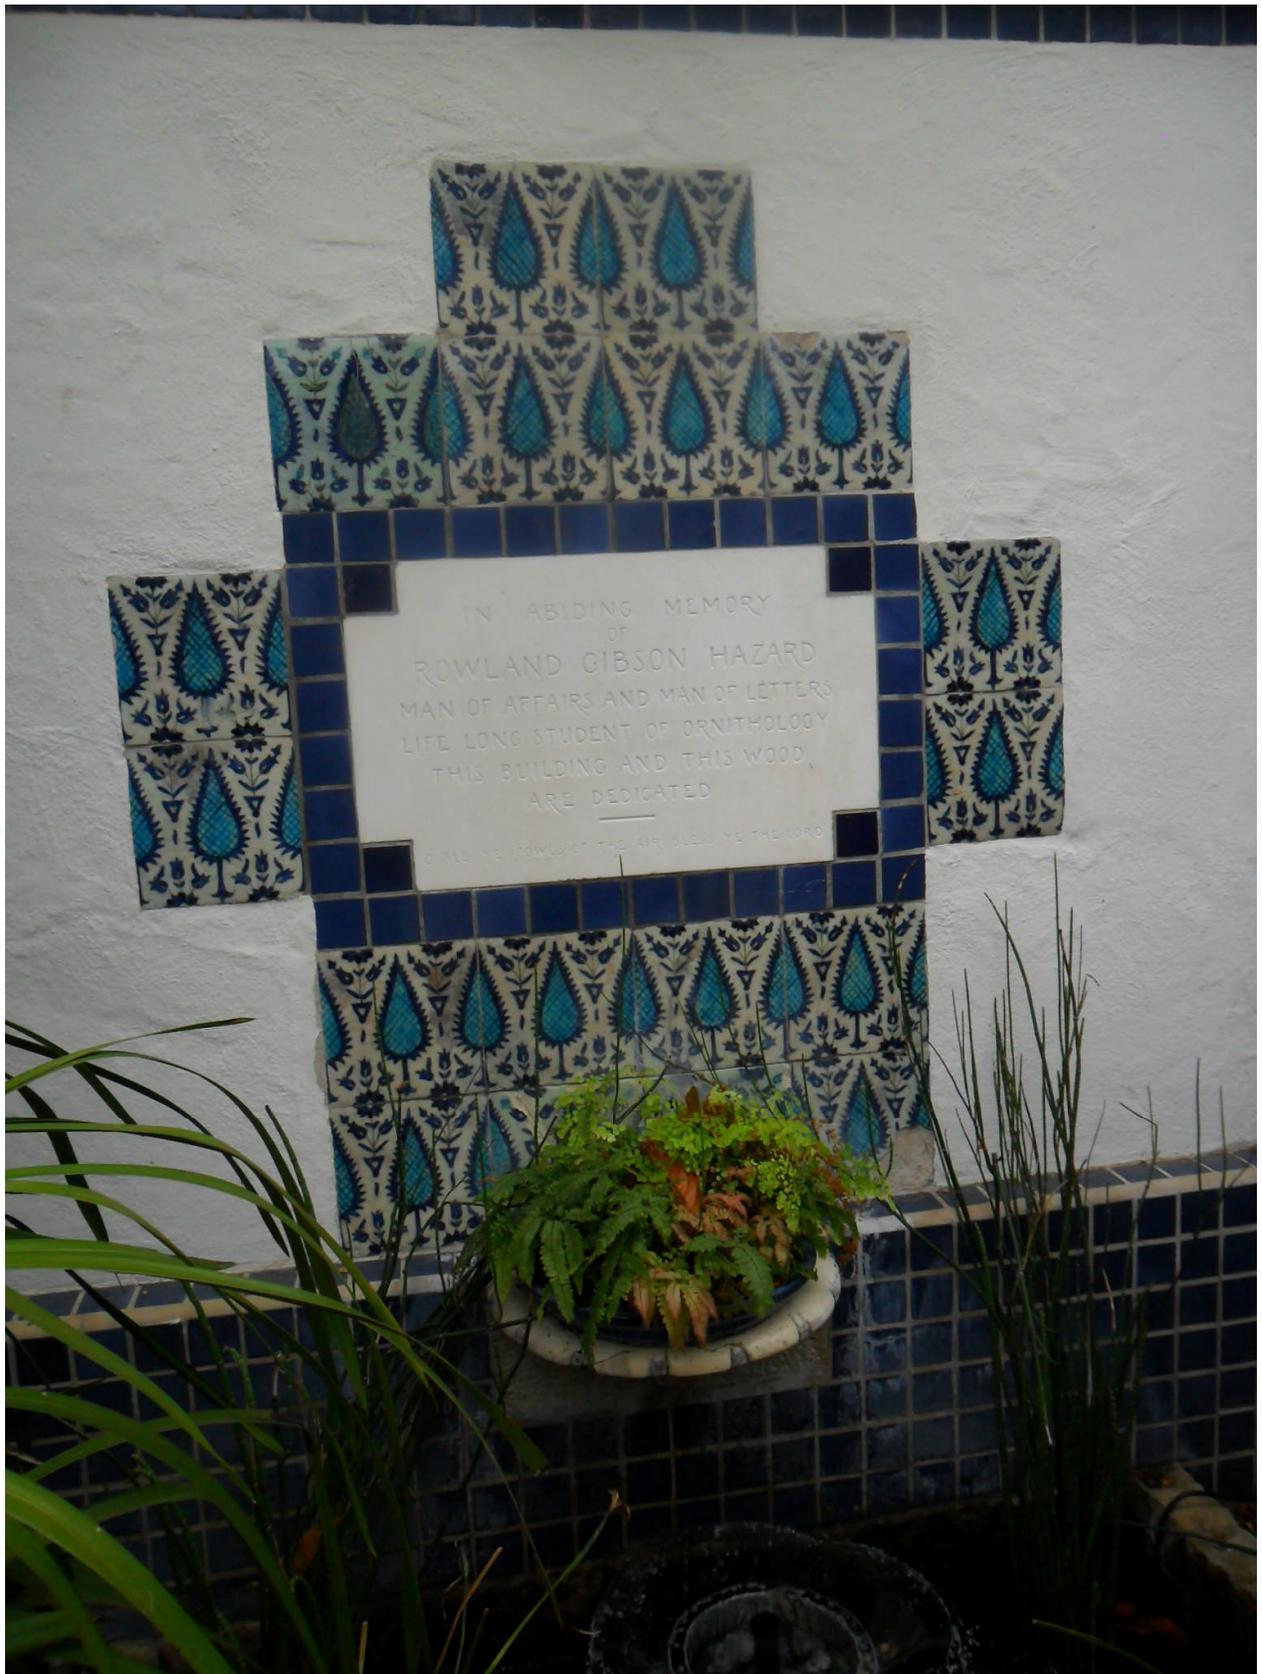
Figure 24  
Detail of wall fountain on south elevation of the 1922 Wing's courtyard (Looking south)

The Master Plan proposes to conserve the Roland Hazard Memorial Fountain (see Figures 24 & 26).

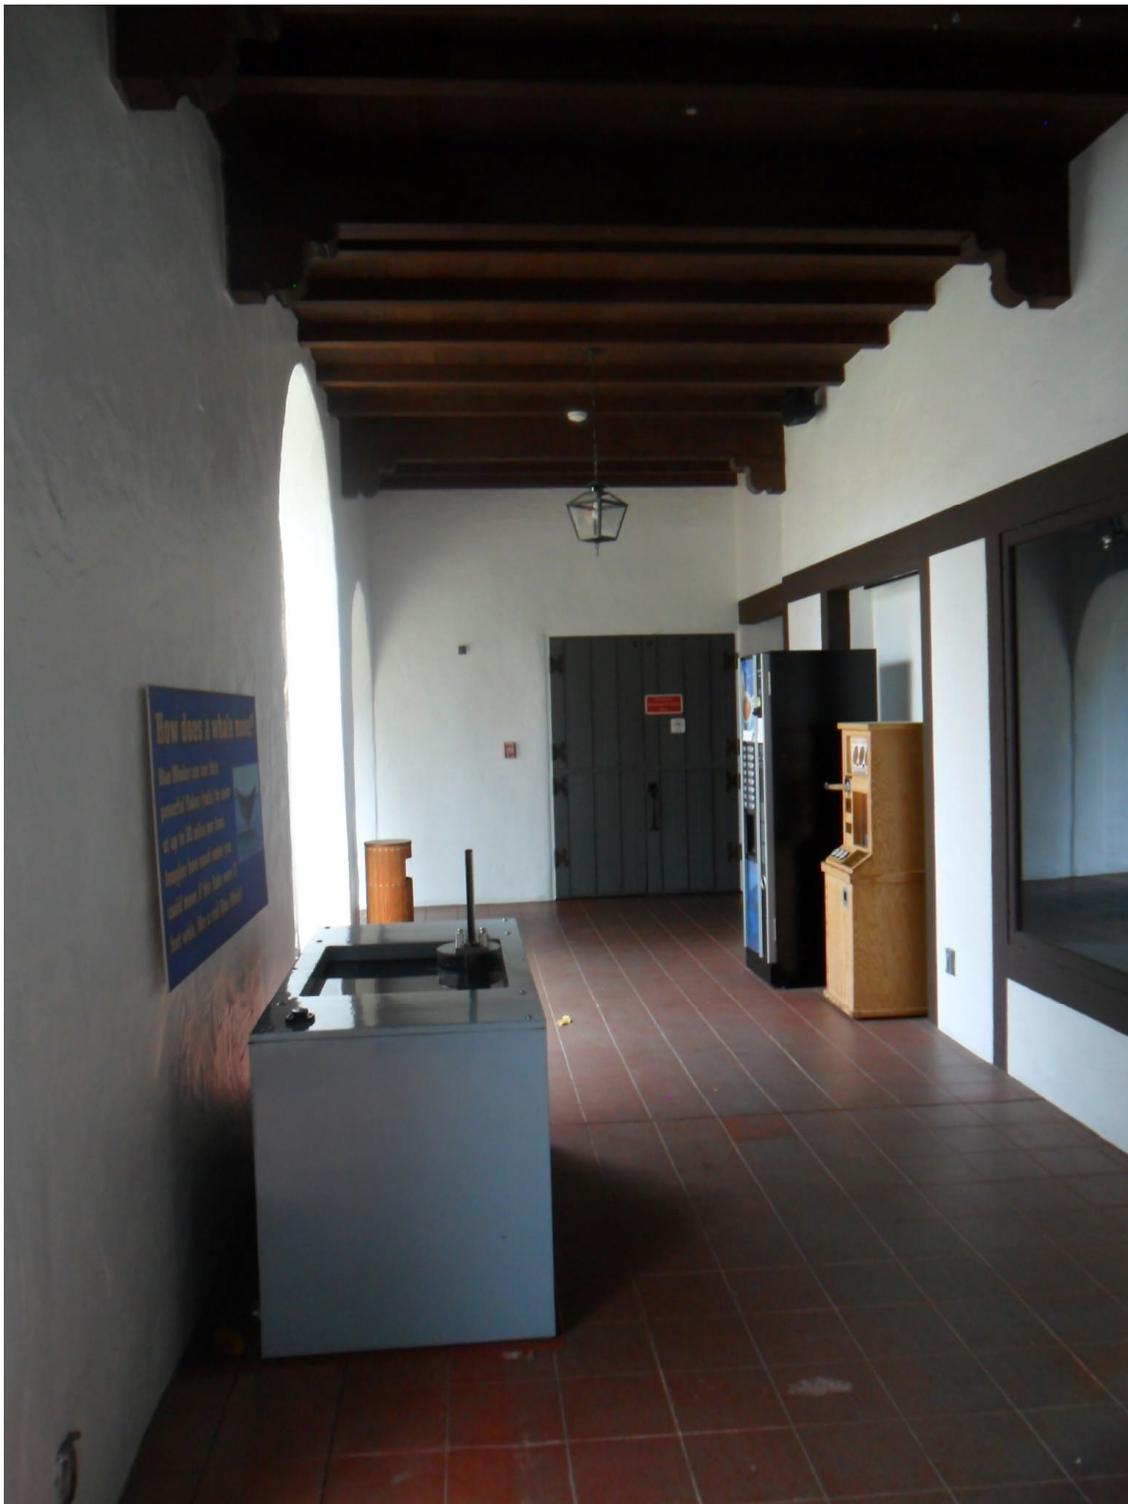
Figure 25  
Corridor on south side of the courtyard in the 1922 Wing, detail of scored  
concrete flooring and ceiling beams (Looking east)

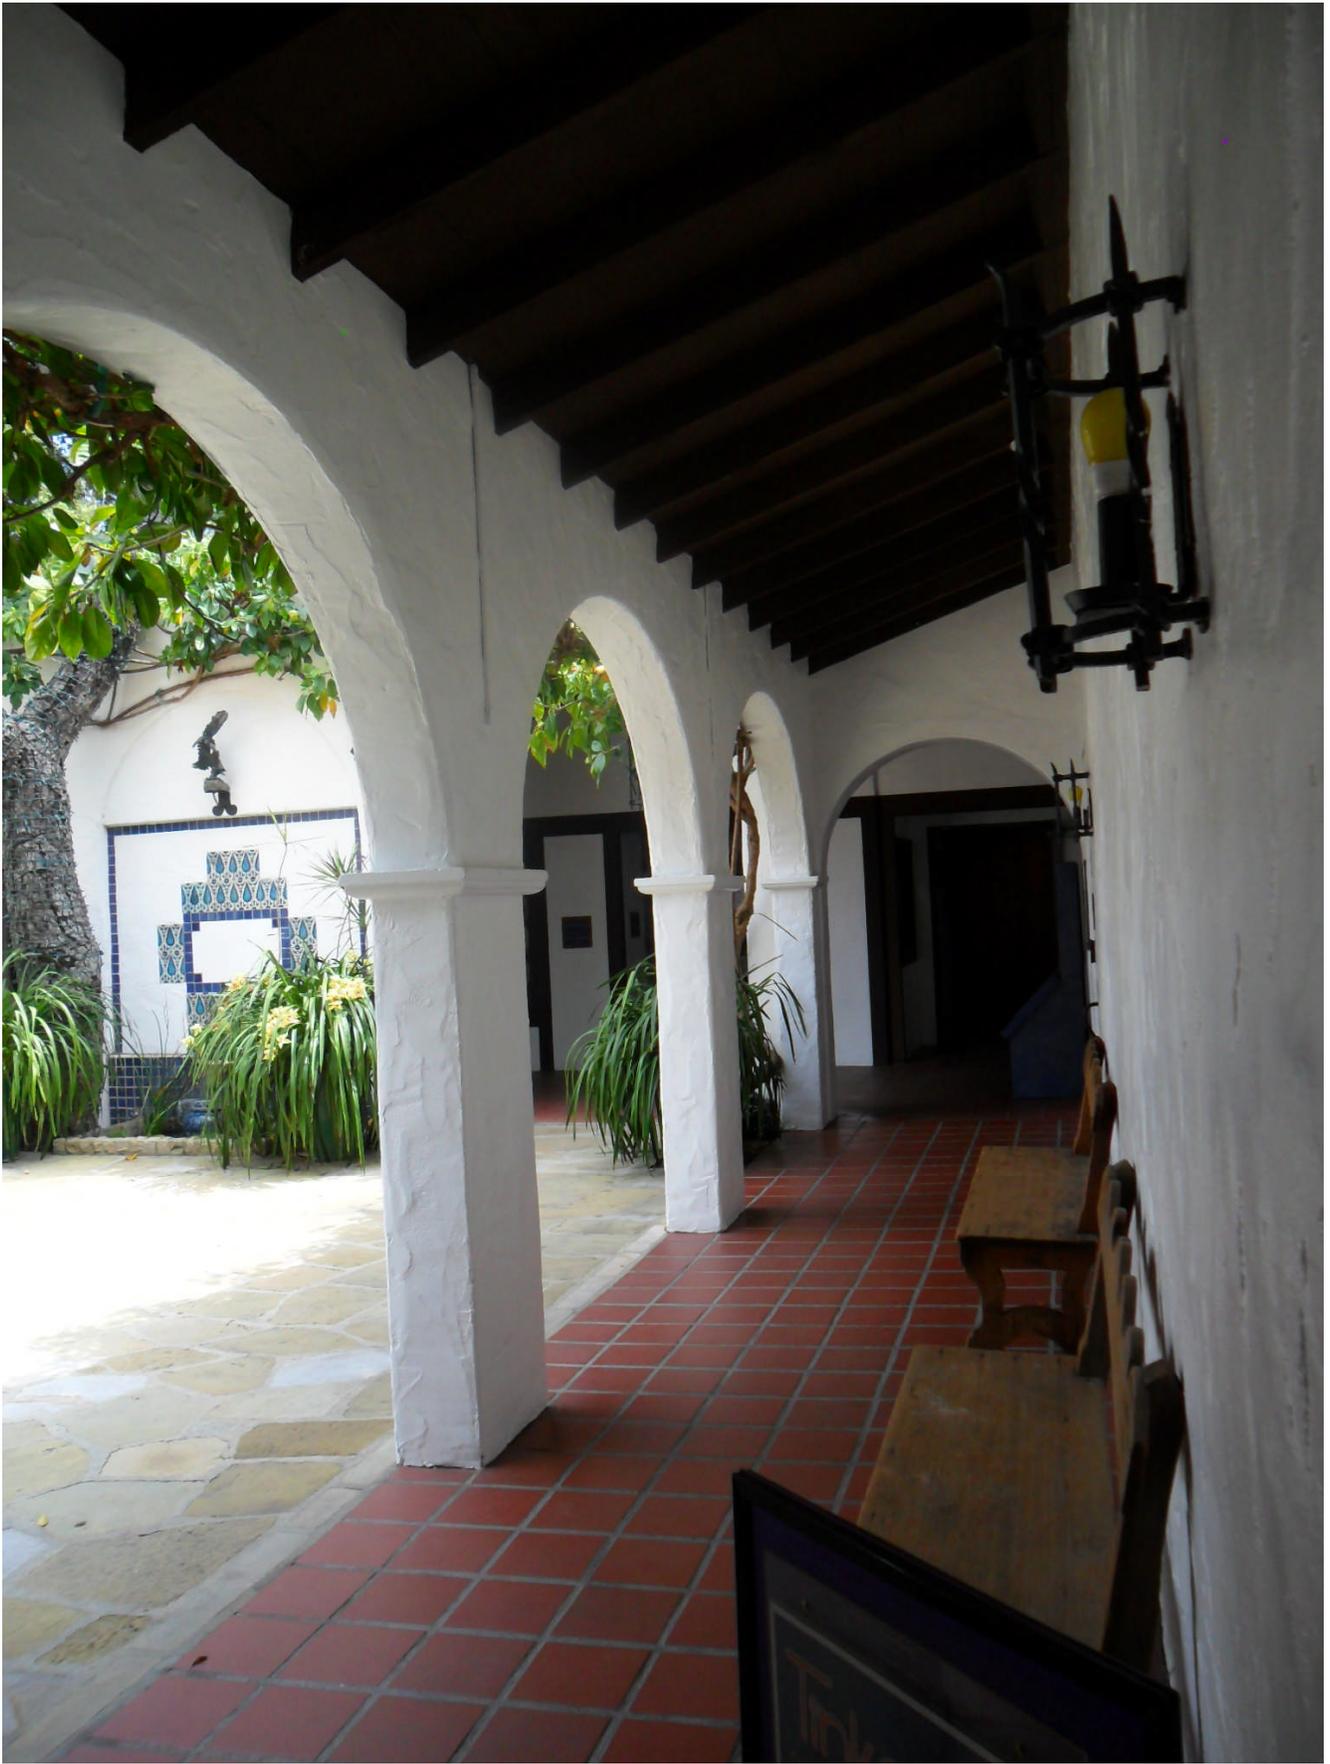
Figure 26  
Corridor on the west side of the courtyard in the 1922 Wing, detail of flooring, piers and ceiling beams (Looking east)

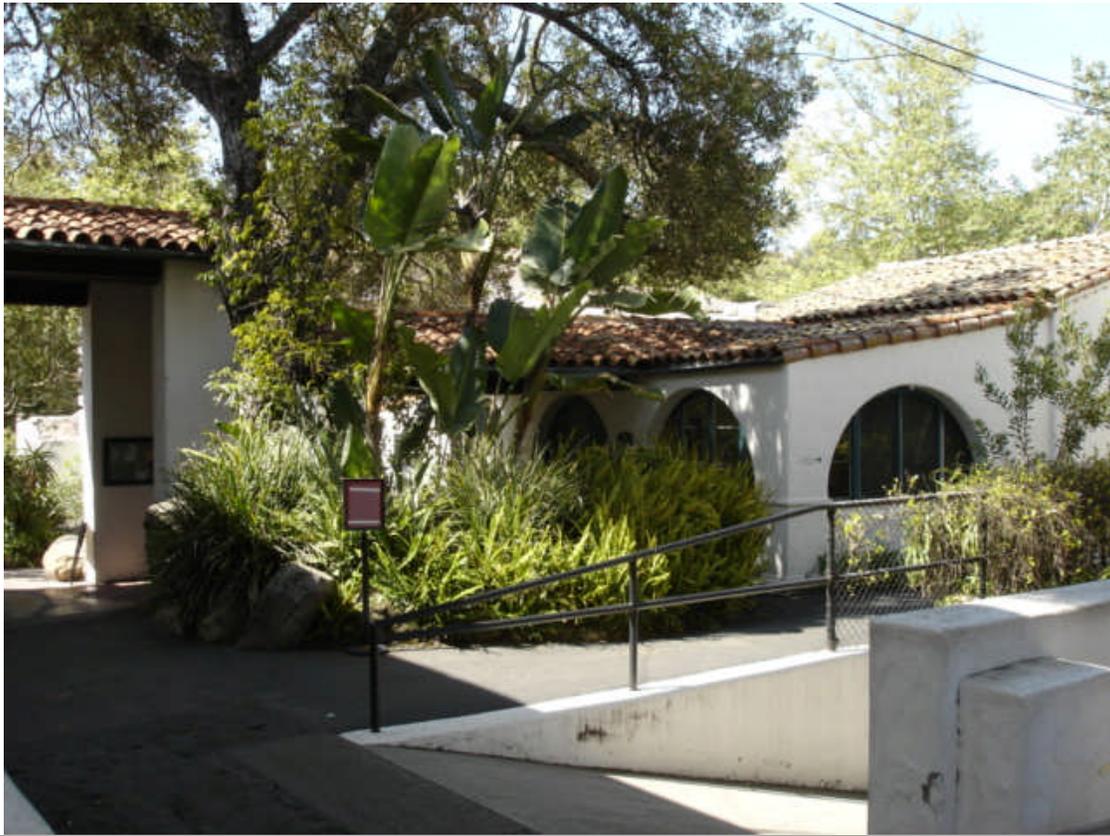
Figure 28  
Education Building's east elevation with ramp to basement of Fleischmann Auditorium in foreground

Located across a narrow walkway from the south elevation of Fleischmann Auditorium, the one-story Education Building has an irregular footprint (see Figures 28 -29). The masonry and wood-frame building is capped by a complex roof made up of a number of flat and shed-roofed elements sheathed in terra cotta tiles. Fenestration is composed of a combination of fixed light and casement windows (Figures 28 -29). The original wing of the building was built in 1926 to house a seismograph. In 1932 an addition, named in honor of Ralph Hoffmann, was added to the building's east elevation. Capped by a side gable roof, the wing features arched openings fitted with removable screens and glazing that extends around all four sides. In 1939 a rectangular addition, housing two classrooms, was made to the rear (west) end of the building. In 1952, a loggia linking the building to the former Geology Hall was built off the east elevation. In 1995, a small water feature was added to the south side of the façade. The last alteration was made in 2001 when the kitchen, located at the southeast corner of the building, was remodeled. The Phase 1 HSSR determined that the Education Building was not a significant resource for the purposes of environmental review. Tables listing of the Museum property's non-character-defining buildings structures and features are found in Table 3 -5 at the end of Section 6.

The Marine/Paleontology/Geology Hall, including the loggia linking the wing to the Education Building, is not a historic resource for the purposes of environmental review (Figure 82 and see Figures 28 & 29). The proposed scheme would alter the exterior by removing a loggia and door on the west elevation and removing/adding basement windows on the south elevation. A new visitor door set in a shallow recess, three multi-light windows (two of the windows would be capped by awnings) and a remodeled entrance to the basement level staff offices would also be added to the south elevation. Two recessed windows would be inserted into the west elevation. The existing cornice on the south and west elevations would be increased in height by 11 inches.

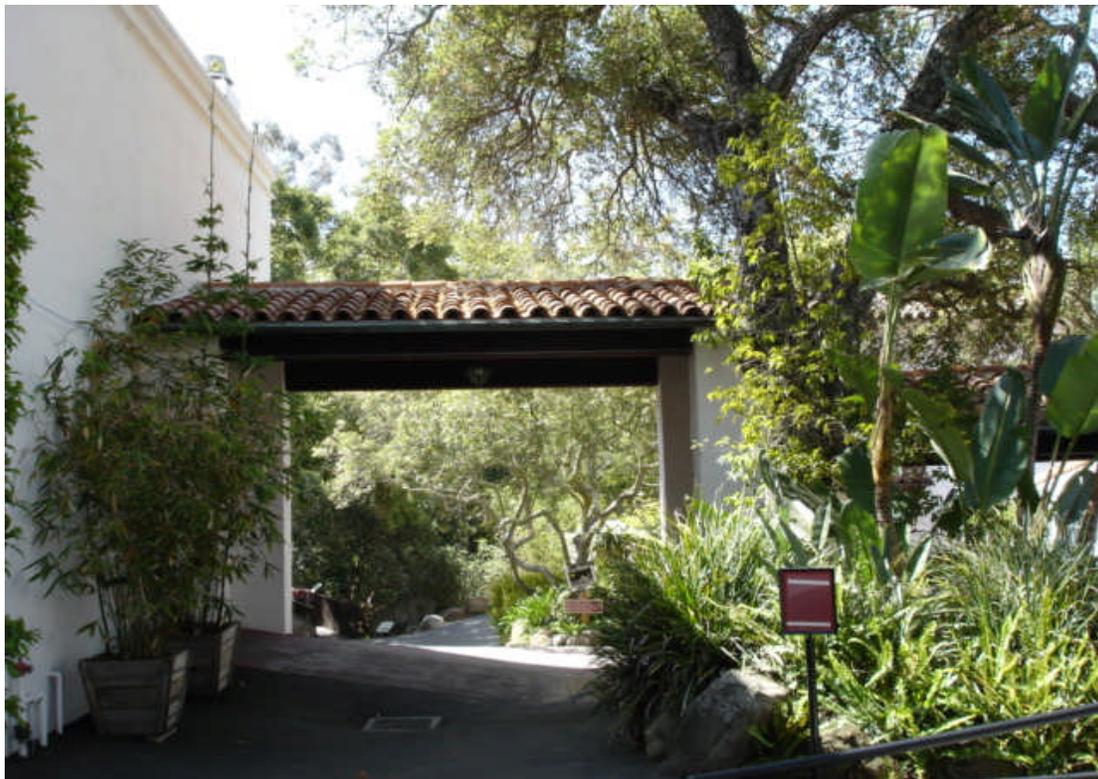
Figure 29  
Loggia linking Marine/Paleontology/Geology Hall to Education Building  
(Looking south)

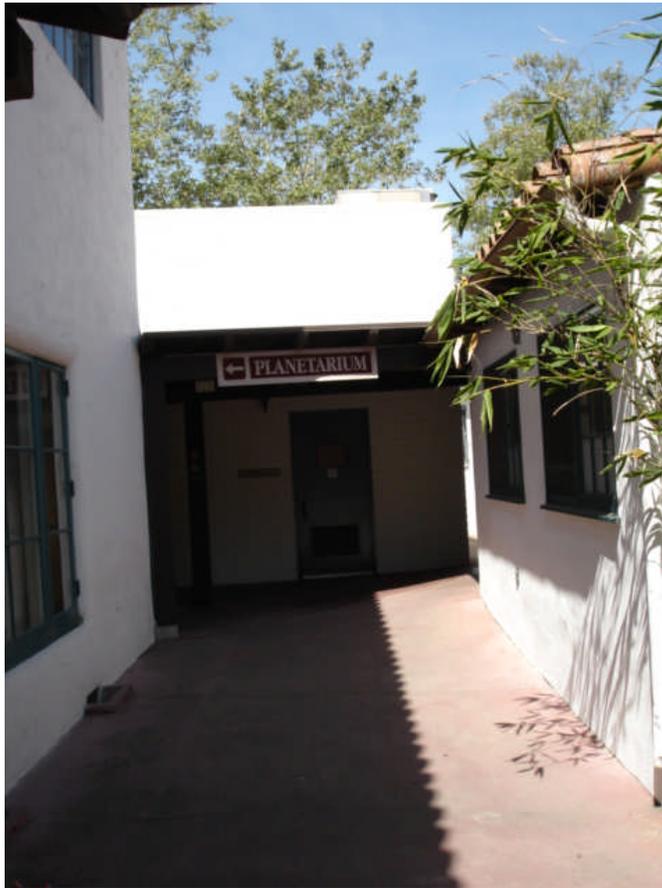
Figure 30  
East Elevation of Farrand Hall (Looking west)

Built in 1961, Farrand Hall was designed by the firm of Cooke and Schmandt. With its flat roof, concrete block walls and lack of architectural ornamentation, the one-story building is a reductive interpretation of postwar Modernist architecture (Figure 30). Originally, the building functioned as the auditorium for the Junior (Education) Department. The Phase 1 HSSR determined that Farrand Hall is not a significant resource for the purposes of environmental review.

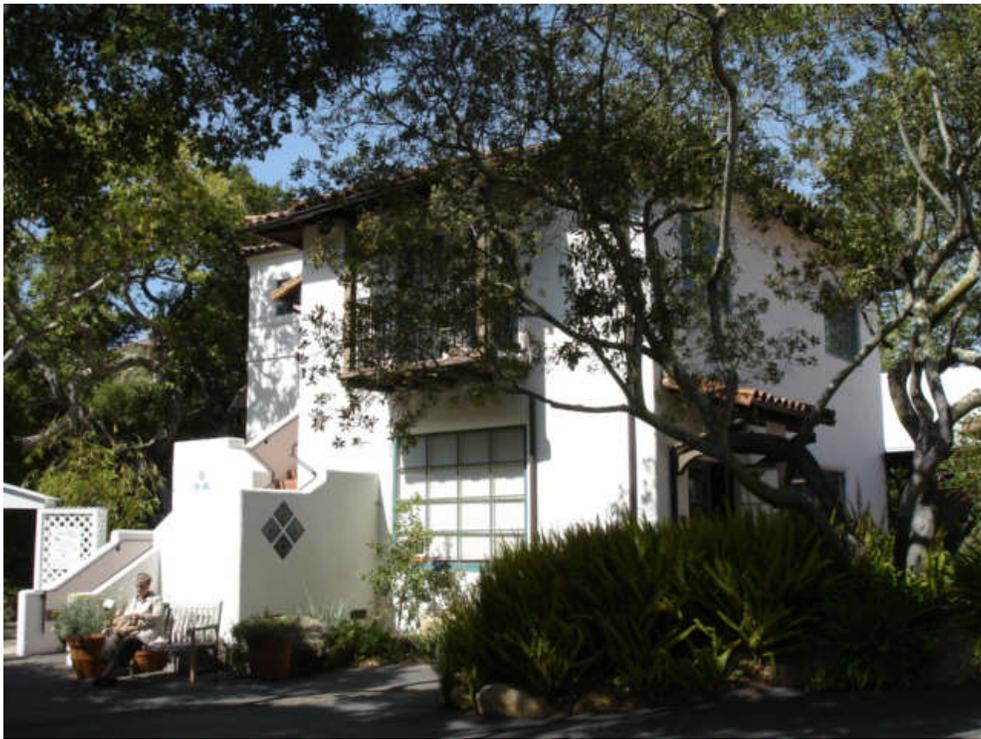
Figure 31  
Alice Touhy Planetarium, Docent Library, and Offices (former Gladwin Planetarium and Koefod Library)  
(Looking southwest)

As it exists today this building has three distinct components, a small library built in 1956, a planetarium constructed in 1957 (the former Gladwin Planetarium) and a two-story wing constructed in 1993 (Figure 31). Built in 1956, the one -story Docent Library (former Koefod Library) was located to the southwest of the Main Museum Complex, near the north bank of Mission Creek, and named in honor of Hilmar Koefod, a former member of the Museum's Board of Trustees. Capped by a side gable roof, this modest wood-framed building originally featured a wrought-iron screen decorated with owls (this screen now functions as an entrance gate for the Museum). A year later, in 1957, the Gladwin Planetarium (now the Alice Touhy Planetarium) was built just to the southwest of the Docent Library. With its pyramidal roof covered in c-shaped terra cotta tiles and plastered walls, the building's architectural scheme is a more schematic
