**PHASE 2  
HISTORIC STRUCTURES/SITES REPORT  
FOR THE  
SANTA BARBARA MUSEUM OF NATURAL HISTORY  
MASTER PLAN**

**MST 2014-00116**

**SANTA BARBARA, CALIFORNIA**

Prepared by:  
Post/Hazeltine Associates

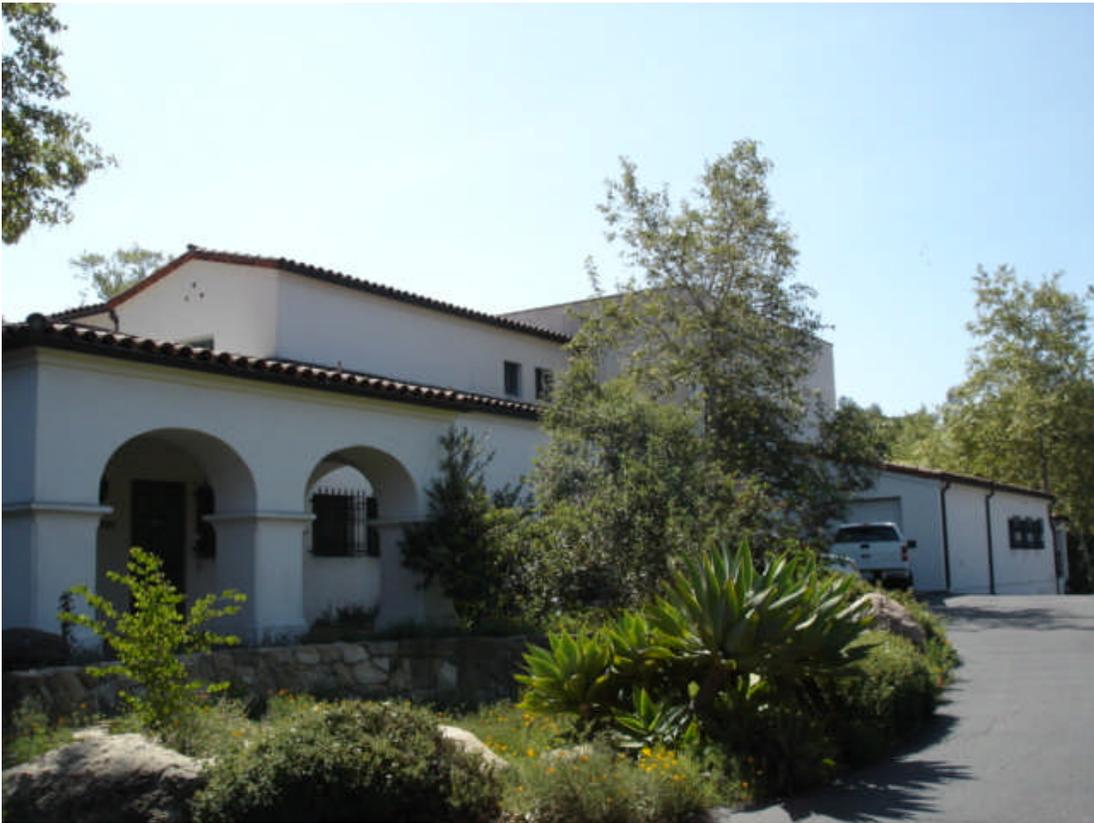
Figure 32  
Collections and Research Center (west elevation)  
(Looking southeast)

Located to the west of the Main Museum Complex, the Collections and Research Center is composed of two distinct elements, a one-story building designed in 1962 by the architectural firm of Arendt, Moser and Grant and a large, two-story addition designed by the firm of Edwards-Pitman in 1989 (Figure 32). Originally, the one-story, reinforced-concrete-block building was built to accommodate the zoology department. Capped by a flat roof and surrounded by a solid parapet, the building's architectural scheme employed Modernist detailing, including masonry screens, ribbon windows, flush panel doors and stuccoed canopies over ribbon windows that mimicked the design of a projecting ledge that ran beneath the ribbon windows. Initially, the north elevation of the building featured a centrally placed bay door. Its interior was symmetrical in design, with a central workroom flanked on the east and west by laboratories and offices. A central corridor, bounded on either side by storage rooms, extends through the building to a large bay door set at the center of the north elevation. Sometime after its construction the building was named the Hale-Rett Building in honor of Clinton B. Hale, a Museum trustee and benefactor, and Egmont Rett, the longtime curator of the Zoology Department.

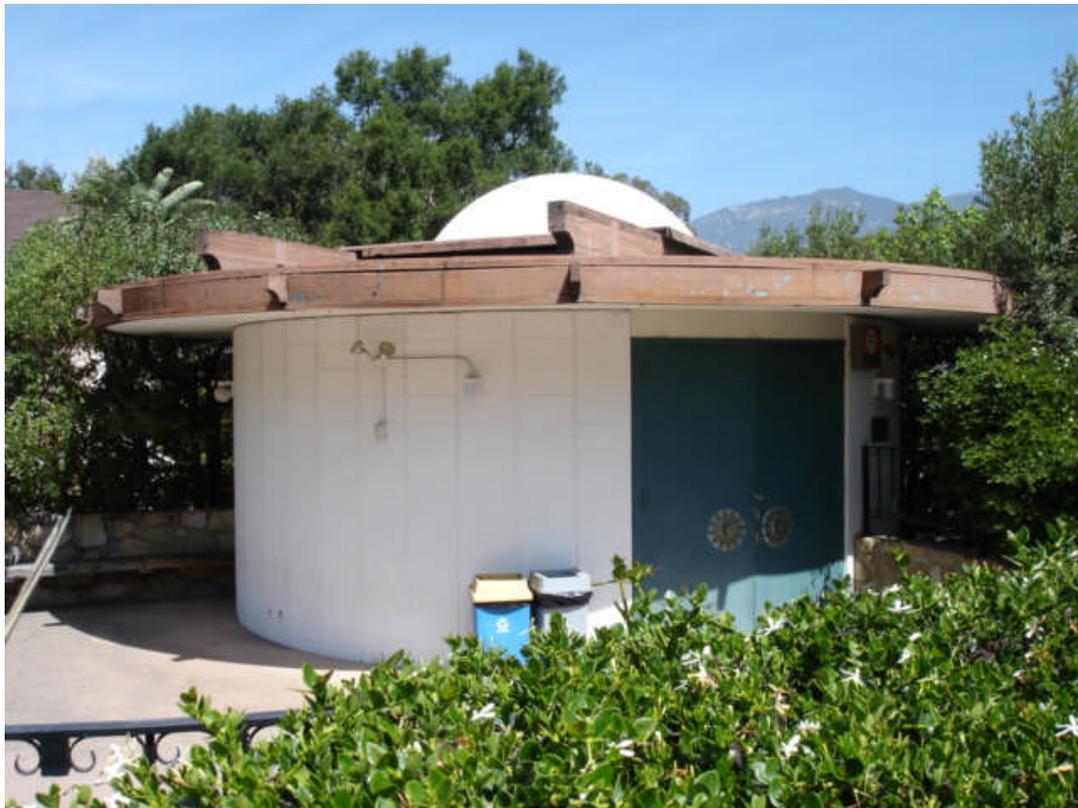
Figure 33  
Doris Fay Palmer Observatory  
(Looking north)

The Doris Fay Palmer Observatory, which is located just to the east of the Collections and Research Center, was designed by the architectural firm of Arendt, Mosher and Grant. Completed in 1967, the circular, concrete-block building is capped by a flat roof with a partially retractable dome at its center (Figure 33). A set of flush panel doors, whose door knobs are ornamented with the signs of the zodiac, is set on the east side of the building. On its south side a low wall of randomly set sandstone surrounds a small circular terrace. A wood bench, extending around the inner wall, provides seating for lectures. The Phase 1 HSSR determined that the Doris Fay Palmer Observatory is not a significant resource for the purposes of environmental review.

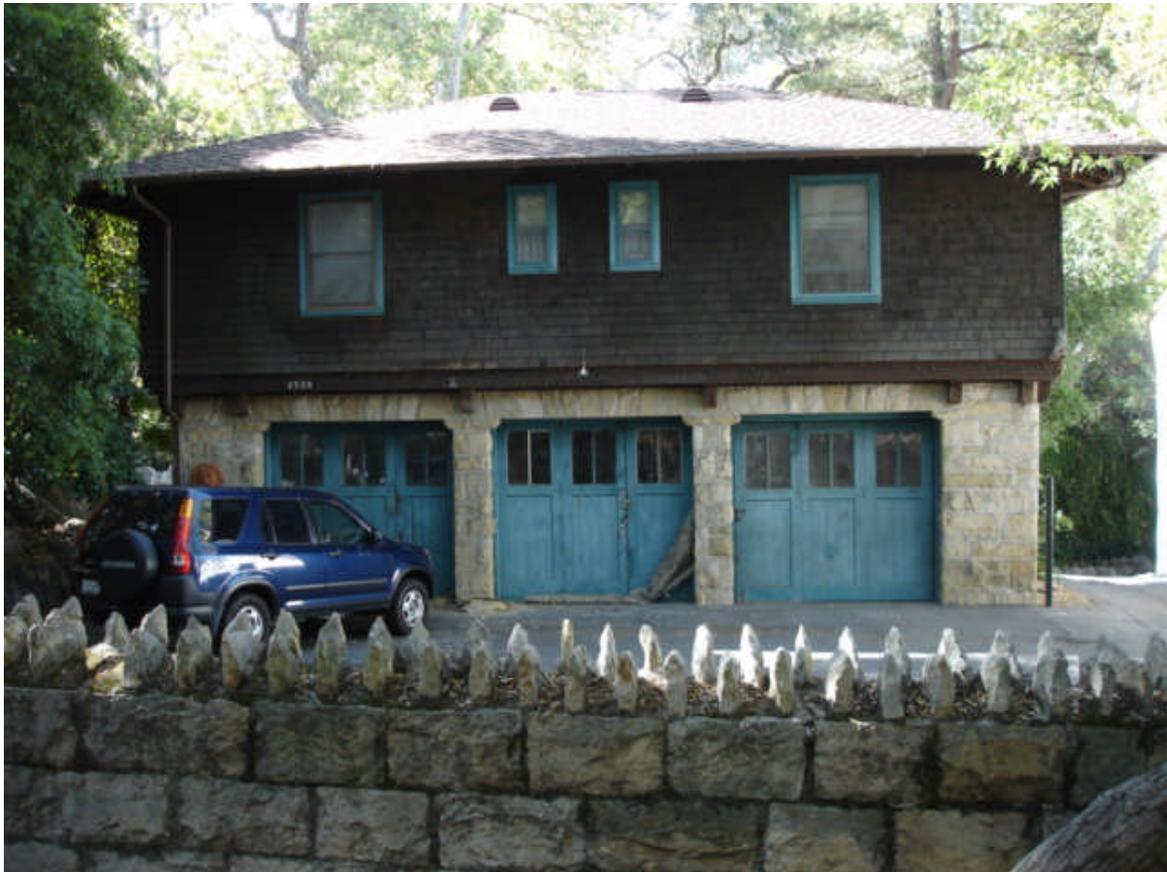
Figure 44  
South Elevation of 653 Mission Canyon Road (Looking northwest)

Located on the north side of Puesta del Sol the one-story, wood frame, shingle-clad, Craftsman-style Director's House was built in circa 1903-1905 by Samuel Ilsey for Herman H. Eddy, a Santa Barbara banker (Figure 44).

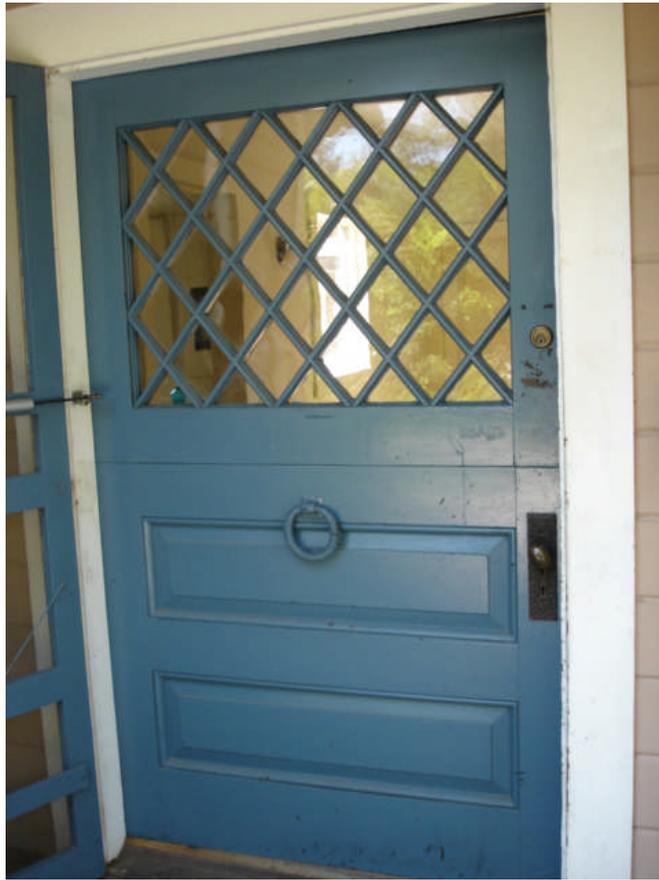
Figure 49  
North elevation of MacVeagh House with view of terrace and front door  
(Looking south)

The MacVeagh House, located to the west of the Museum's Collections and Research Center, is a wood-framed house clad in a combination of vertical board siding, shiplap siding and wood shingles (Figures 49 - 57). The house's complex footprint is composed of four distinct elements surrounding a courtyard (see Appendix A, Sheet AD1.11). The house's original wing, a small, one-story house that presently forms a wing that projects off the northeast corner of the main two-story block, was built sometime before 1888. Several features of the original house, including its vertical emphasis, steeply pitched roof, narrow windows and horizontal siding, identify it as an example of the Folk Victorian style. The architect of a late 19th-century, Arts and Crafts-style addition to the house is unknown. It is possible that Samuel Ilsley, who designed Glendessary for the Sherman Rogers family, may have played a role in its design (Ilsley was a friend of both the Rogers and MacVeagh families).

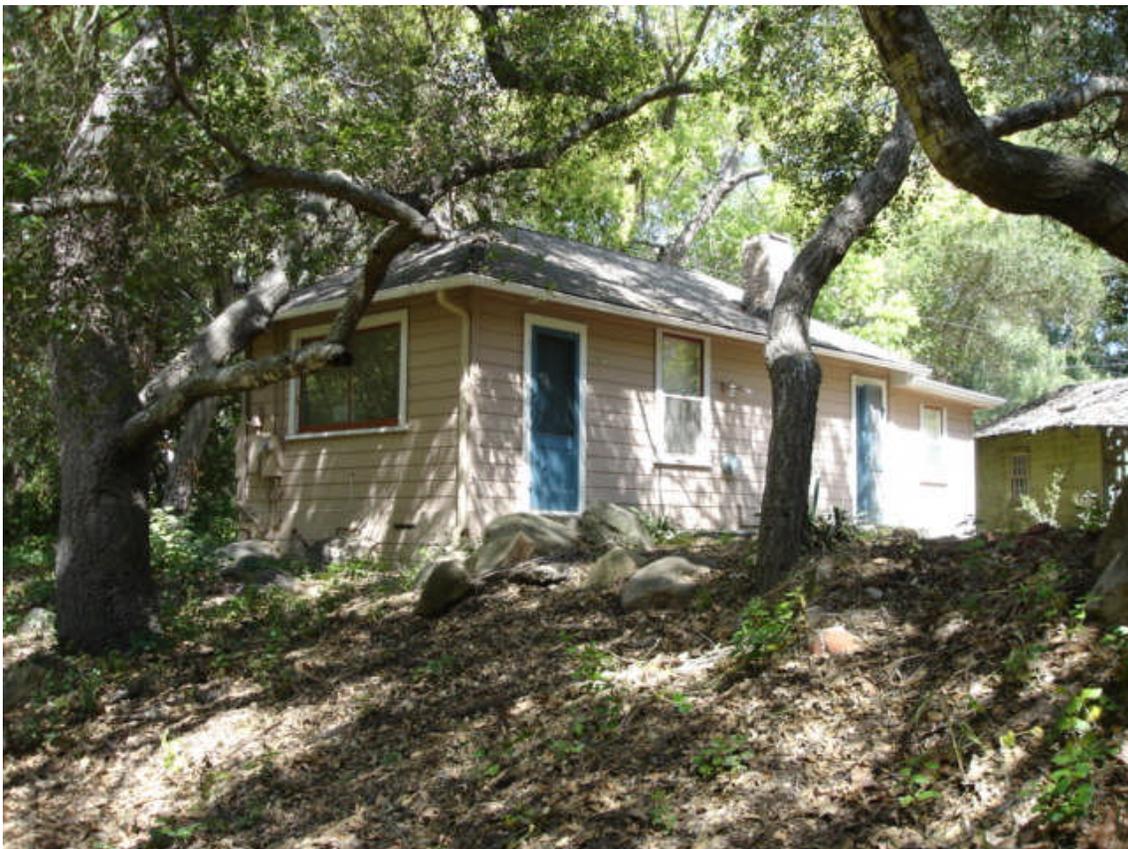
Figure 58  
The north and East Elevations of MacVeagh Cottage (Looking west)

The cottage associated with the MacVeagh House is a one-story, wood-framed house set on a raised foundation (Figures 58 - 61). Its exterior is clad in narrow, horizontal tongue-and-groove siding. Fenestration is composed of rectangular, wood-framed sash windows of varying dimension. The cottage is capped by a hipped roof covered in composition shingles. The wood-paneled front door is located on the east elevation. Small additions, capped by shed roofs, are located on the north and west elevations. A Phase 1-2 HSSR prepared in 2011 determined the building was a significant historic resource for the purpose of environmental review (Post/Hazeltine Associates 2011). MacVeagh Cottage is a contributor to the significant cultural landscape.

Currently MacVeagh Cottage houses education services. Historically the building served as a residence (see Figures 58 – 61). The Master Plan proposed to validate the use of the building for educational services. As part of this conversion the existing wood panel door on the east elevation would be replaced with a wider door to meet universal access requirements. Another

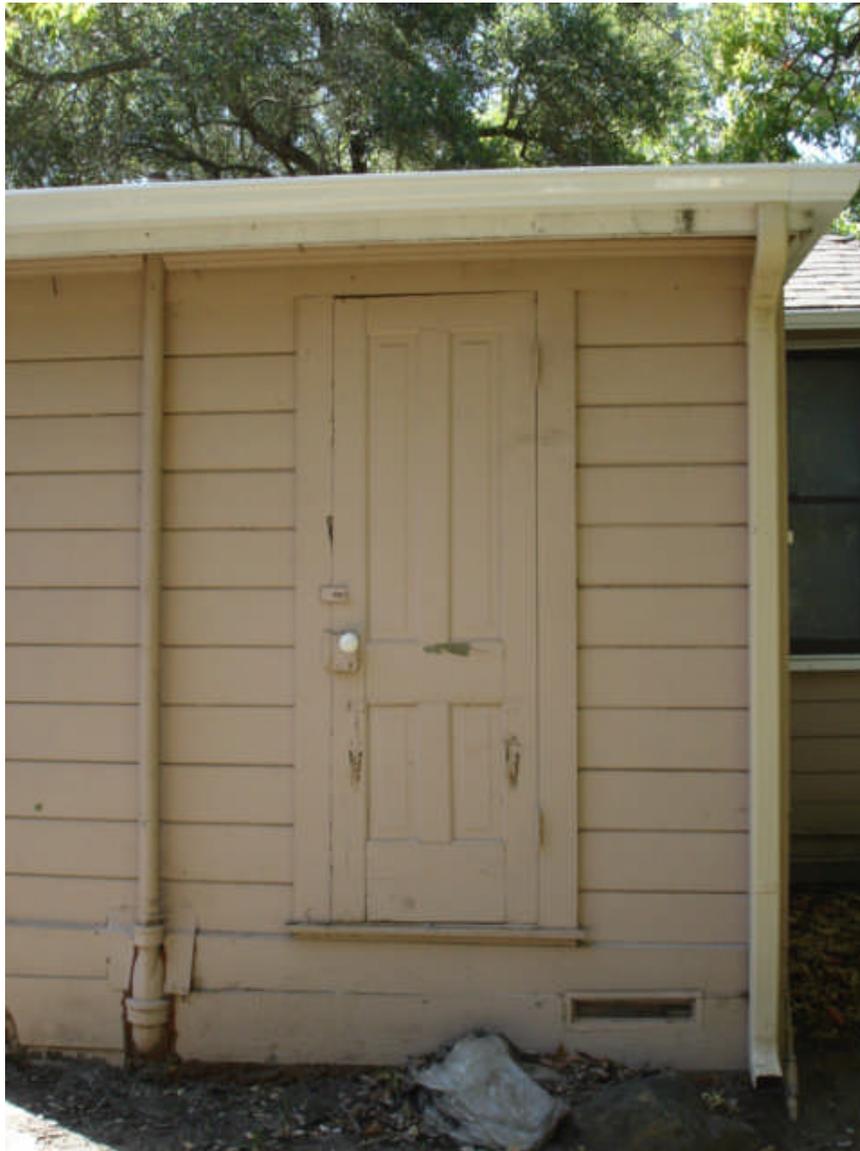
Figure 59  
The South and East Elevations of MacVeagh Cottage (Looking west)

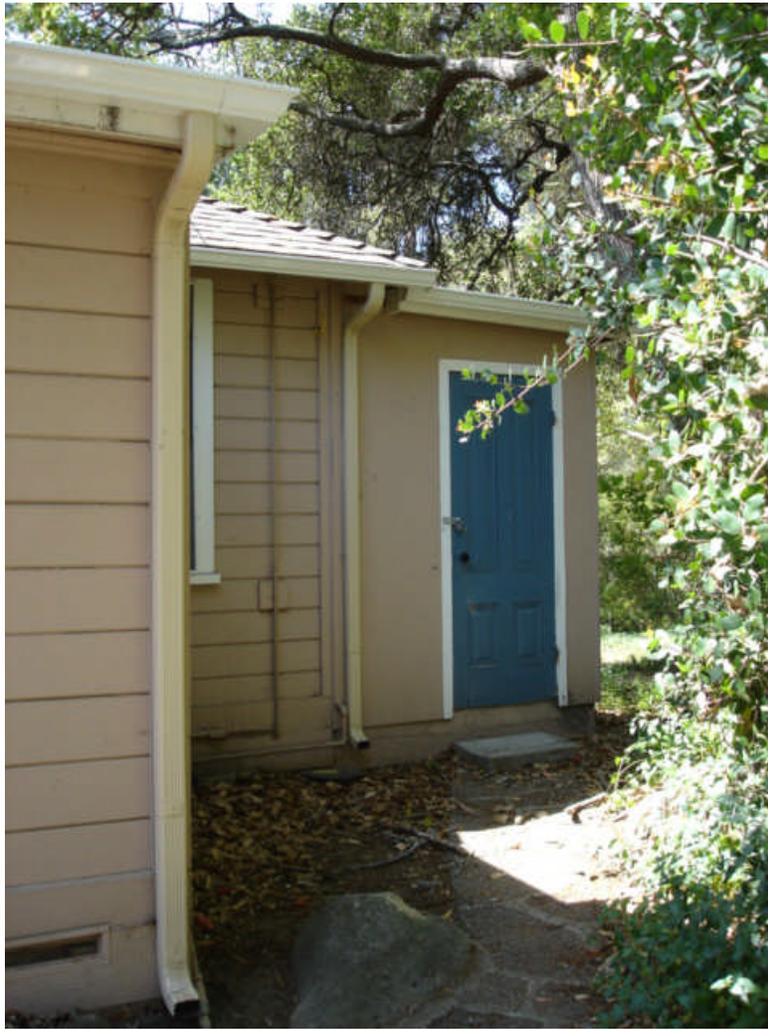
Figure 60  
The North Elevation (east end) of MacVeagh Cottage (Looking south)

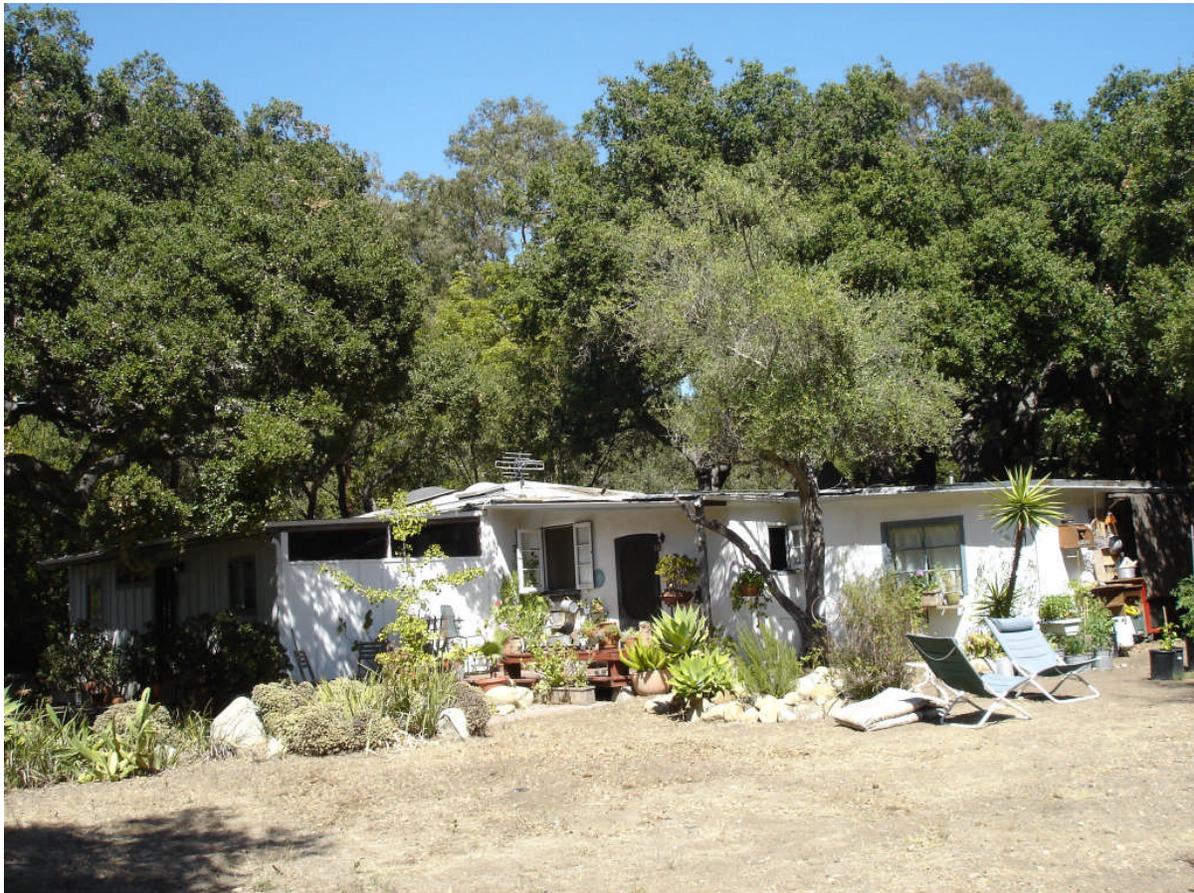
Figure 61  
The North Elevation (west end) of MacVeagh Cottage (Looking south)

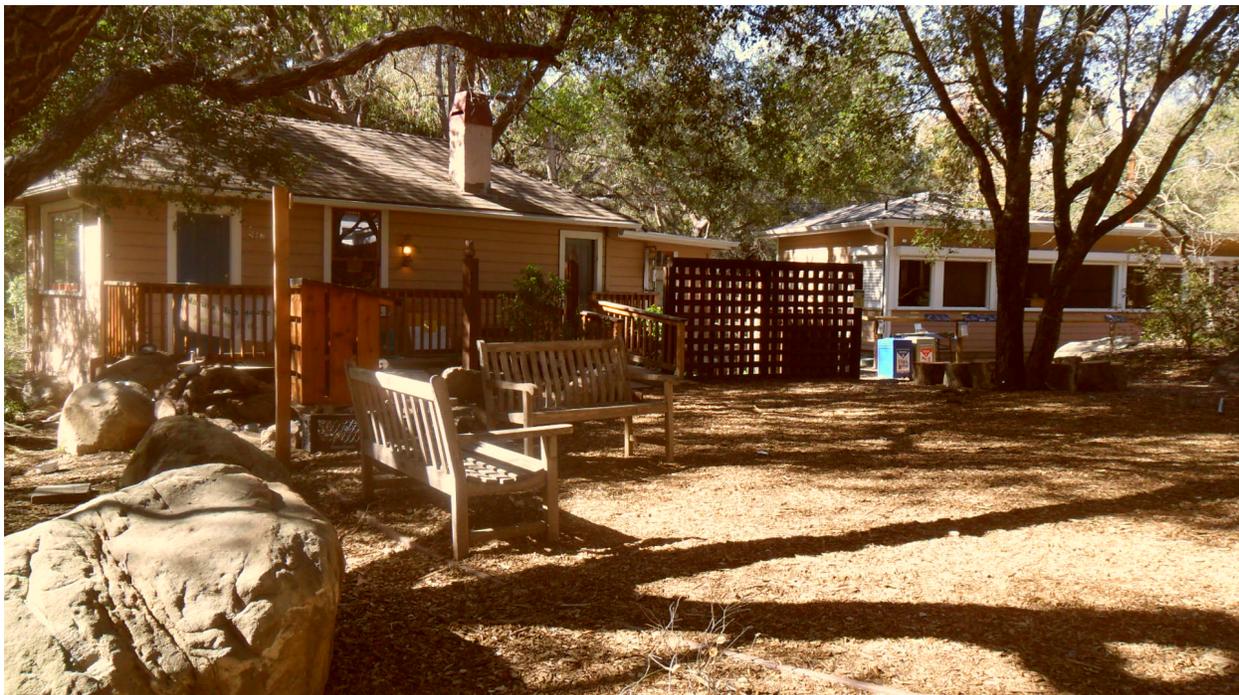
Figure 62  
West Elevation of the Western Residence (Looking north)

A small house, currently known as the Western Residence, located on Parcel 1 at 2758 Las Encinas Road (APN 23-025-066), was originally built in circa- 1920-1922 as a one-bay garage for Guest House #2 associated with the former Bernhard Hoffmann Estate (Figure 62). The garage was enlarged by circa-1930 into a three-bay structure with a small, attached dwelling space. The building was subsequently transformed into a house sometime in the 1950s when several additions were made. Sometime in the 1970s the garage bays were transformed into habitable space. The architecturally significant element of the building is confined to the original one-bay garage, which has been almost entirely encapsulated by later additions. The Phase 1 HSSR determined that the original one-bay garage of this building is a significant historic resource for the purposes of environmental review. The building is a contributor to the significant cultural landscape.

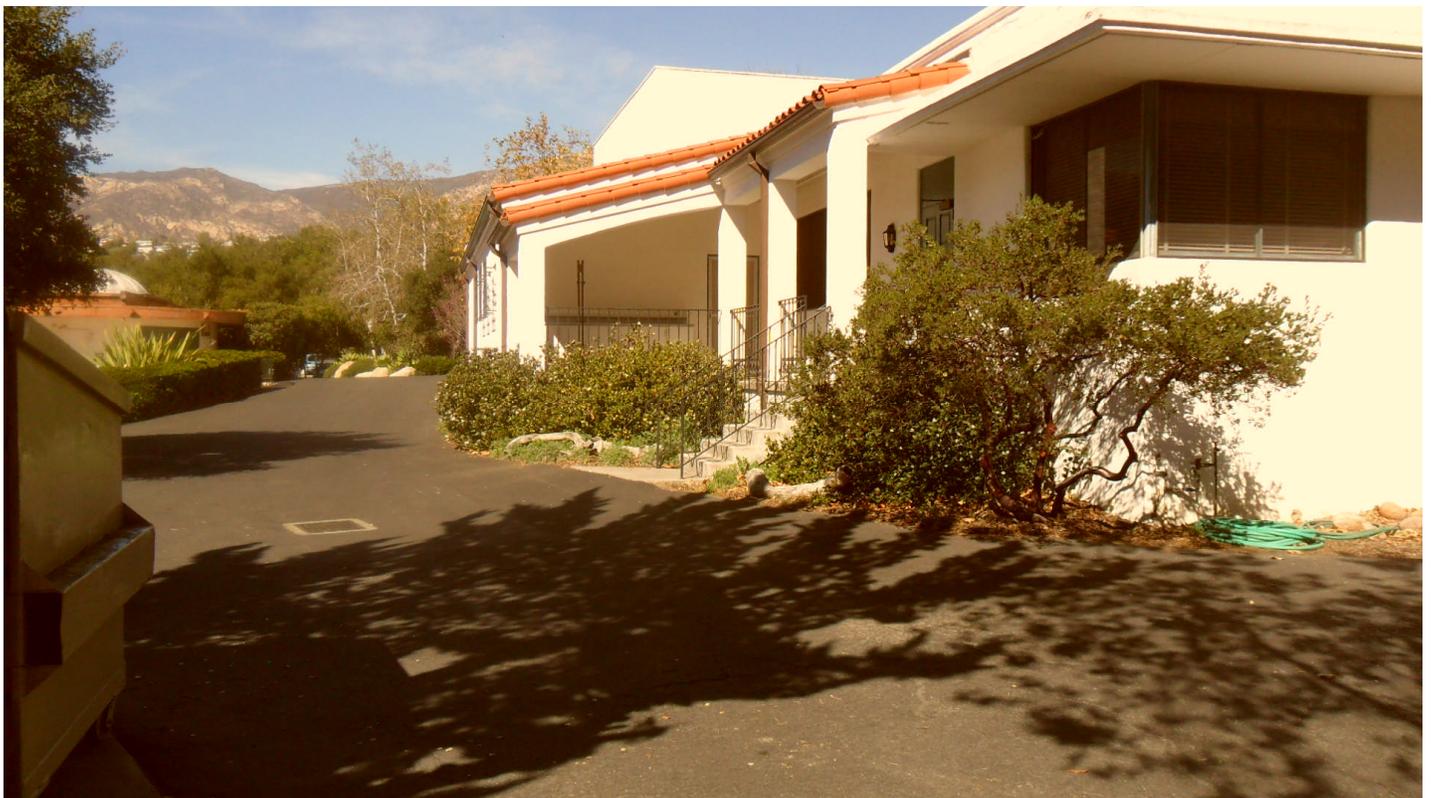
Figure 66  
Looking south from along the west elevation of the Collections and Research Center

The Phase 1 HSSR determined that the Collections and Research Center, Observatory, Observatory plaza, storage sheds and the existing network of paved pathways are not significant historic resources for the purposes of environmental review (Figures 66 – 67). Therefore, the proposed removal of the sheds, portions of the paving, a section of the existing wall off the Observatory and portions of the existing paved pathways and elements of the landscaping in the form of smaller plantings would not impact significant historic resources. The proposed changes would enhance the area by removing all but one of the storage sheds and portions of the existing asphalt paving, which does not enhance the semi-rural character of the surrounding cultural landscape. As proposed the proposed replacement of existing paving with new paving materials whose texture and materials would be less visually obtrusive than the existing paving would meet the Standards provided the following design guidance is implemented on the final plans:

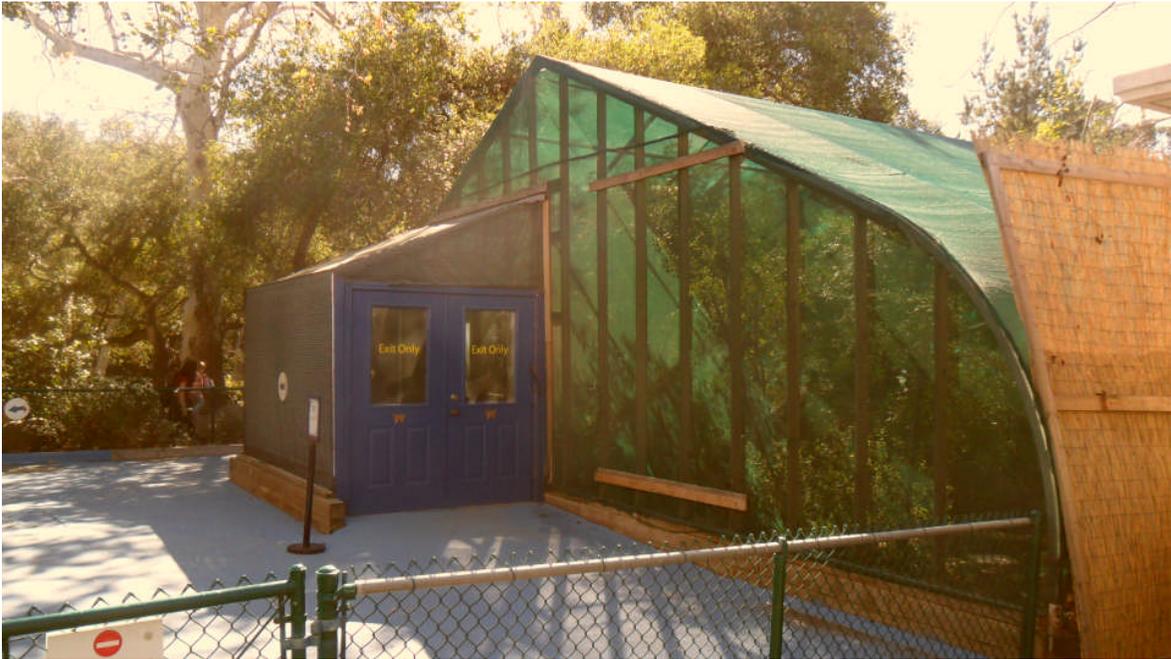
Figure 67  
Looking North from southwest corner of the Collections and Research Center

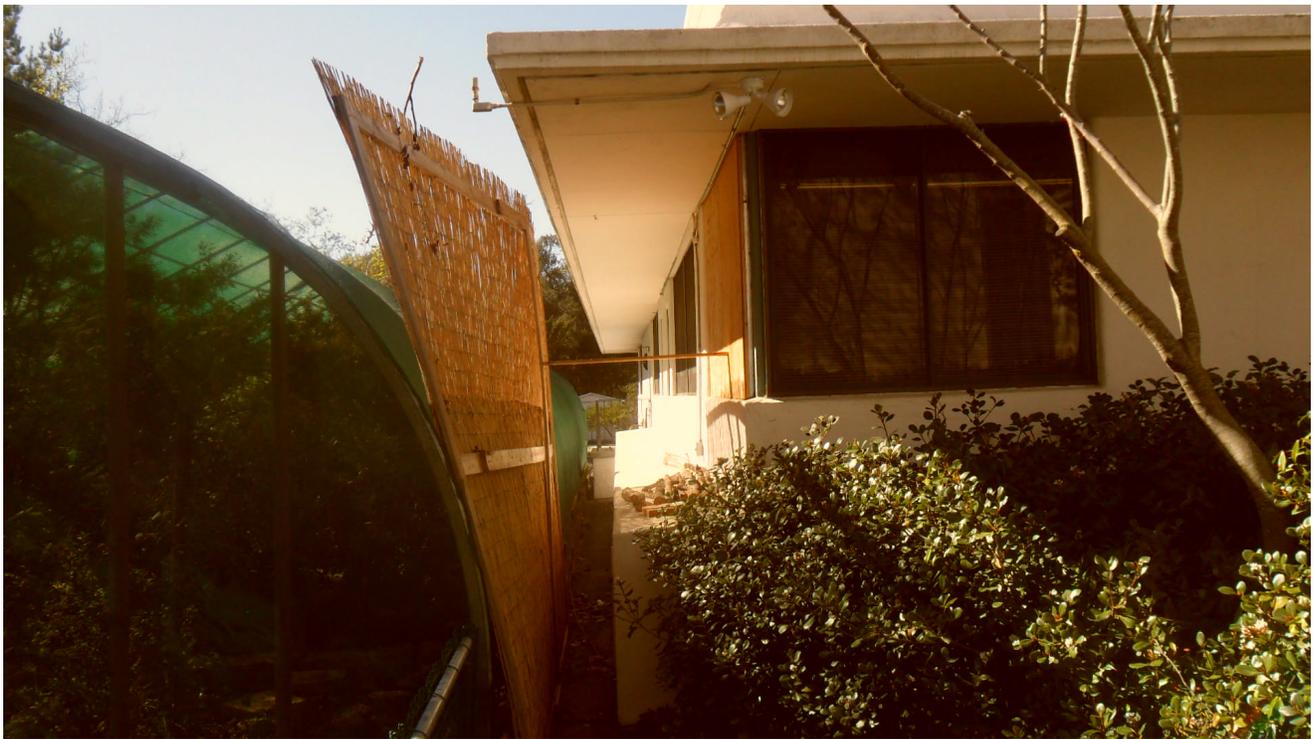
Figure 68  
East elevation of existing butterfly exhibit

The existing butterfly exhibit is a temporary structure that is less than 20 years of age. Therefore, its removal would result in a less than significant impact (Class III) to significant historic resources (Figures 68 – 70). The existing paving material is not historic; therefore, its removal would result in a less than significant impact (Class III) to significant historic resources.

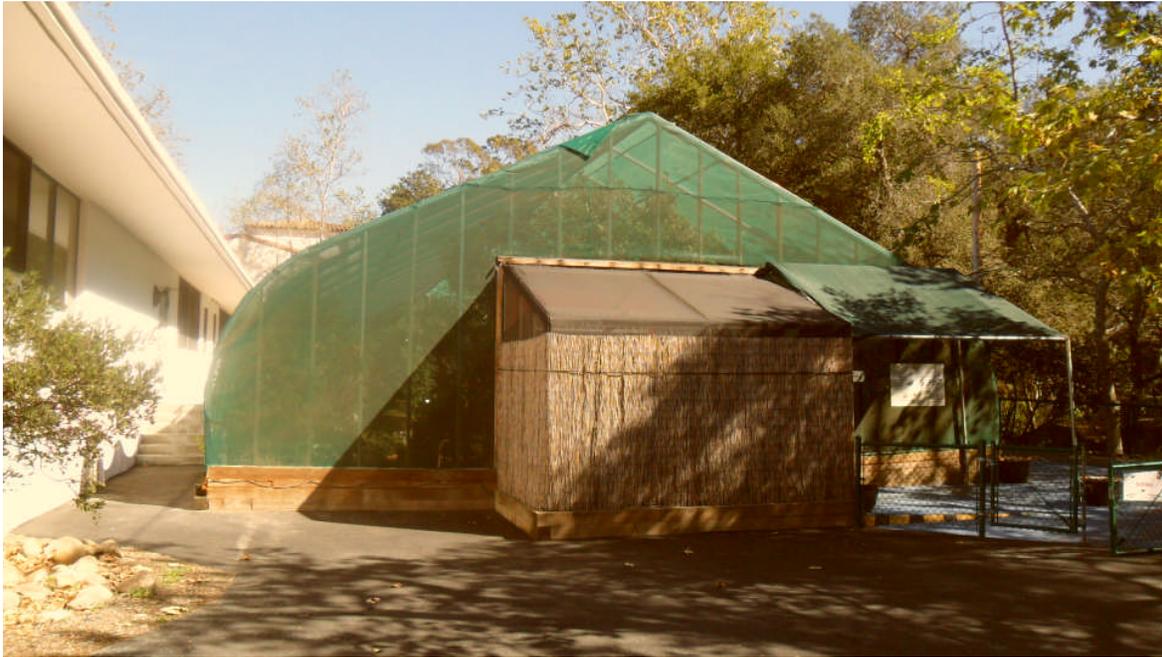
Figure 69  
East and north elevations of the existing butterfly exhibit with Collections  
and Research Center

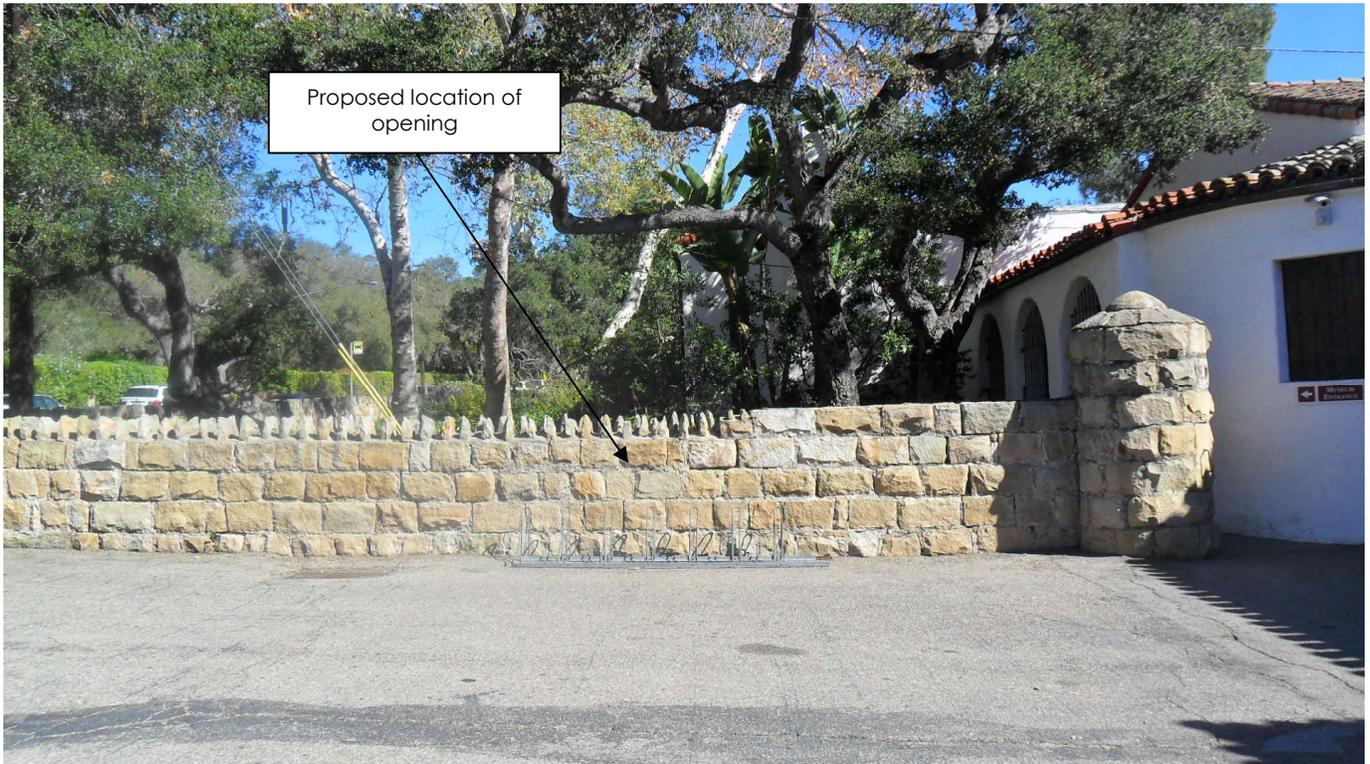
Figure 71  
Looking southeast towards Main Museum Building

The Master Plan proposes to replace the pedestrian portion of the existing asphalt paving in front of the gates off the northeast corner of Fleischmann Auditorium with permeable sandstone-colored flagstone pavers laid in a random pattern (Figure 71). Removable bollards would be placed along the north side of the new paving to maintain a safe pedestrian access separate from deliveries. The design for the bollards has not been finalized.

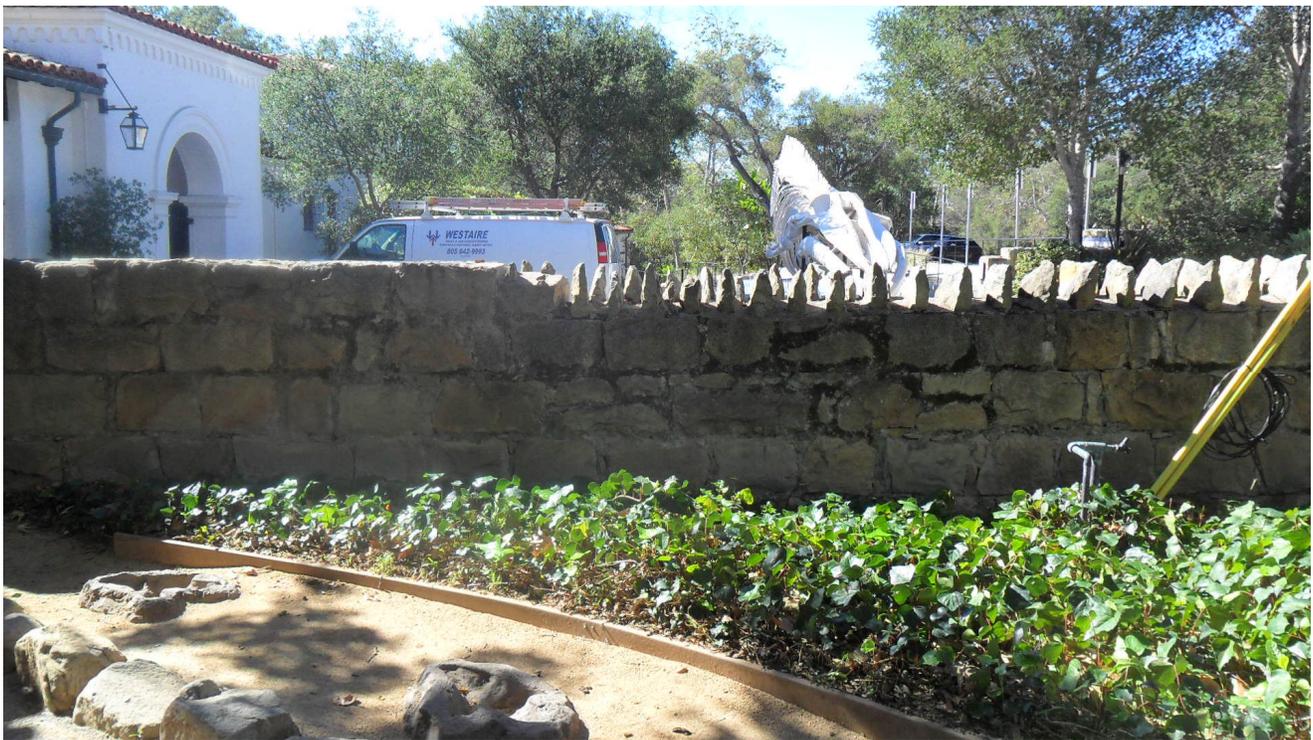
Figure 72  
West elevation of Hazard Estate wall (looking east)

The Master Plan proposes to install an ADA-compliant pathway between the existing ADA-compliant pathway on the north side of the whale courtyard and the existing main visitor entrance at the center of the Main Museum Building's 1922 wing (Figures 72 – 75). Construction of this pathway would provide an accessible pathway linking the parking lot to the Museum's main entrance. The pathway would be composed of the following five segments: 1) the existing ramped pathway extending along the north side of the whale courtyard to the southeast corner of the whale courtyard; 2) from the whale courtyard, a proposed flagstone paved section of pathway would extend to the northwest corner of a new flagstone-paved plaza fronting the set of gates off the northeast corner of Fleischmann Auditorium (please see 10.1.2 g, Item 1 for an

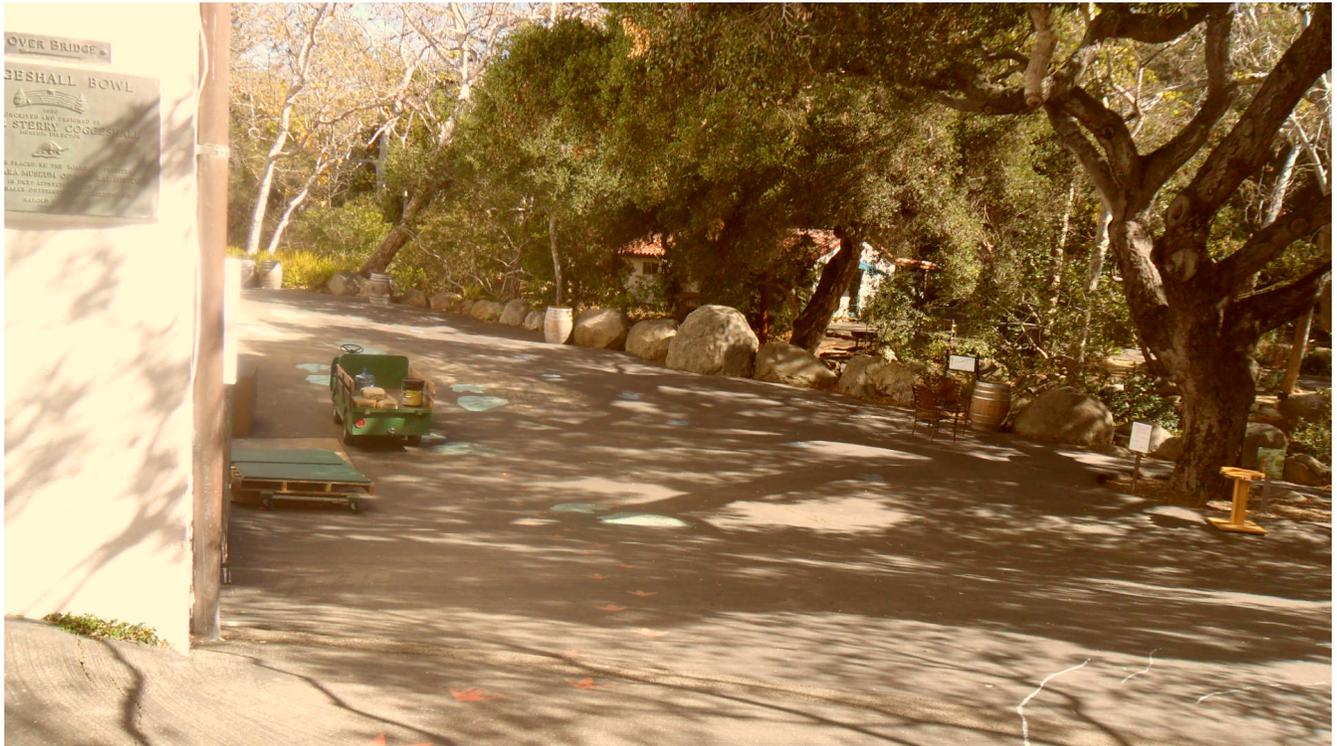
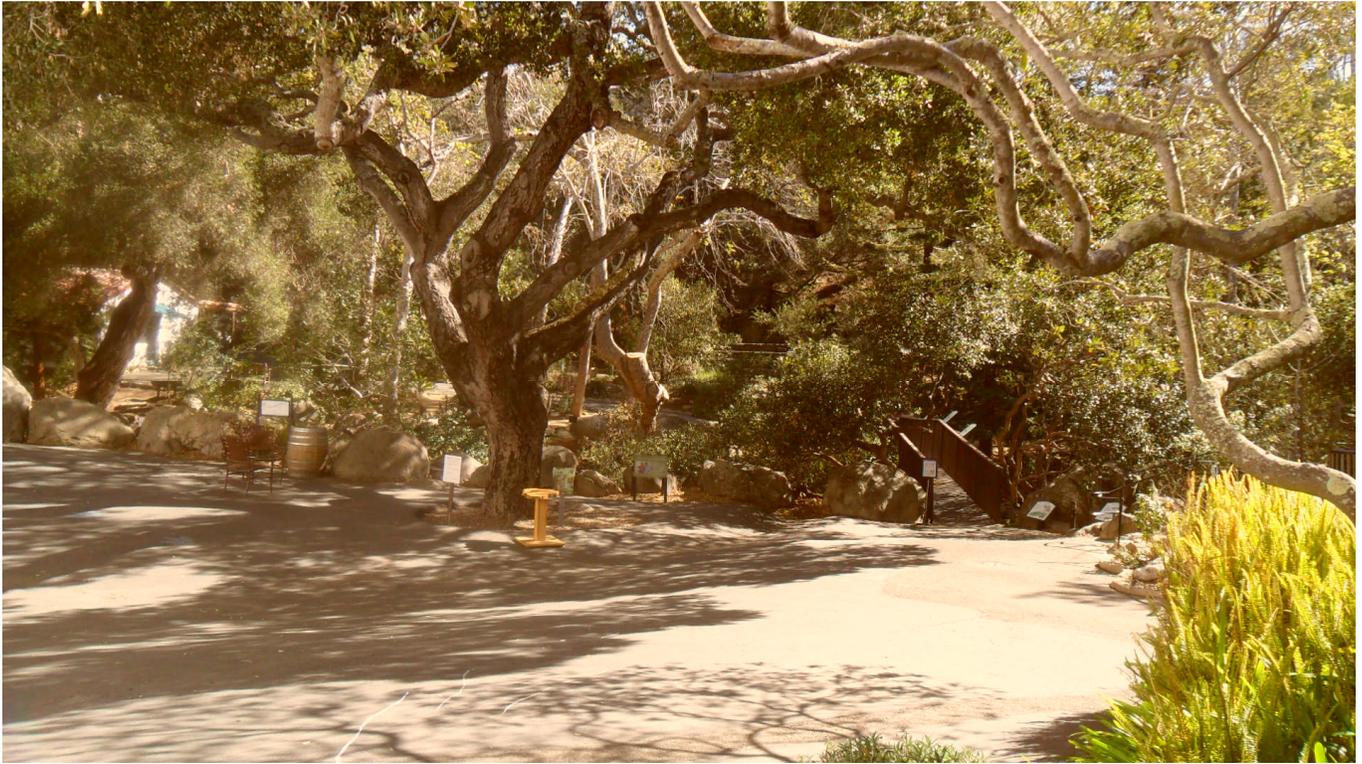
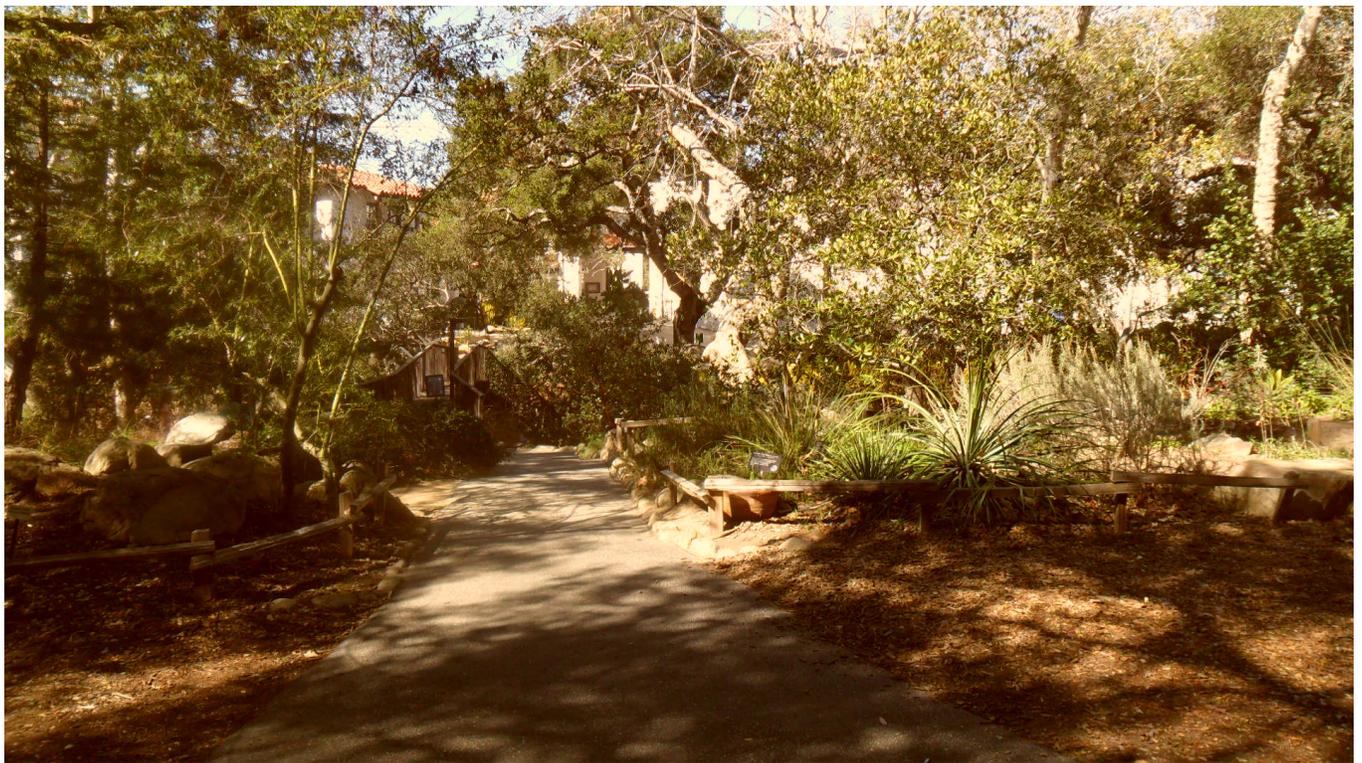
Figure 76  
Asphalt paving off southwest corner of Main Museum Building (looking north)

Figure 77  
Asphalt paving off southwest corner of Main Museum Building (looking southeast)

Figure 78  
Asphalt paving off southwest corner of Main Museum Building (looking south towards Mission Creek)

A new, 1,900-square-foot, raised deck would be constructed over the existing asphalt paving at the west end of the Main Museum Building's south elevation (Figures 76 - 78). Named the Creekside Terrace, the deck would be constructed of wood or composite material. The southerly edge of the deck would feature a composite material fascia with infill wood lattice flanked on its east by a series of steps that would form an informal seating area. The western end of the deck would feature a wood guardrail. Along the western edge of the deck the existing pathways, retaining walls and planters, which are less than 50 years of age, would be reconfigured. The eastern end of the deck would transition to the existing asphalt paving. The northern edge of the deck would be formed by the south elevation of the existing building, a parapet surrounding the entrance to the basement level offices and a planter. The raised deck is proposed to remediate existing issues with the change in grade in this area and to minimize impacts to the creek bank retaining wall and native oak trees.
