**PHASE 2  
HISTORIC STRUCTURES/SITES REPORT  
FOR THE  
SANTA BARBARA MUSEUM OF NATURAL HISTORY  
MASTER PLAN**

**MST 2014-00116**

**SANTA BARBARA, CALIFORNIA**

Prepared by:  
Post/Hazeltine Associates

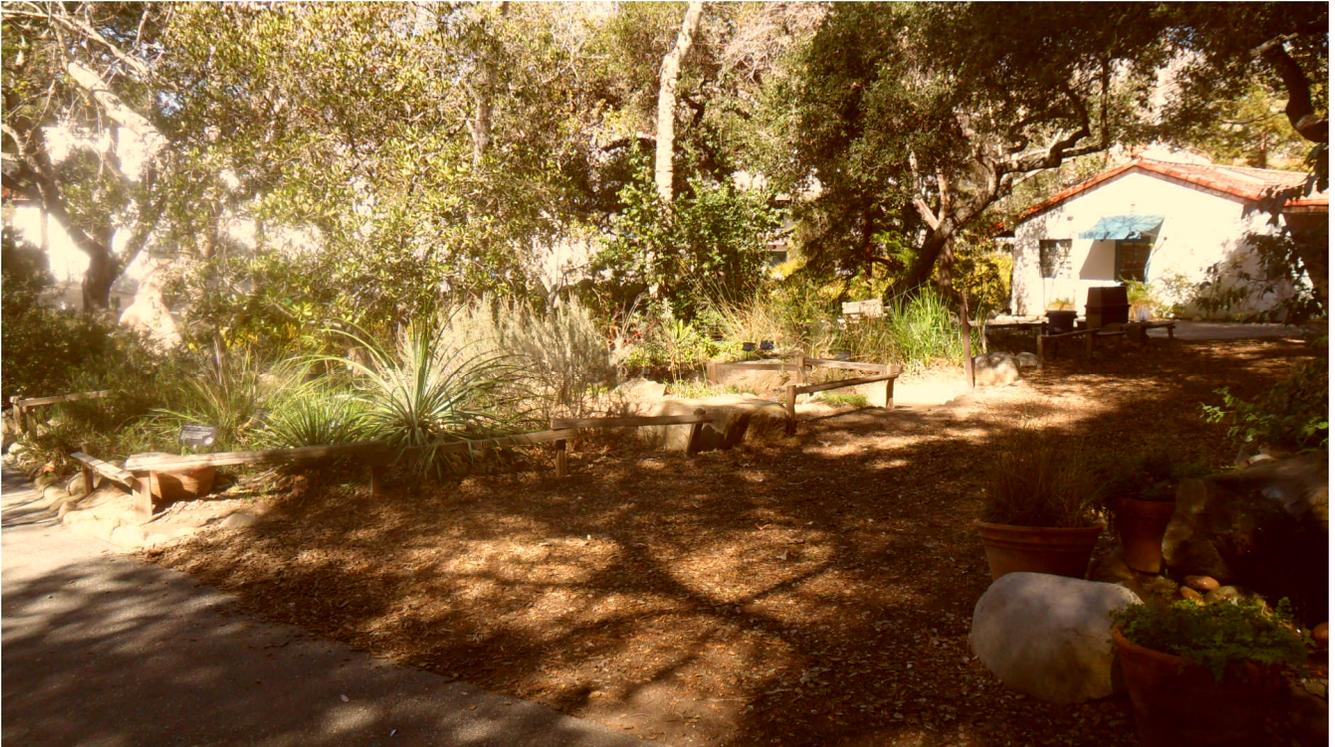
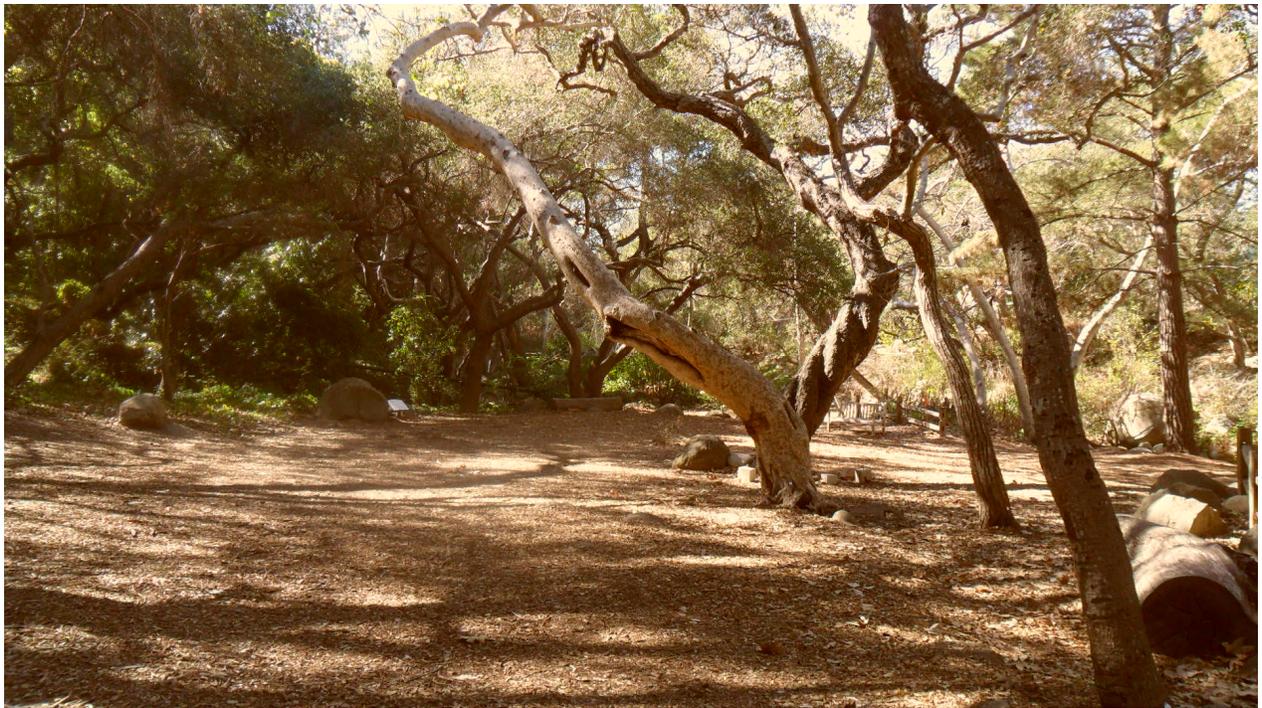
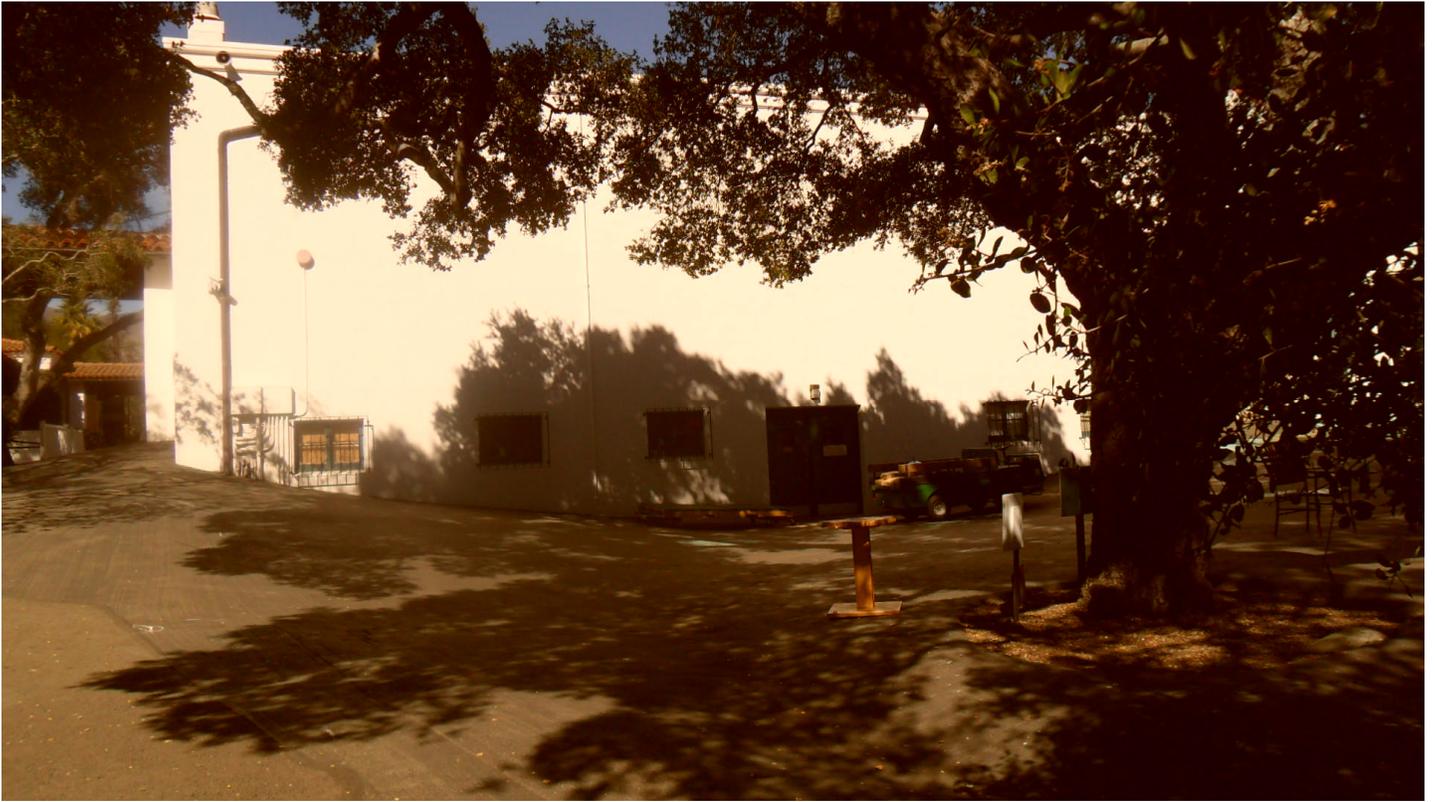
Figure 79  
South side of Mission Creek, looking north

Figure 80  
South side of Mission Creek looking east towards the Broder Building

Figure 81  
South side of Mission Creek looking west towards proposed location of Chumash Interpretive exhibit

The landscaping in the area south of Mission Creek would be enhanced and amplified with new plantings of native plants. Permeable surfaces are proposed for some of the existing pathways while others would remain unaltered. Proposed and existing surface materials include permeable decorative unit pavers, permeable flagstone pavers, mulch, engineered wood fiber, decomposed granite, wood or composite material boardwalks and asphalt. Existing resources that contribute to the setting of the Main Museum Building and the cultural landscape include Coggeshall Bowl and the large specimen trees. The remainder of the landscaping and the Broder Building are not contributors to the historic character of the Main Museum Building or the cultural landscape. A design for the Chumash village life interpretive display has not been finalized (Figures 79 – 81).

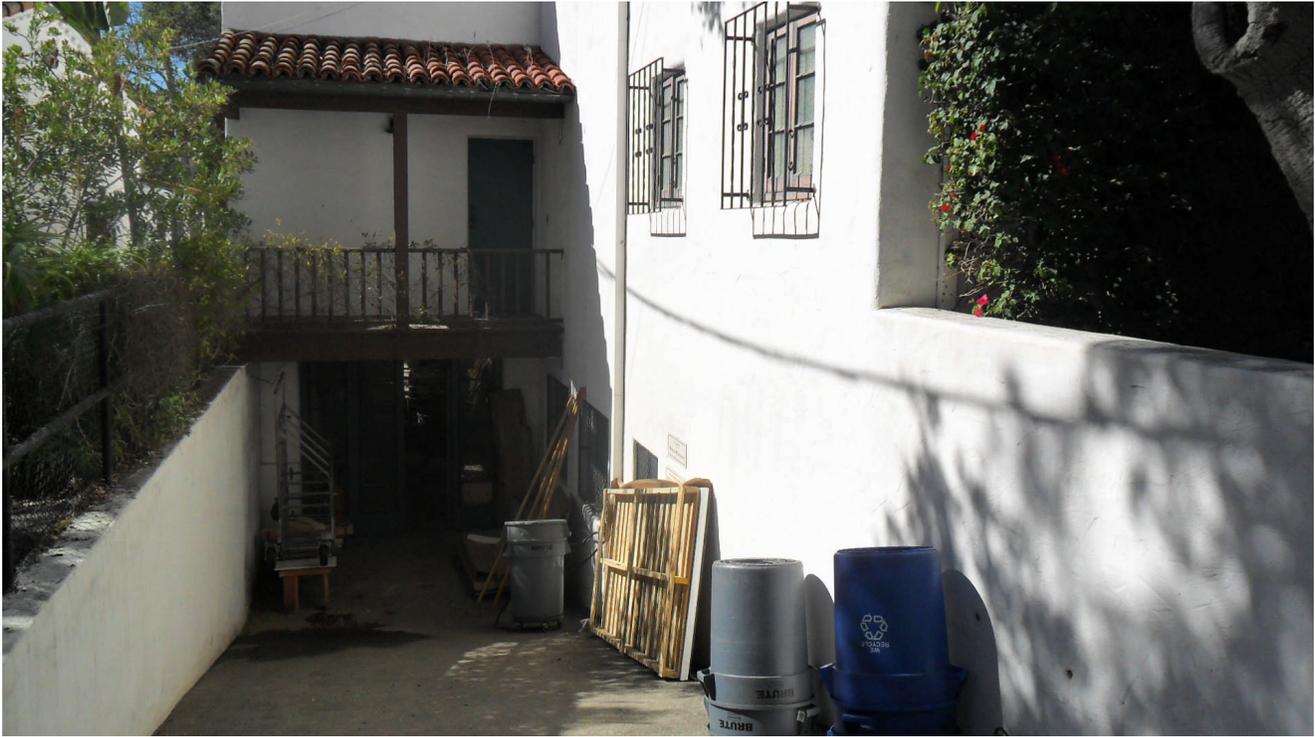
Figure 83  
Restroom wing, west Elevation of Main Museum Building (looking southeast)

The Phase 1 HSSR determined that the restroom wing (built 1952 and subsequently remodeled) is not a significant historic resource (Figure 83). Therefore, its alteration would not result in a significant impact to significant historic resources. Moreover, the proposed scheme would employ architectural motifs of the existing wing including its arched opening and multi-light windows. It should also be noted that the remodeled wing would maintain its existing roof ridge, thereby leaving the existing view of the roof of Gould Indian Hall from Fleischmann Auditorium unimpaired. Reversing the swing on the north elevation of Gould Indian Hall would not impact the historic character of this elevation because the doors would remain in place. Because the proposed alterations would not impact a historic wing of the building and are broadly referential to the Spanish Colonial Revival style, this proposed alteration meets Standard 9. Therefore, the remodeling of the non-historic restroom wing would result in a less than significant impact to significant historic resources (Class III).

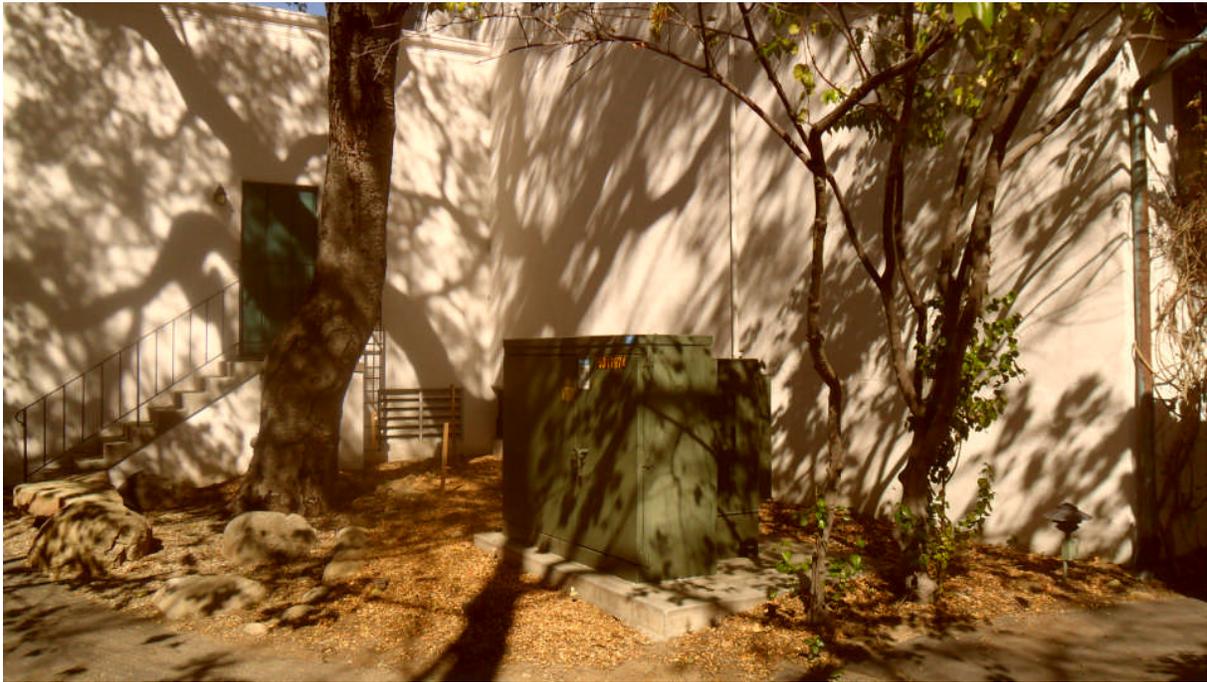
Figure 84  
Ramp at southeast corner of Fleischmann Auditorium  
(looking west)

The Master Plan proposes to remove an existing ramp and metal pole railing and install a set of exterior stairs and a hydraulic lift at the southeast corner of Fleischmann Auditorium (Figure 84). A new stucco clad cmu wall would be installed in place of the current metal pipe rail fence. At the east end of the existing ramp a metal gate and cmu wall covered in stucco would regulate access to the lift and stairs. At the west end of the south elevation a six-foot tall, wood fence would be installed to shield mechanical equipment from view (Figure 85).

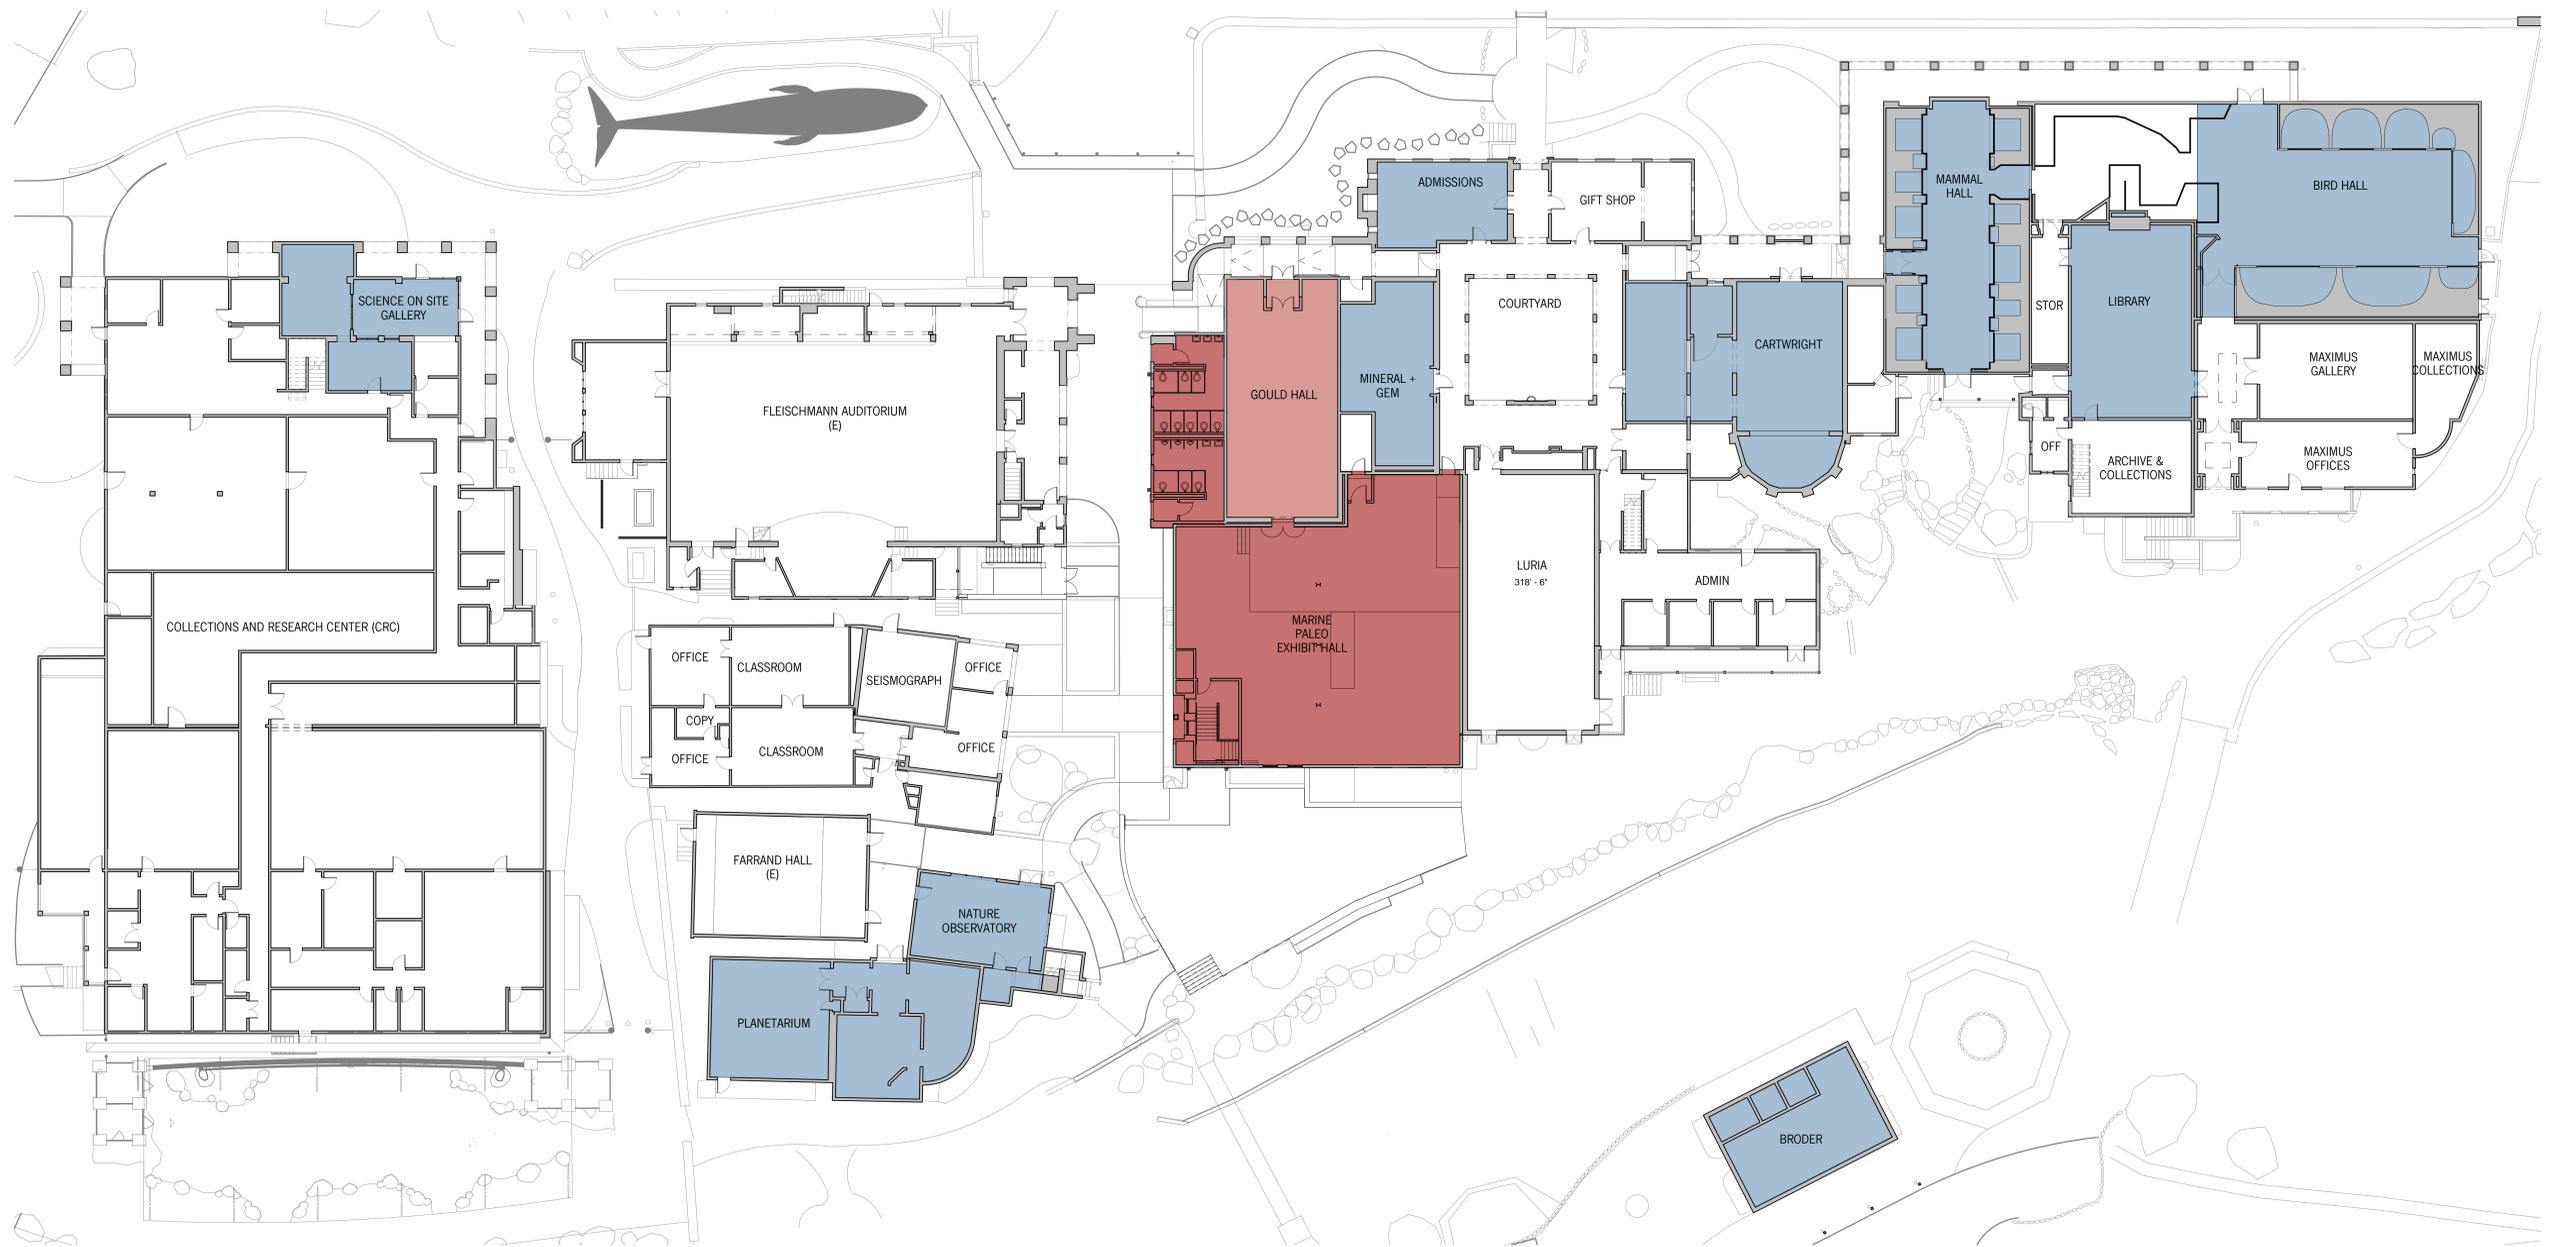
1  
T1.3  
MAIN LEVEL PLAN - SCOPE DIAGRAM  
1/16" = 1'-0"

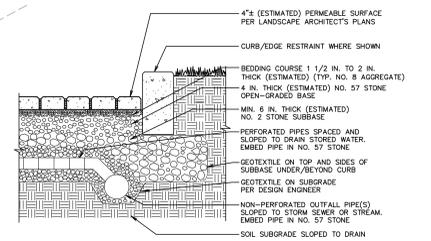
- NOTES:**
- 2 3/8" N. (60 MM) THICK PAVERS MAY BE USED IN PEDESTRIAN AND RESIDENTIAL APPLICATIONS.
  - NO. 2 STONE SUBGRADE THICKNESS VARIES WITH DESIGN. CONSULT ICI PERMEABLE INTERLOCKING CONCRETE PAVEMENT MANUAL.
  - NO. 2 STONE MAY BE SUBSTITUTED WITH NO.3 OR NO.4 STONE.

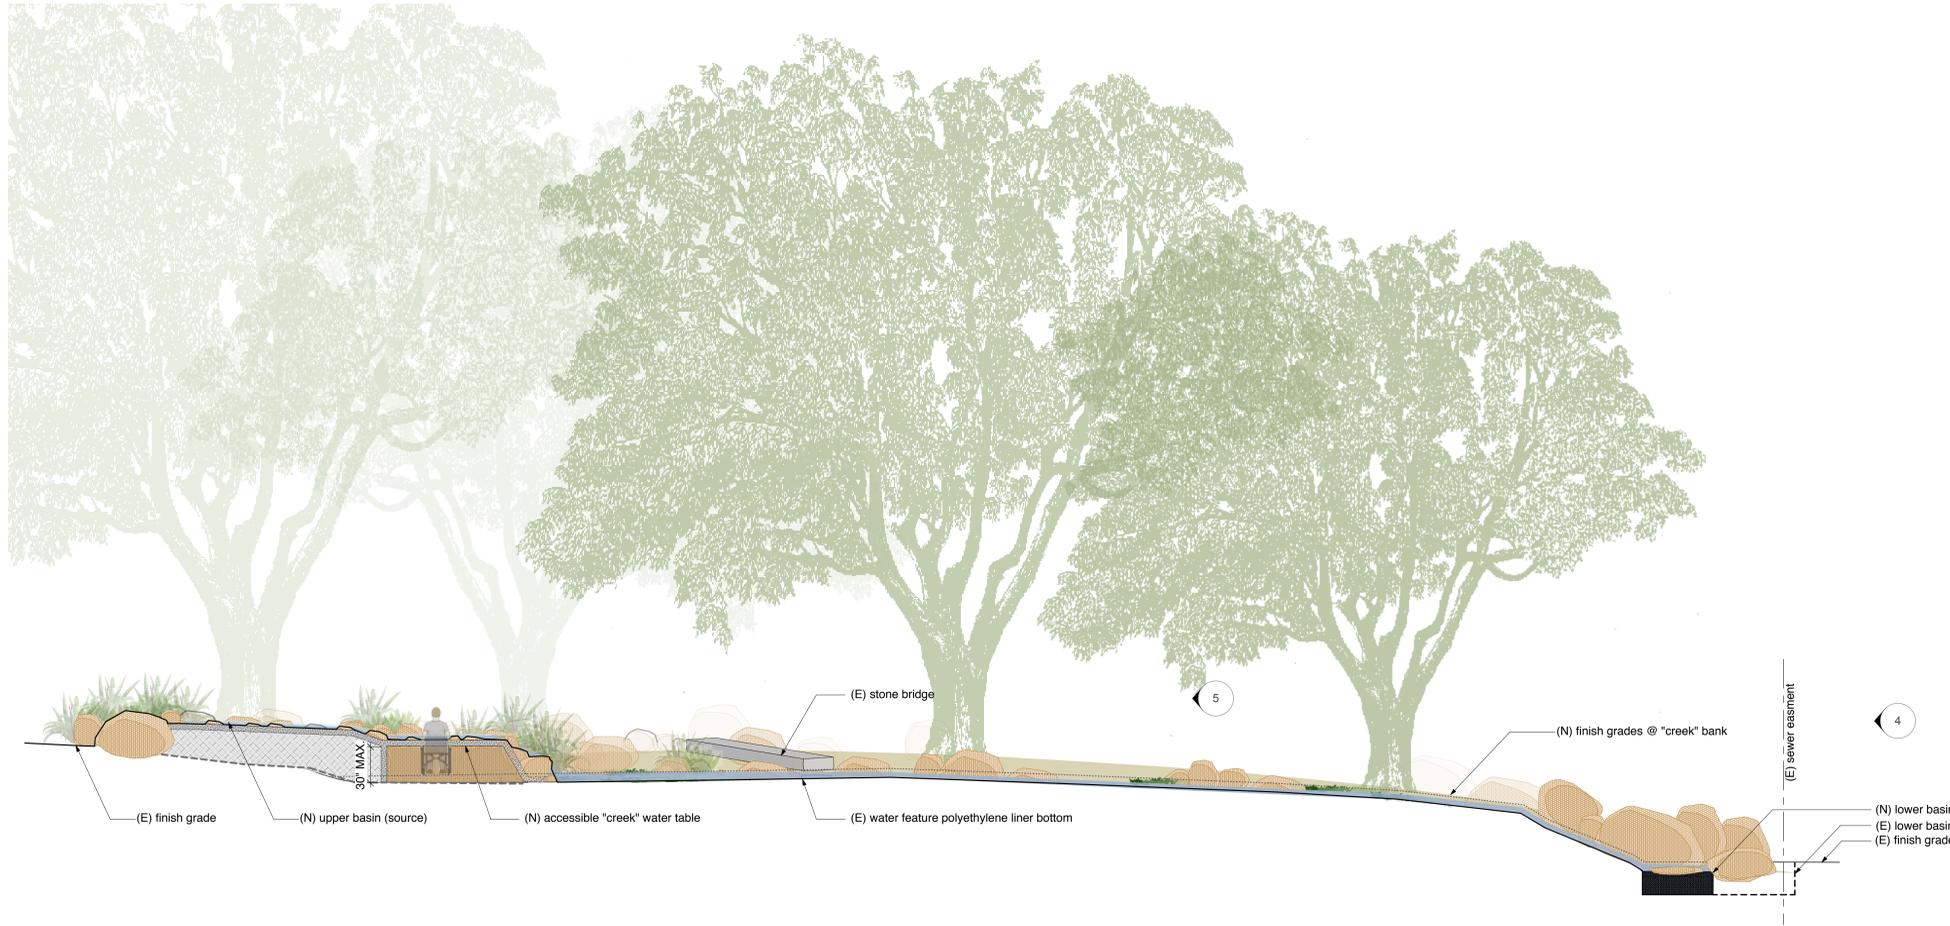
**3** Backyard "Creek" Water Feature

SECTION

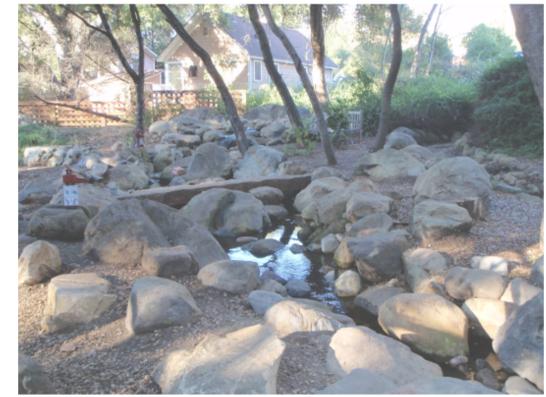
**5** (E) Backyard "Creek" Water Feature

VIEW MID-RUN

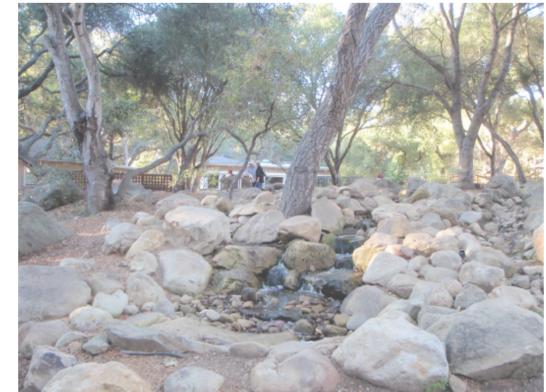
**4** (E) Backyard "Creek" Water Feature

VIEW FROM BOTTOM BASIN

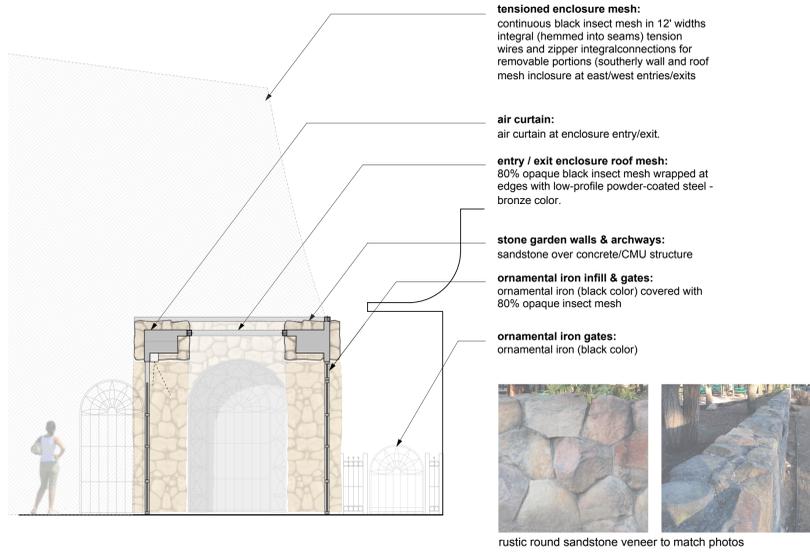
- tensioned enclosure mesh:** continuous black insect mesh in 12' widths integral (hemmed into seams) tension wires and zipper integral connections for removable portions (southerly wall and roof mesh inclosure at east/west entries/exits)
- air curtain:** air curtain at enclosure entry/exit.
- entry / exit enclosure roof mesh:** 80% opaque black insect mesh wrapped at edges with low-profile powder-coated steel - bronze color.
- stone garden walls & archways:** sandstone over concrete/CMU structure
- ornamental iron infill & gates:** ornamental iron (black color) covered with 80% opaque insect mesh
- ornamental iron gates:** ornamental iron (black color)

8 butterfly garden - entry/exit enclosure technical section

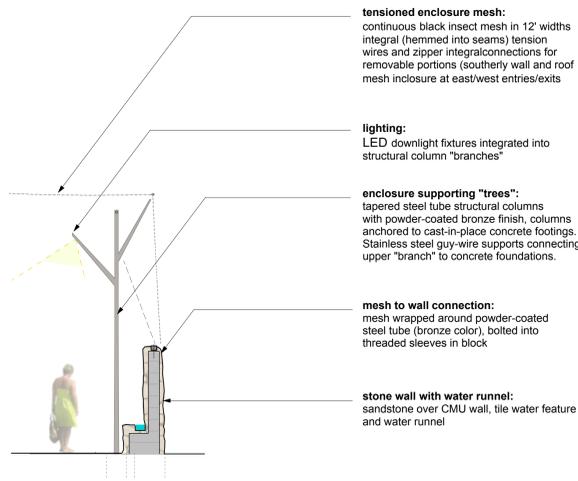
- tensioned enclosure mesh:** continuous black insect mesh in 12' widths integral (hemmed into seams) tension wires and zipper integral connections for removable portions (southerly wall and roof mesh inclosure at east/west entries/exits)
- lighting:** LED downlight fixtures integrated into structural column "branches"
- enclosure supporting "trees":** tapered steel tube structural columns with powder-coated bronze finish, columns anchored to cast-in-place concrete footings. Stainless steel guy-wire supports connecting upper "branch" to concrete foundations.
- mesh to wall connection:** mesh wrapped around powder-coated steel tube (bronze color), bolted into threaded sleeves in block
- stone wall with water runnel:** sandstone over CMU wall, tie water feature and water runnel

7 butterfly garden - northerly edge enclosure technical section

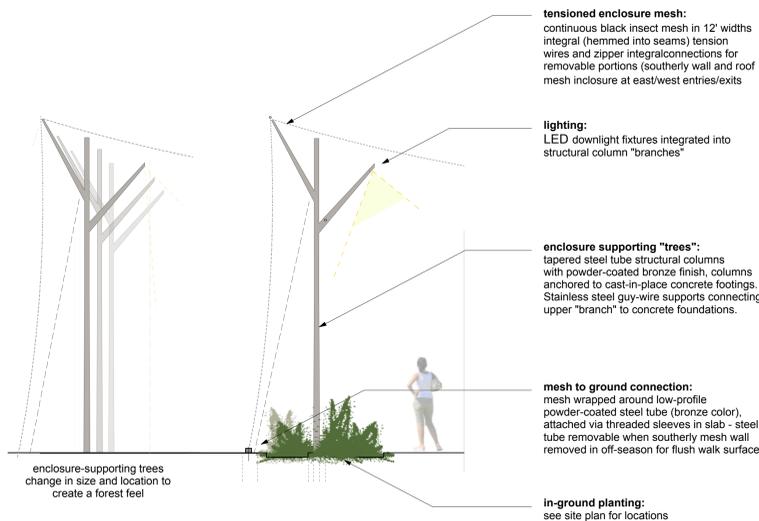
- tensioned enclosure mesh:** continuous black insect mesh in 12' widths integral (hemmed into seams) tension wires and zipper integral connections for removable portions (southerly wall and roof mesh inclosure at east/west entries/exits)
- lighting:** LED downlight fixtures integrated into structural column "branches"
- enclosure supporting "trees":** tapered steel tube structural columns with powder-coated bronze finish, columns anchored to cast-in-place concrete footings. Stainless steel guy-wire supports connecting upper "branch" to concrete foundations.
- mesh to ground connection:** mesh wrapped around low-profile powder-coated steel tube (bronze color), attached via threaded sleeves in slab - steel tube removable when southerly mesh wall removed in off-season for flush walk surface
- in-ground planting:** see site plan for locations

6 butterfly garden - southerly edge enclosure technical section

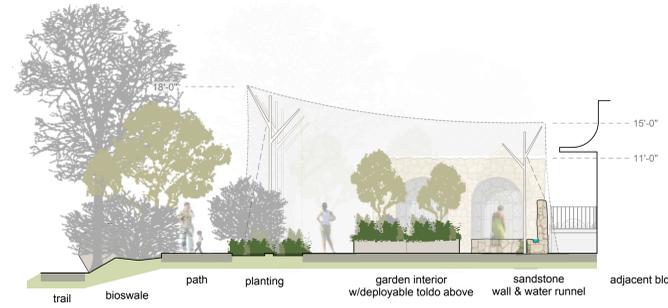
4 butterfly garden - north-south section

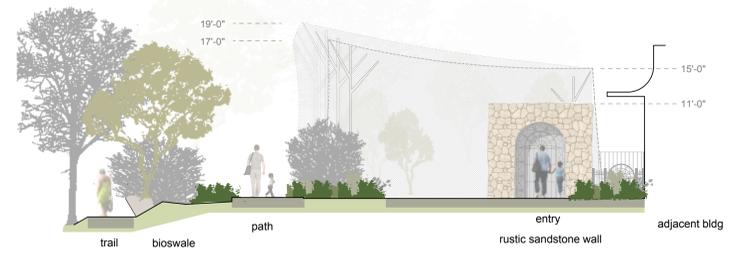
5 butterfly garden - east elevation

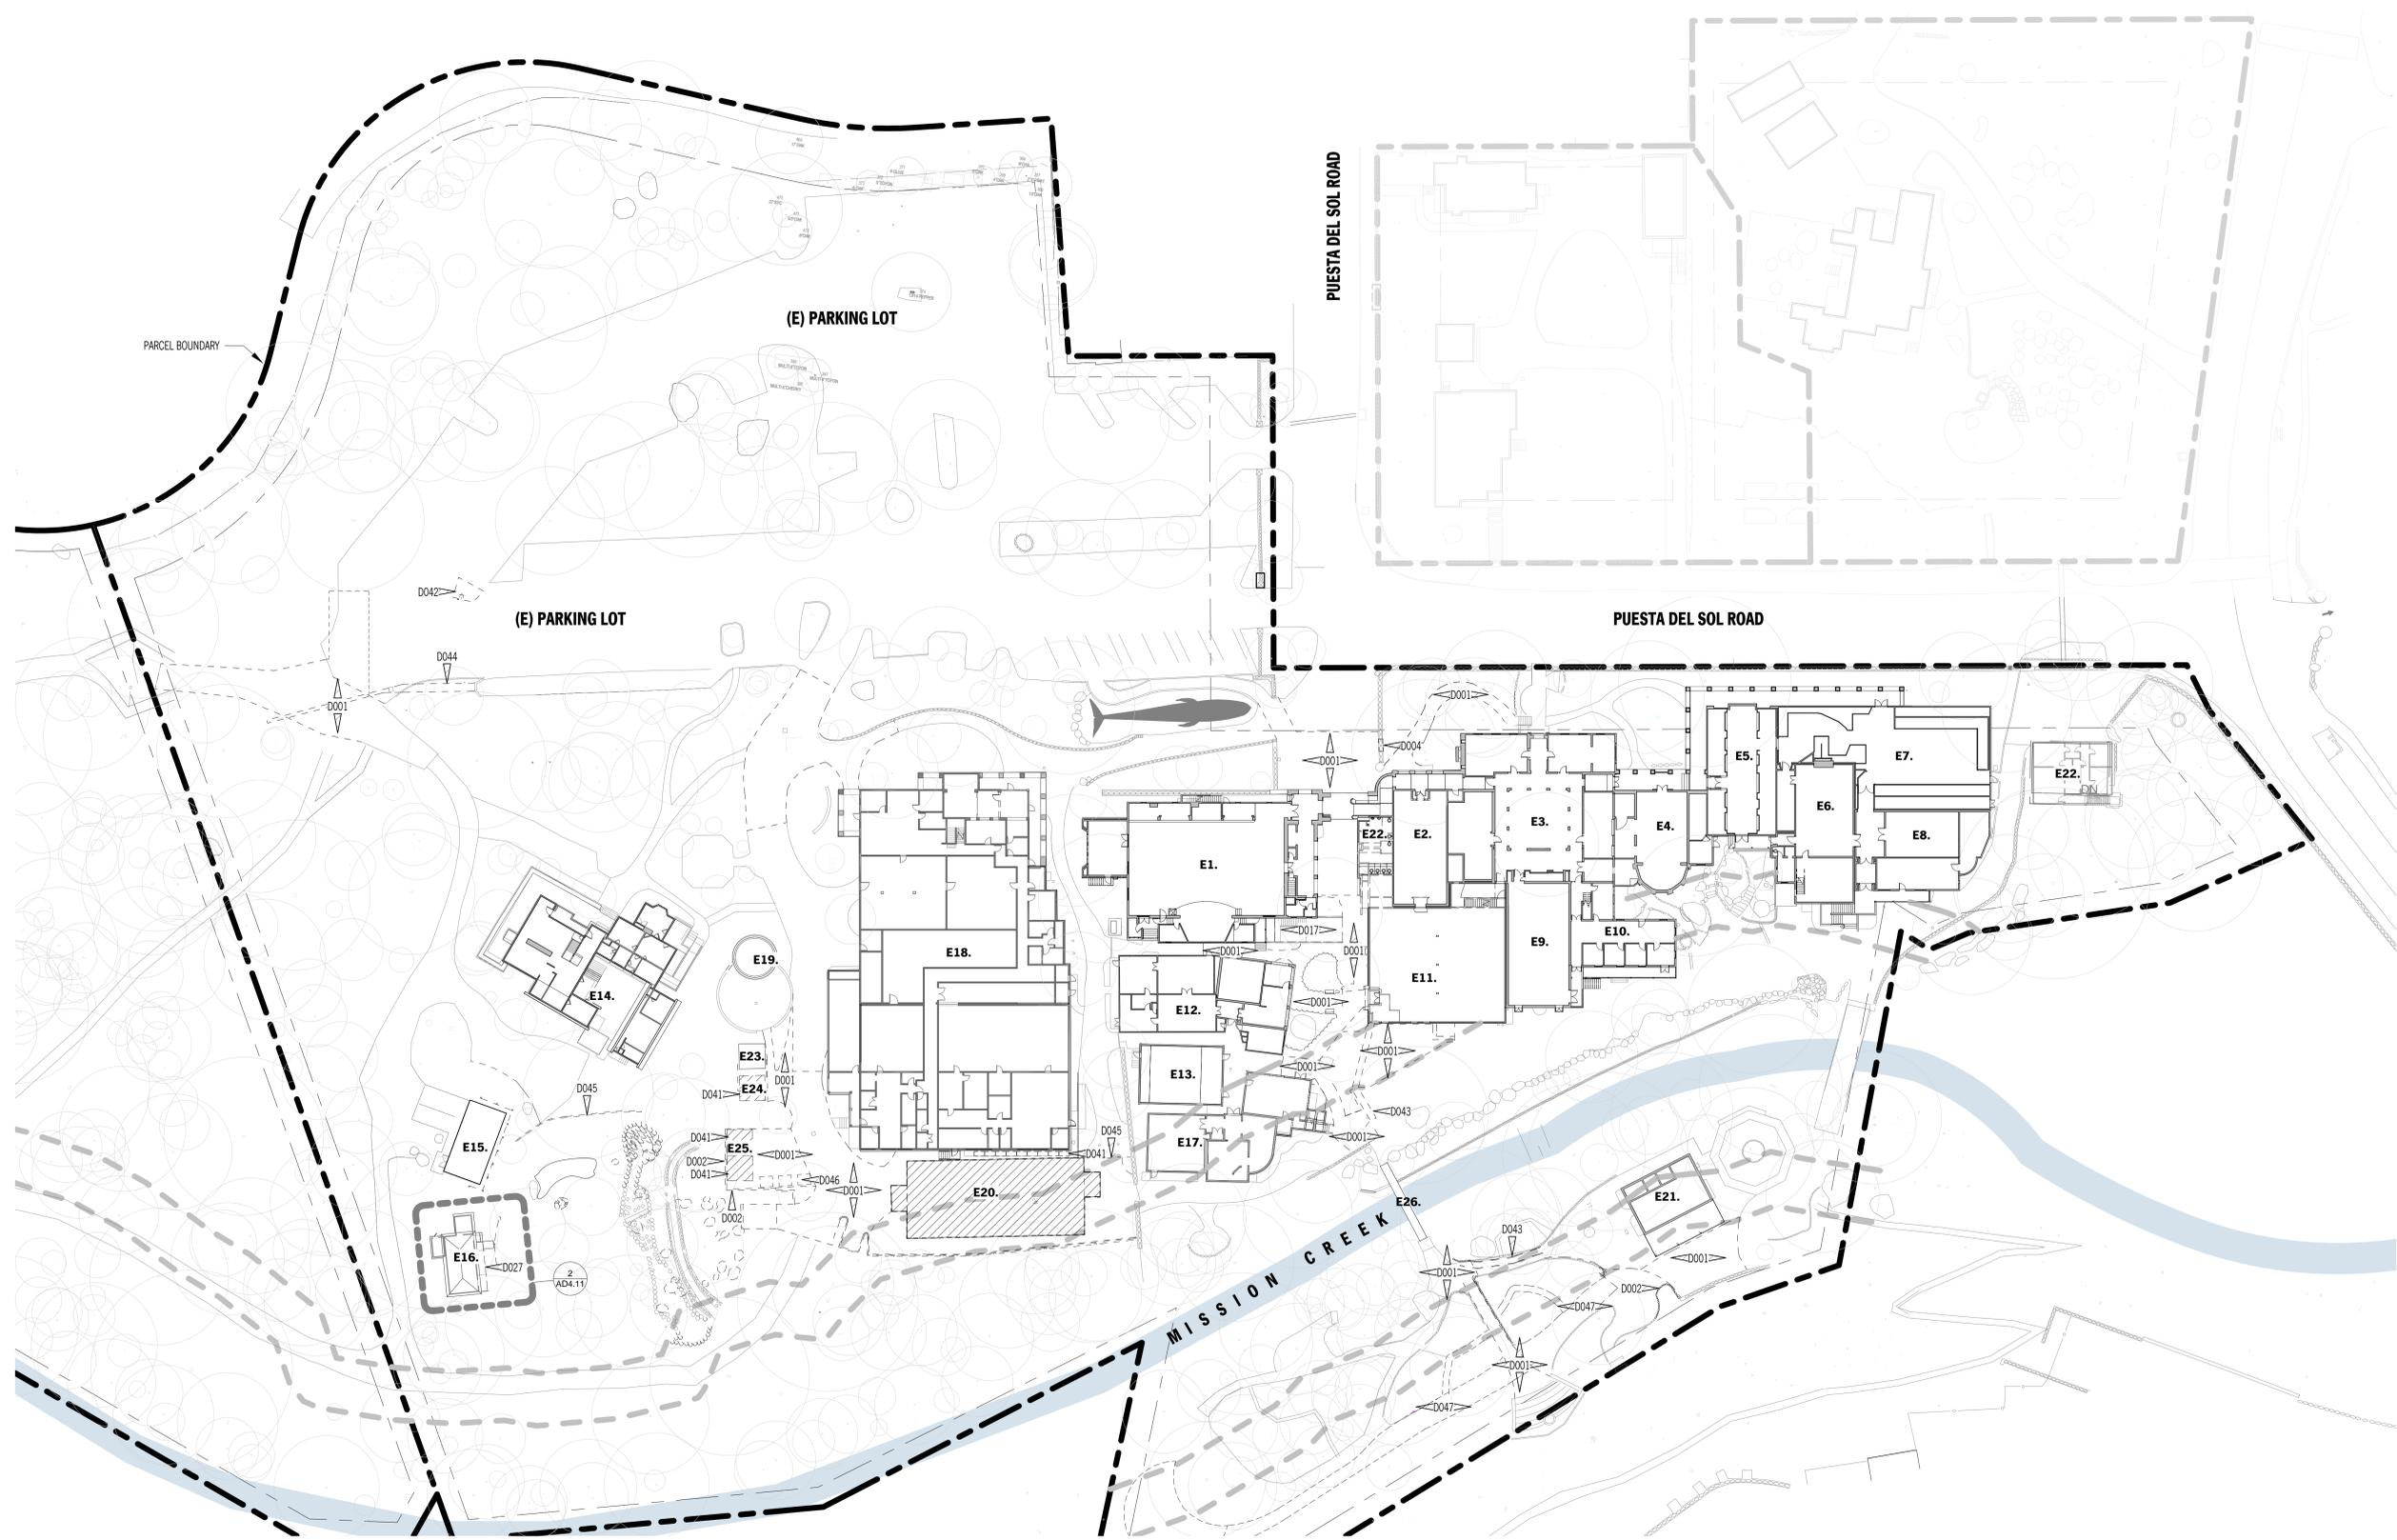
Demolition Site  
Plan

D001	REMOVE (E) ASPHALT, EXISTING STONE PAVEMENT SYSTEM AND/OR CONC SIDEWALK AND CURB AND ALL ASSOC.	D027	DEMOLISH (E) DECK, STAIR & ALL ASSOCIATED
D002	REMOVE (E) WALL AND ALL ASSOC. TO EXTENTS SHOWN	D041	REMOVE (E) STORAGE SHED
D004	SAWCUT AND REMOVE (E) HAZARD ESTATE WALL TO EXTENTS SHOWN. PRESERVE AND PROTECT EXISTING STONES	D042	REMOVE (E) PLANTING ISLAND, BOULDERS AND LAMP POST
D017	EXCAVATE TO EXTENTS SHOWN FOR BASEMENT. SHORING AND COORDINATION W/ STRUCT DWGS REQUIRED PRIOR TO EXCAVATION	D043	EXCAVATION FOR UTILITY TRENCH. PROVIDE STUBOUT FOR FUTURE CONNECTION OF UTILITY ACROSS MISSION CREEK
		D044	REMOVE AND REROUTE UNDERGROUND PIPE
		D045	REMOVE (E) FENCE
		D046	RELOCATE (E) DUMPSTERS
		D047	REMOVE (E) PATH IN PREPARATION FOR NEW PERMEABLE ADA PATH

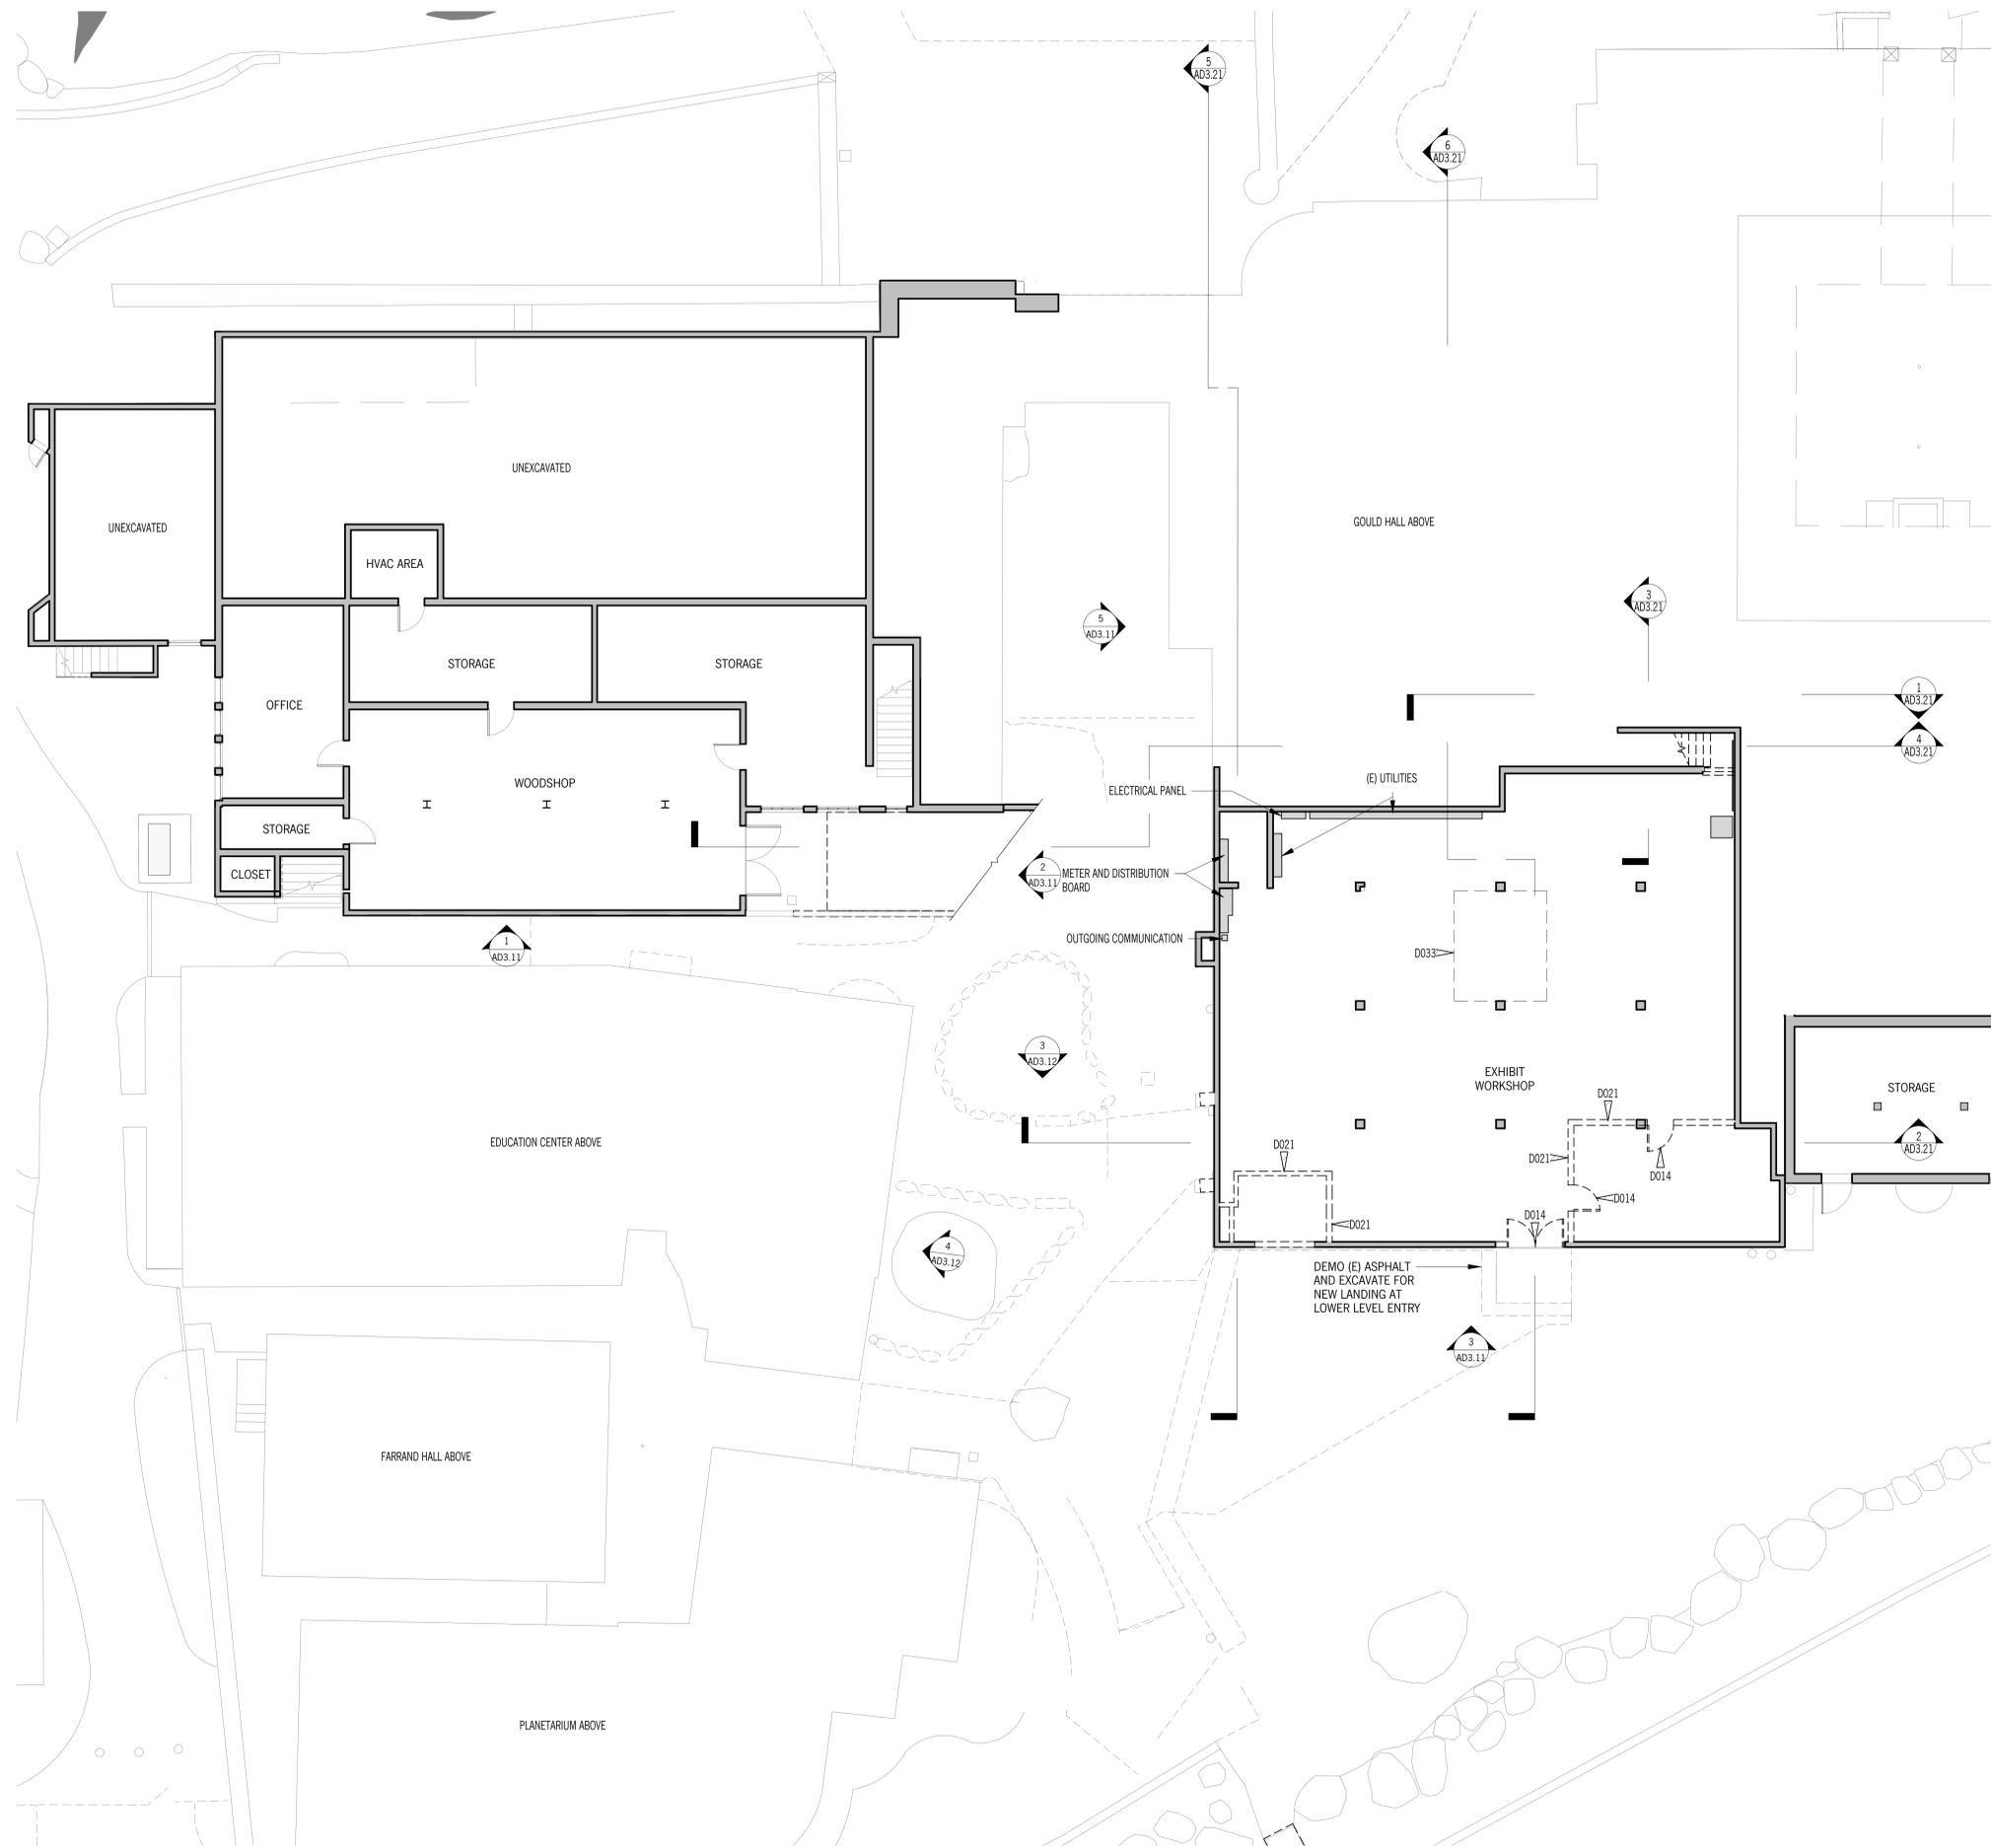
Demolition Floor  
Plan - Lower Level  
Central  
**AD2.21**

- D014 REMOVE (E) DOOR AND FRAME
- D021 REMOVE (E) WALL & ALL ASSOC. TO EXTENTS SHOWN
- D033 REMOVE (E) MECHANICAL EQUIPMENT
