**PHASE 2  
HISTORIC STRUCTURES/SITES REPORT  
FOR THE  
SANTA BARBARA MUSEUM OF NATURAL HISTORY  
MASTER PLAN**

**MST 2014-00116**

**SANTA BARBARA, CALIFORNIA**

Prepared by:  
Post/Hazeltine Associates

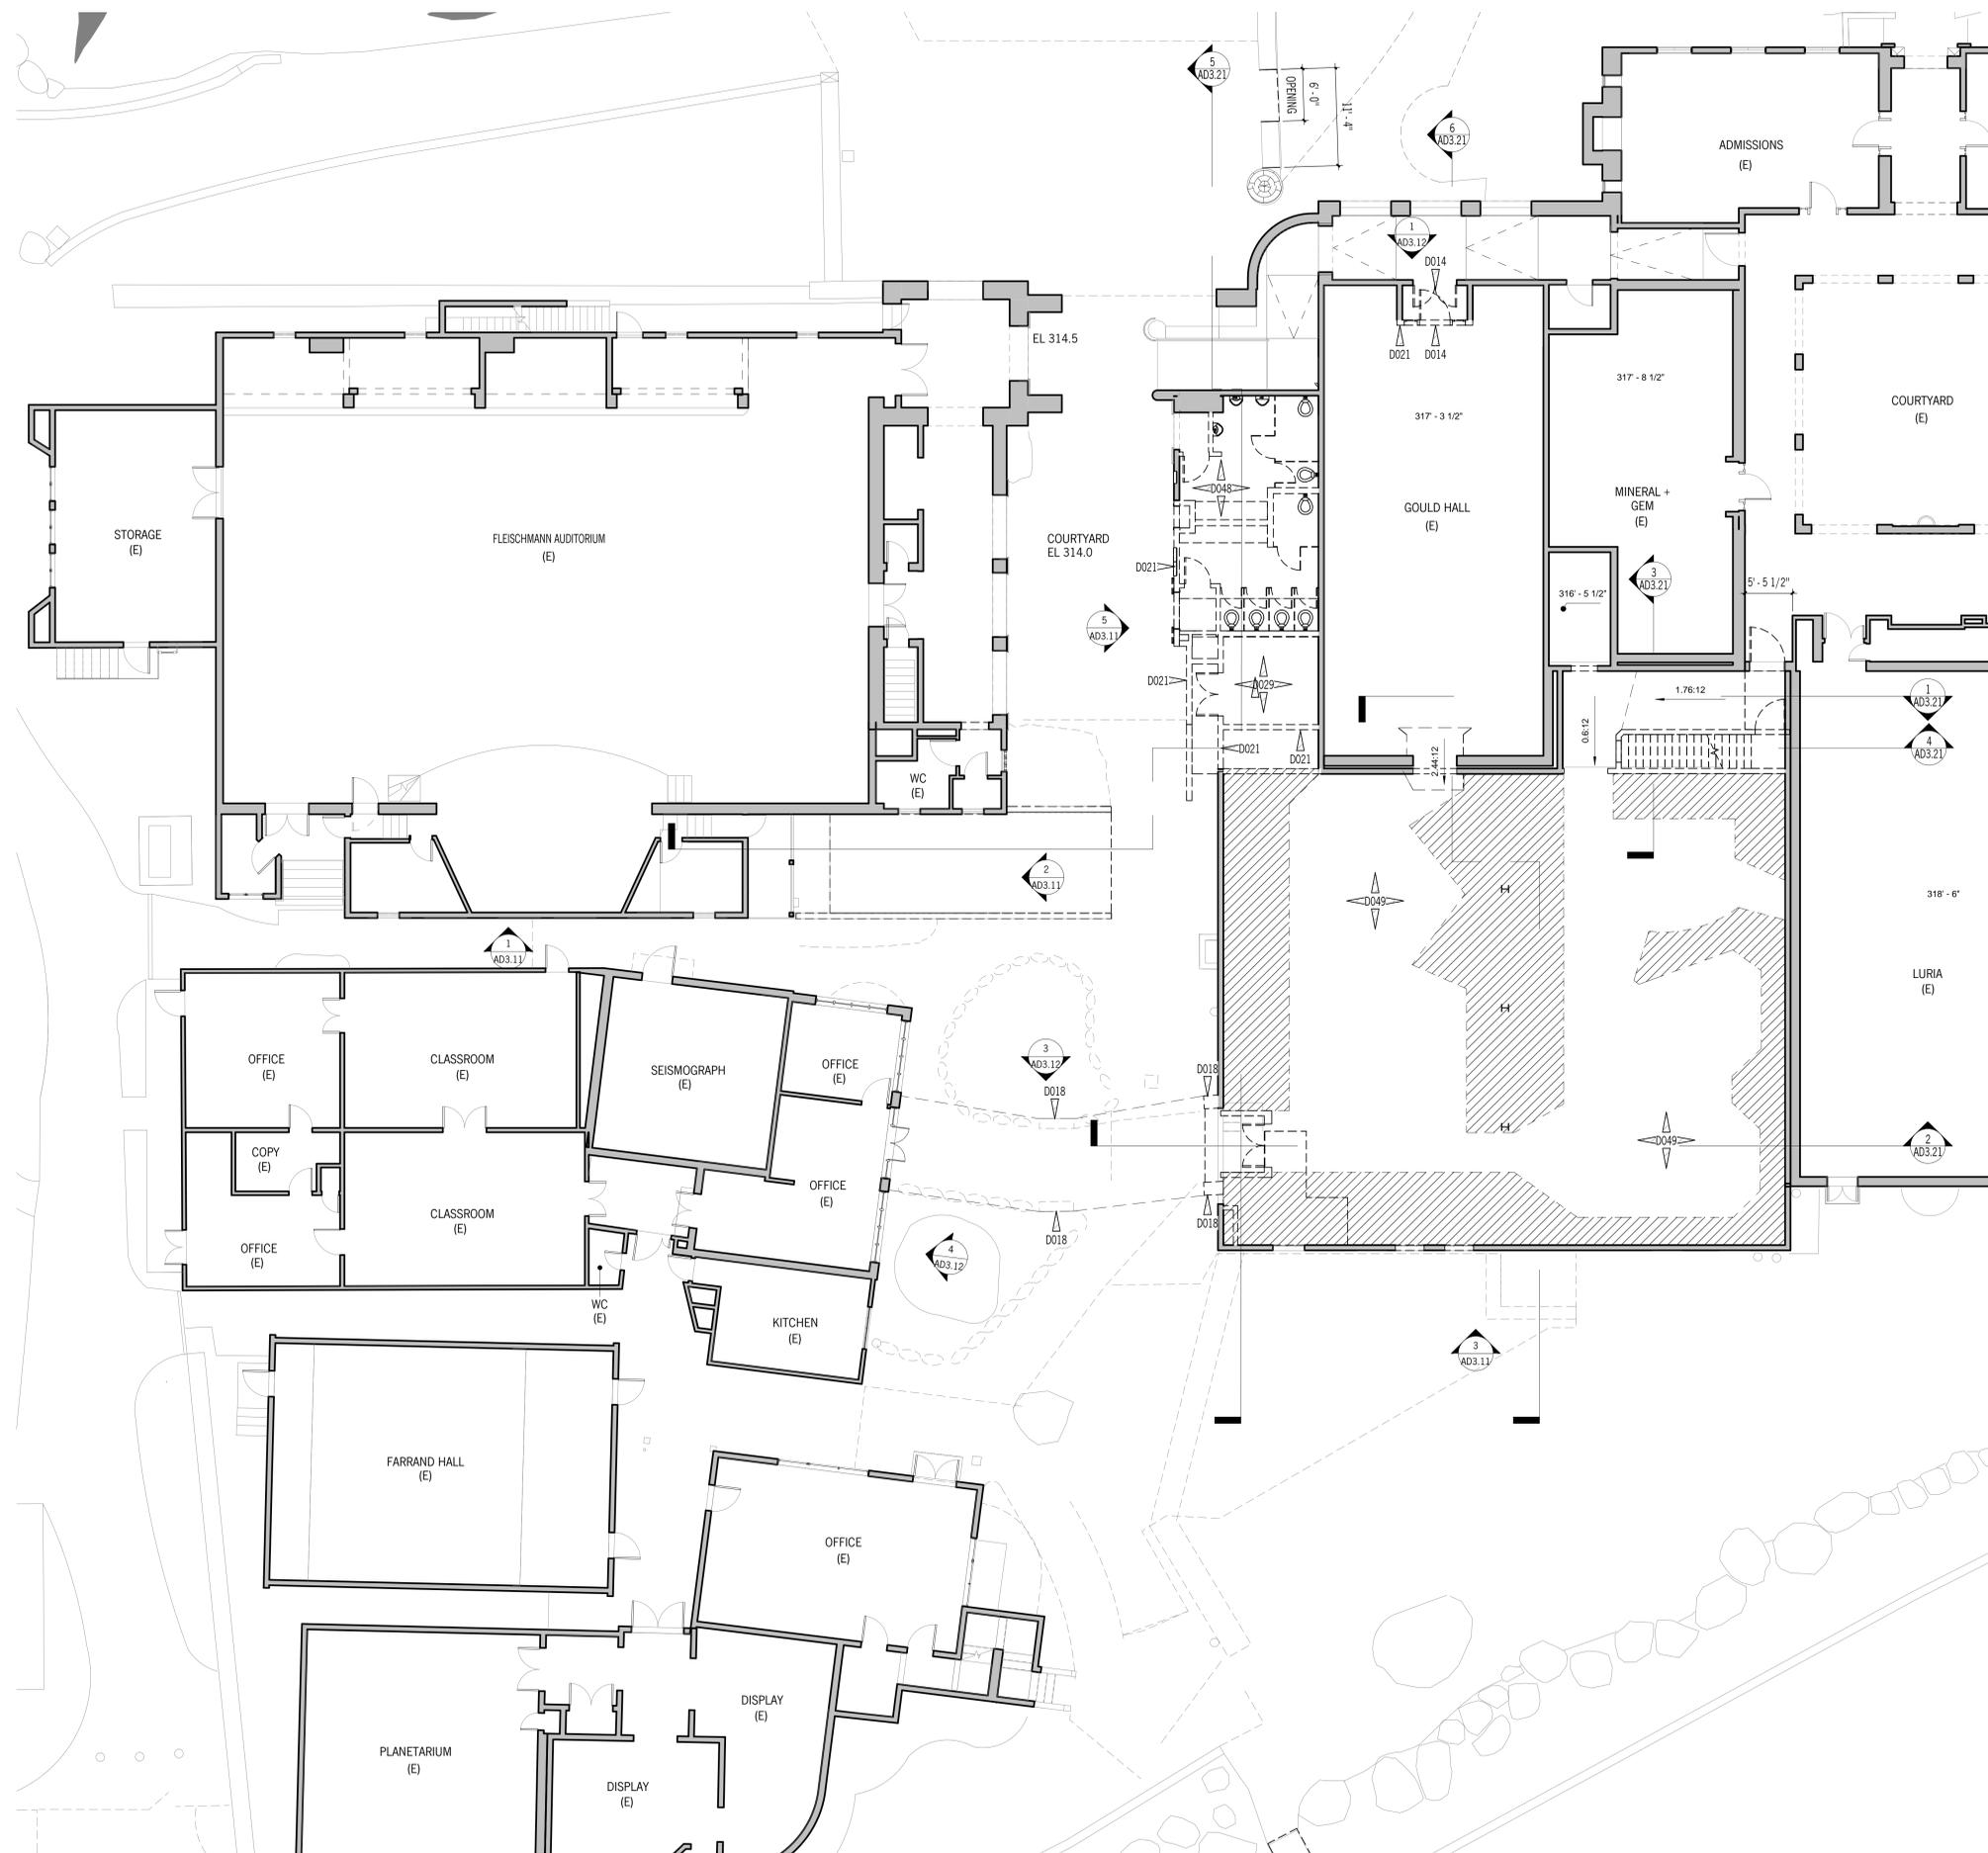
Demolition Floor  
Plan - Main Level  
Central  
**AD2.22**

- D014 REMOVE (E) DOOR AND FRAME
- D018 DEMOLISH (E) ROOF & COLUMNS OF COVERED WALKWAY TO EXTENTS SHOWN. CAREFULLY REMOVE & STORE WOOD JOISTS FOR REUSE.
- D021 REMOVE (E) WALL & ALL ASSOC. TO EXTENTS SHOWN
- D029 REMOVE (E) FLOOR AND FLOOR STRUCTURE IN ITS ENTIRETY
- D048 REMOVE (E) PARTITIONS, COUNTERS, AND PLUMBING FIXTURES TO THE EXTENT SHOWN
- D049 REMOVE (E) EXHIBIT CASEWORK

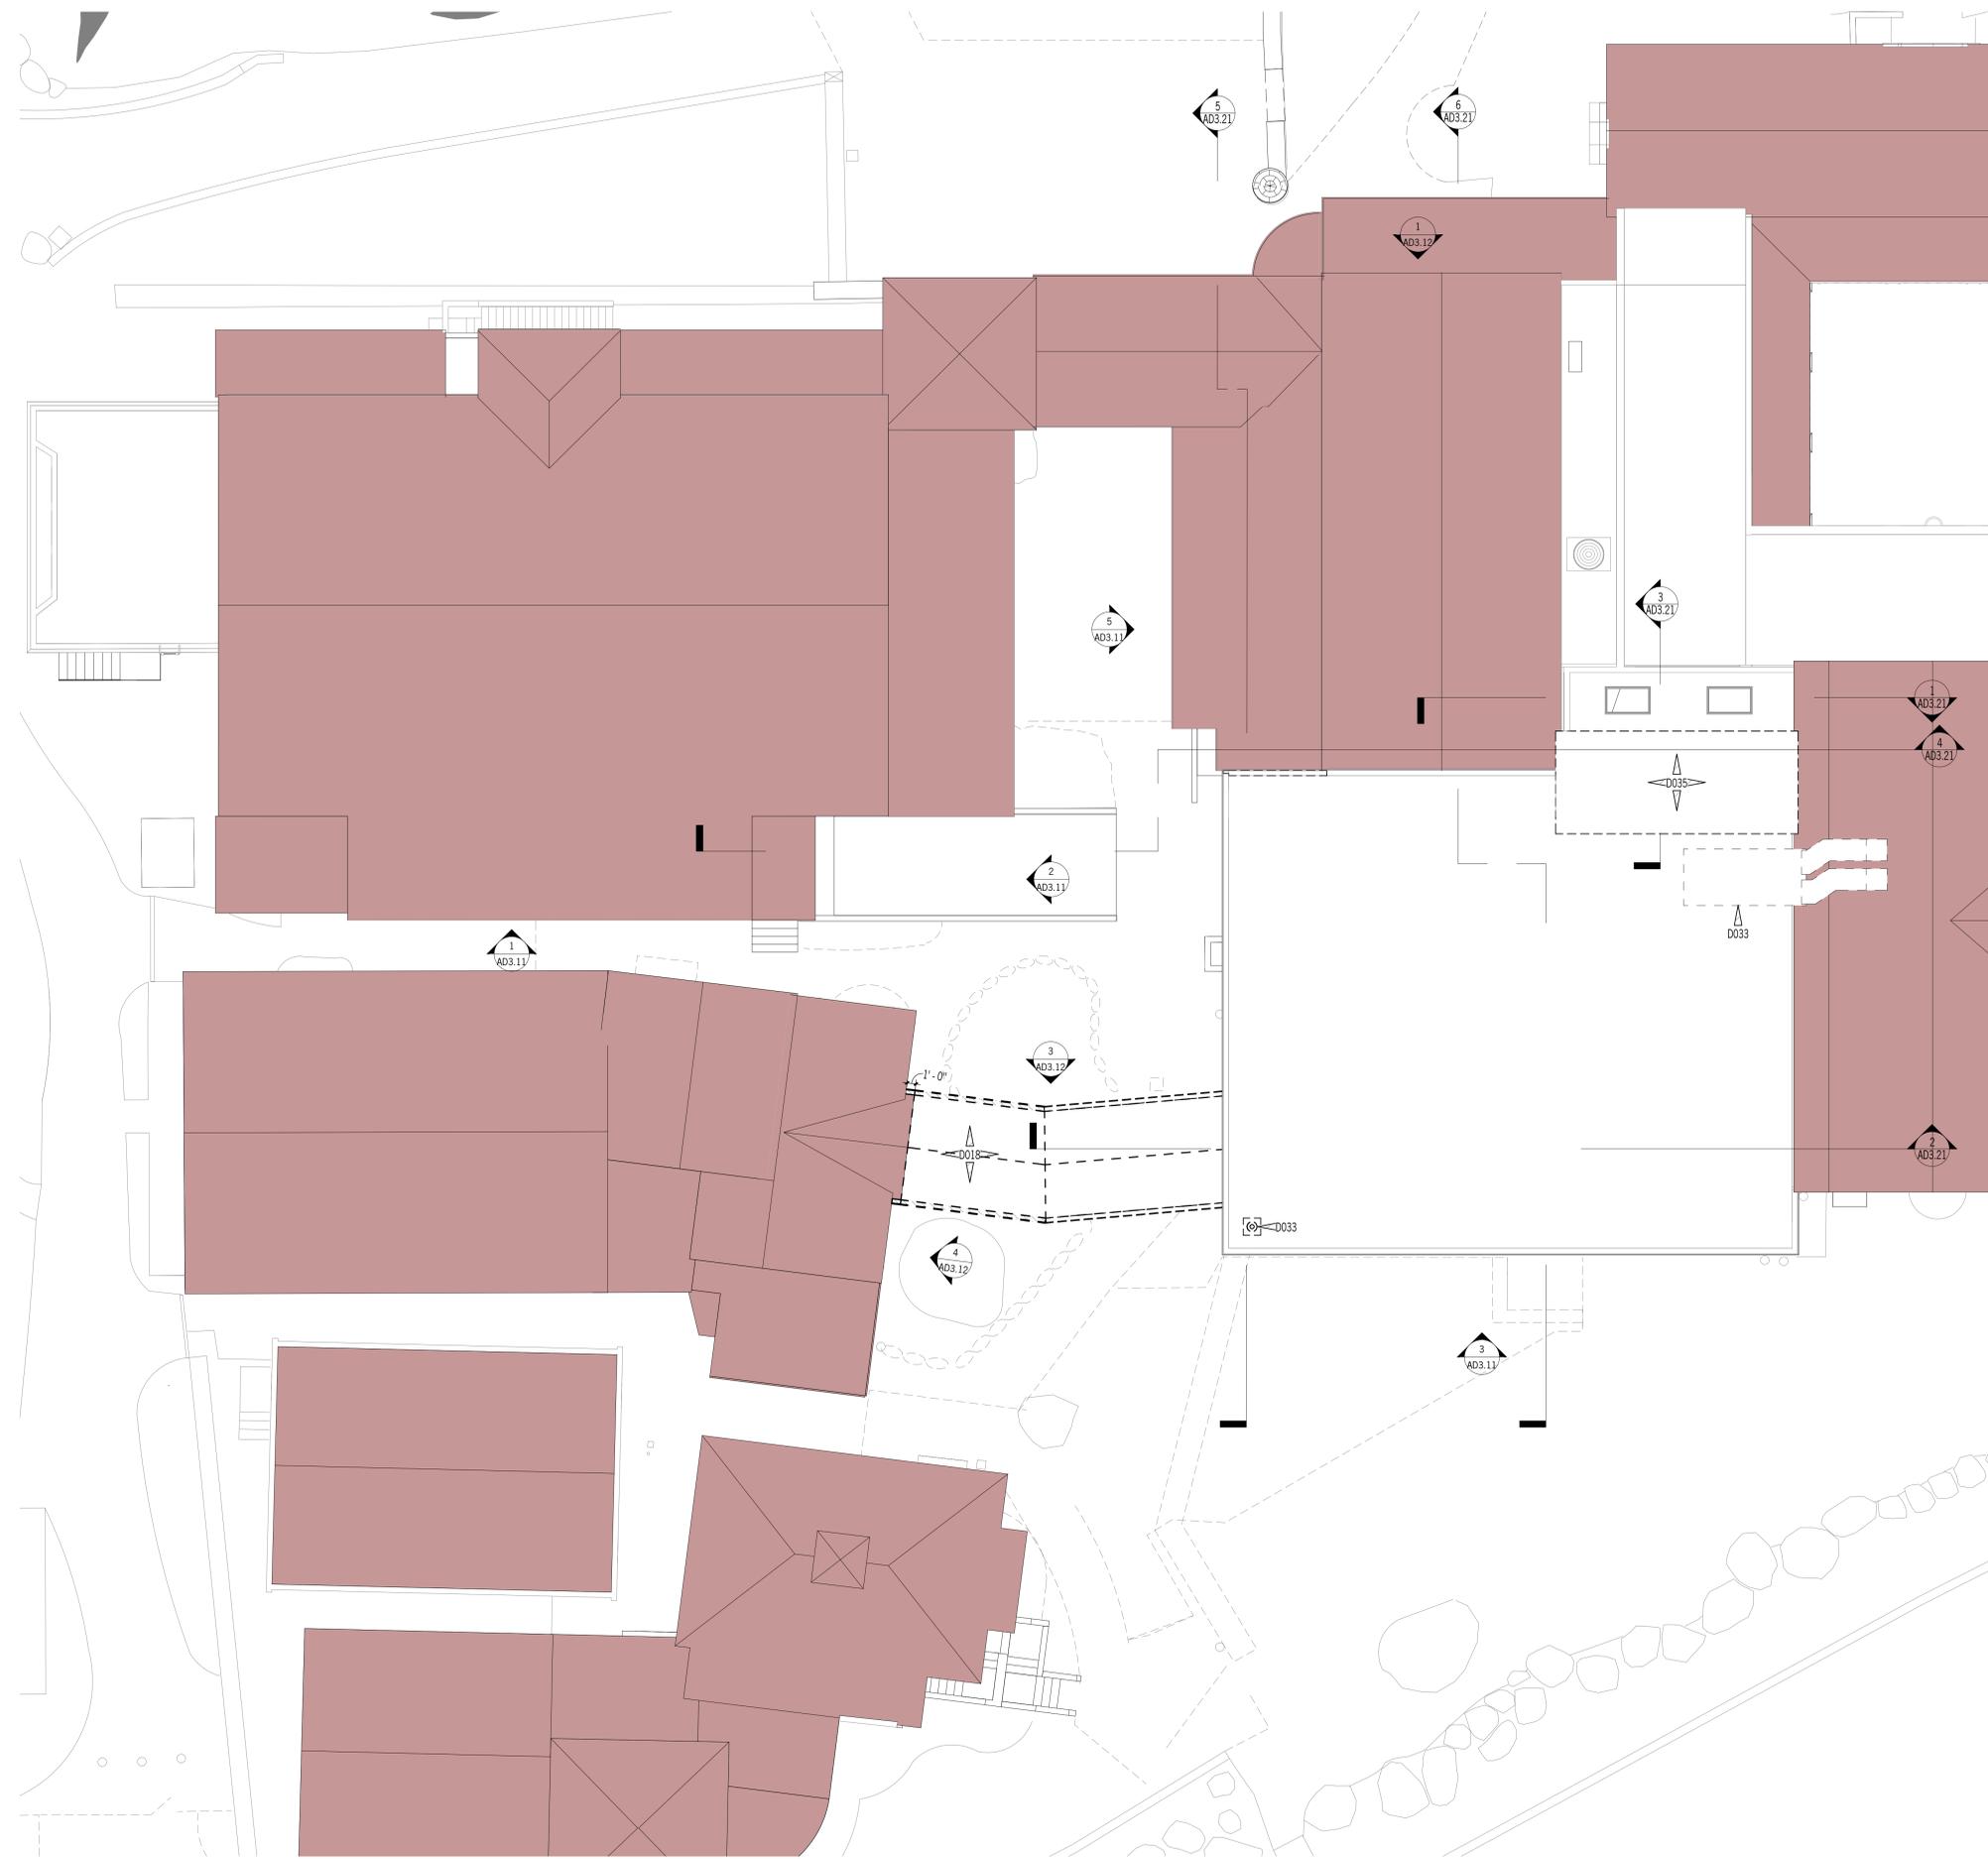
- D018 DEMOLISH (E) ROOF & COLUMNS OF COVERED WALKWAY TO EXTENTS SHOWN. CAREFULLY REMOVE & STORE WOOD JOISTS FOR REUSE.
- D033 REMOVE (E) MECHANICAL EQUIPMENT
- D035 REMOVE (E) STAIR TOWER AND ALL ASSOCIATED TO EXTENTS SHOWN

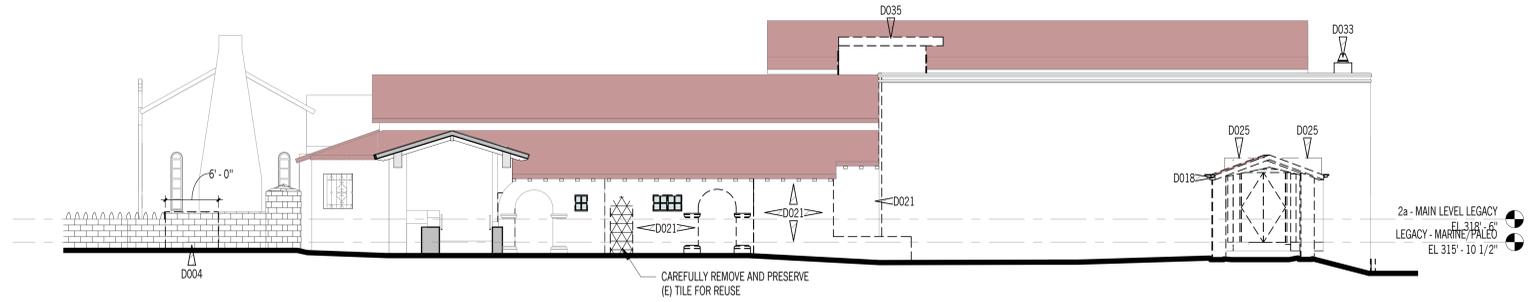
DEMOLITION ELEVATION WEST - RESTROOM, MARINE PALEO

- D004 SAWCUT AND REMOVE (E) HAZARD ESTATE WALL TO EXTENTS SHOWN. PRESERVE AND PROTECT EXISTING STONES
- D014 REMOVE (E) DOOR AND FRAME
- D018 DEMOLISH (E) ROOF & COLUMNS OF COVERED WALKWAY TO EXTENTS SHOWN. CAREFULLY REMOVE & STORE WOOD JOISTS FOR REUSE.
- D021 REMOVE (E) WALL & ALL ASSOC. TO EXTENTS SHOWN
- D024 REMOVE (E) RAMP & ALL ASSOC.
- D025 REMOVE (E) WALL TO EXTENTS SHOWN FOR DOOR OR OPENING
- D033 REMOVE (E) MECHANICAL EQUIPMENT
- D035 REMOVE (E) STAIR TOWER AND ALL ASSOCIATED TO EXTENTS SHOWN
- D037 REMOVE (E) ELECTRICAL BOX AND ALL ASSOCIATED
- D038 REMOVE (E) UTILITIES
- D050 REMOVE (E) RAILING

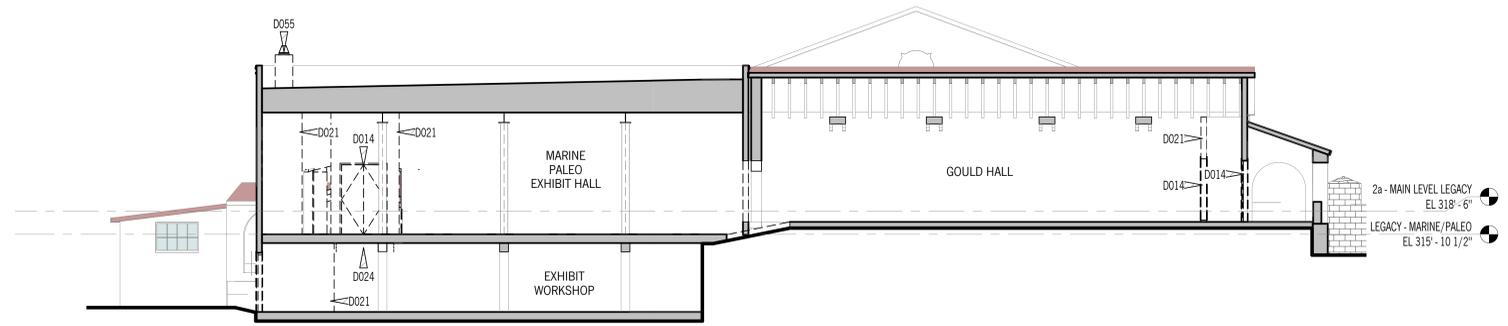
6 DEMO SECTION THROUGH RAMP @ GOULD  
1/8" = 1'-0"

- D011 REMOVE (E) STAIR & ALL ASSOCIATED
- D014 REMOVE (E) DOOR AND FRAME
- D018 DEMOLISH (E) ROOF & COLUMNS OF COVERED WALKWAY TO EXTENTS SHOWN. CAREFULLY REMOVE & STORE WOOD JOISTS FOR REUSE.
- D021 REMOVE (E) WALL & ALL ASSOC. TO EXTENTS SHOWN
- D023 REMOVE (E) WINDOW
- D024 REMOVE (E) RAMP & ALL ASSOC.
- D026 DEMOLISH (E) PLUMBING AND FIXTURES
- D033 REMOVE (E) MECHANICAL EQUIPMENT
- D034 REMOVE (E) FLOOR TO EXTENTS SHOWN
- D035 REMOVE (E) STAIR TOWER AND ALL ASSOCIATED TO EXTENTS SHOWN
- D055 REMOVE (E) VENT STACK

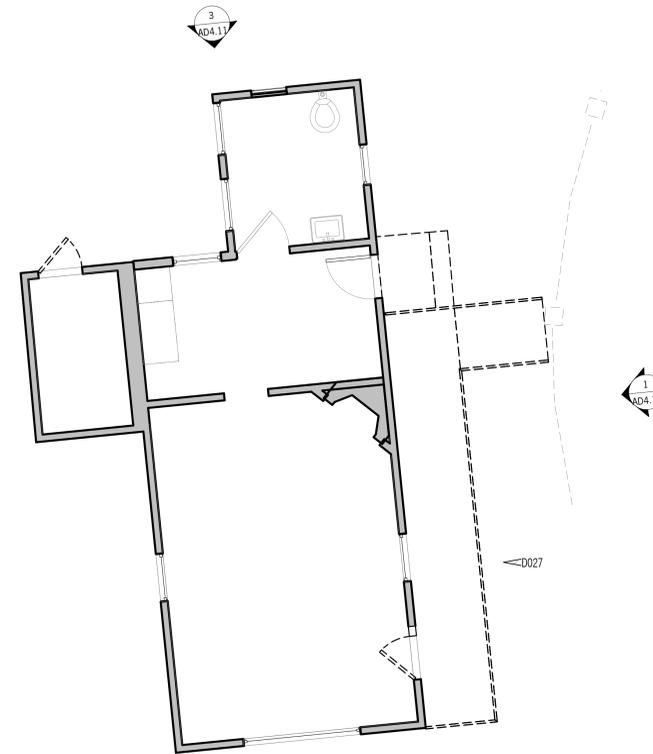
2  
AD4.11  
1/4" = 1'-0"  
DEMOLITION - MAIN LEVEL PLAN - WEST - MACVEAGH COTTAGE

NOTE: NO INTERIOR DEMOLITION PROPOSED

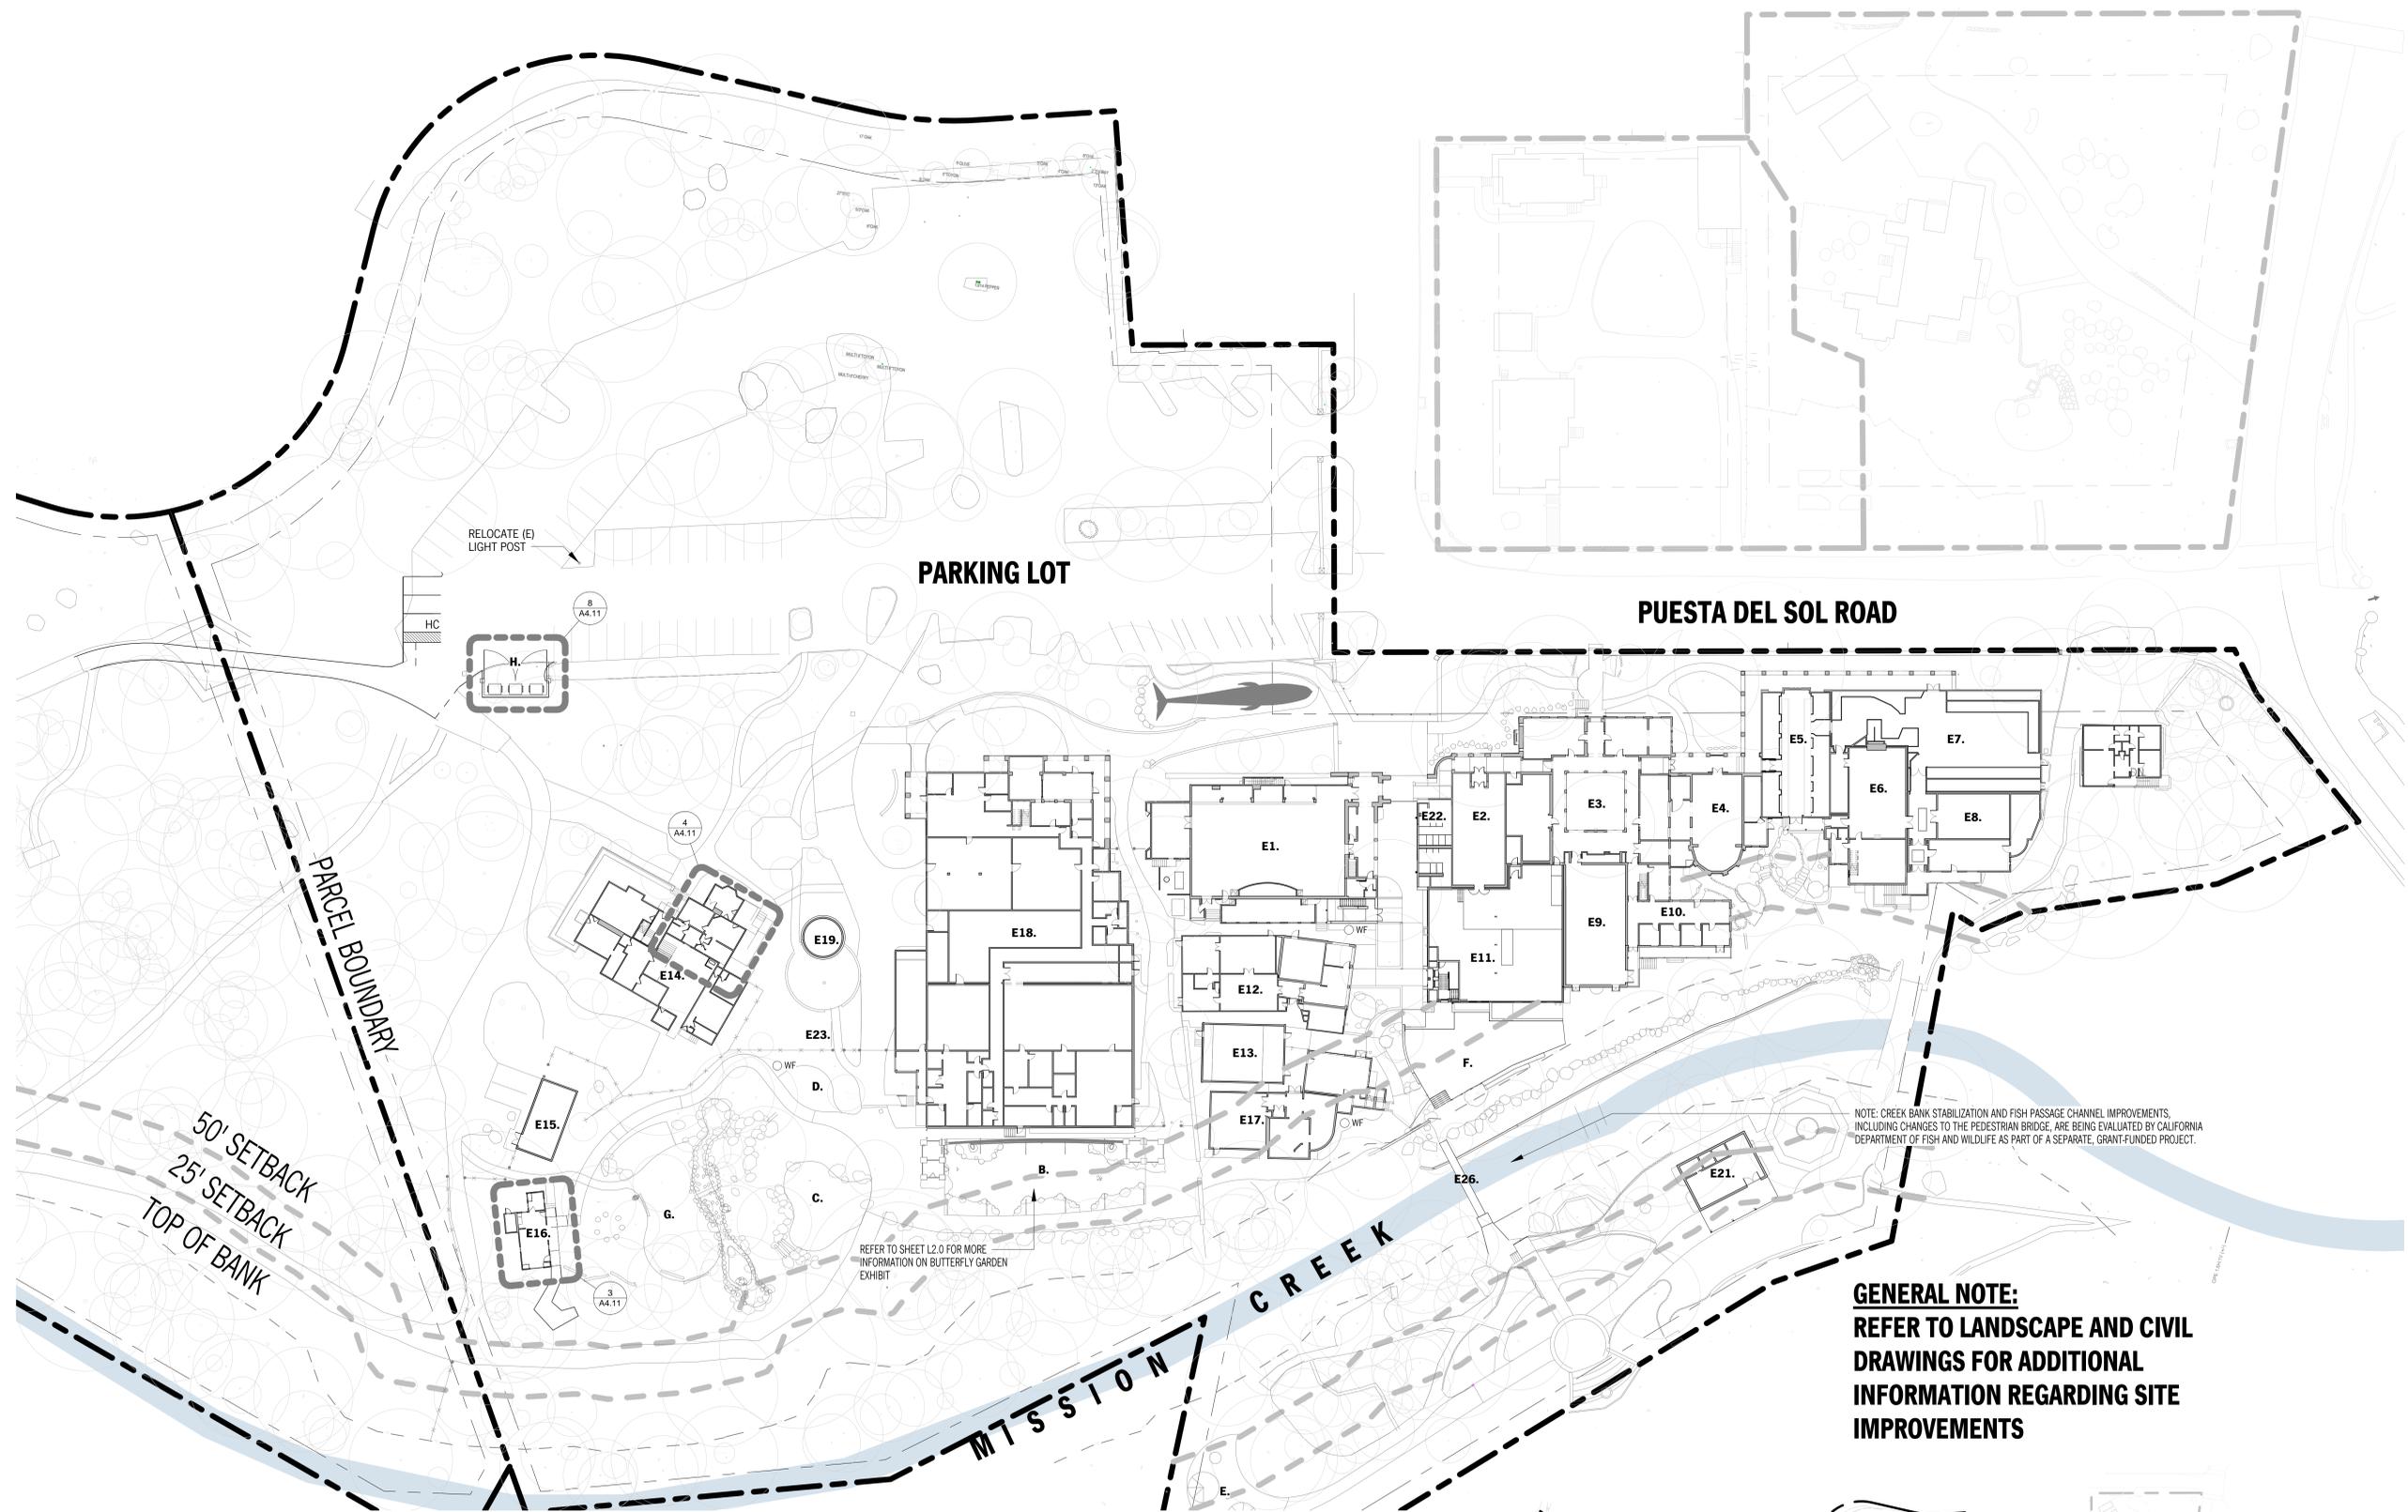
1  
A1.11  
SITE PLAN  
1/32" = 1'-0"

- PROPOSED REPLACEMENT STRUCTURES:**
  - B. BUTTERFLY GARDEN EXHIBIT
- EXISTING STRUCTURES REHABILITATED OR RENOVATED:**
  - E2. GOULD EXHIBIT HALL
  - E11. MARINE PALEO EXHIBIT HALL

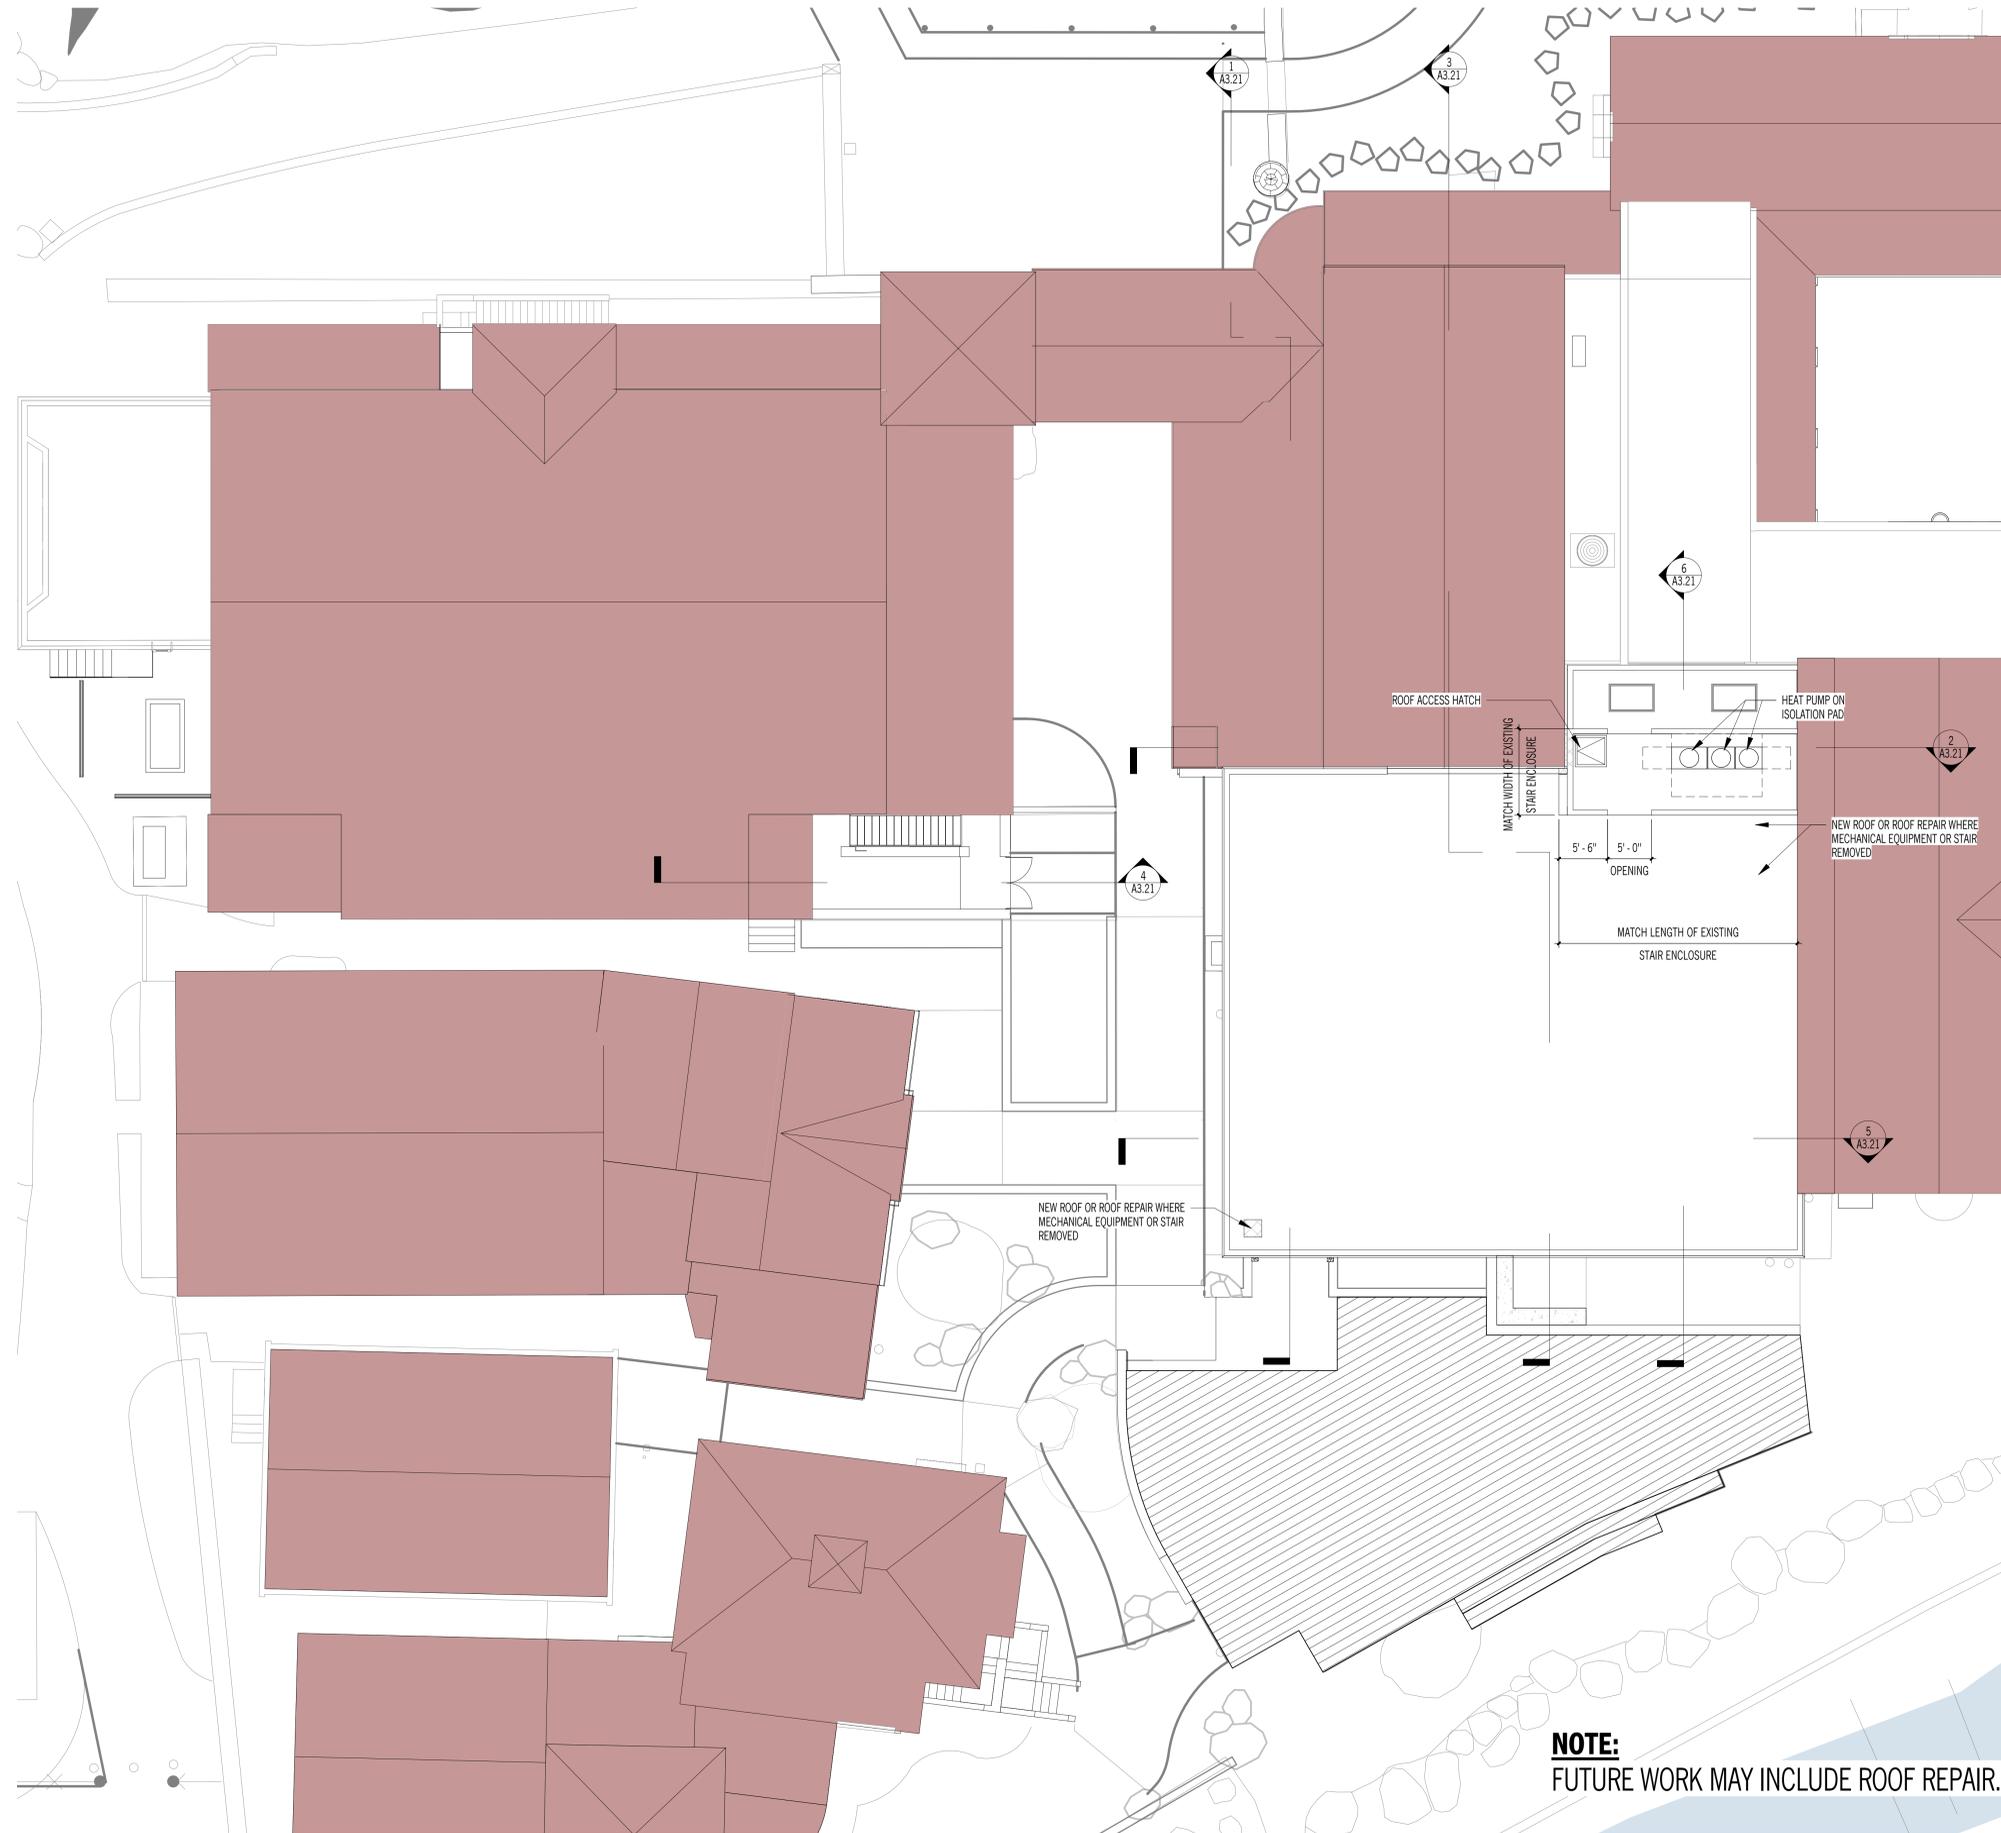
Roof Plan - Central

**NOTE:**  
FUTURE WORK MAY INCLUDE ROOF REPAIR.

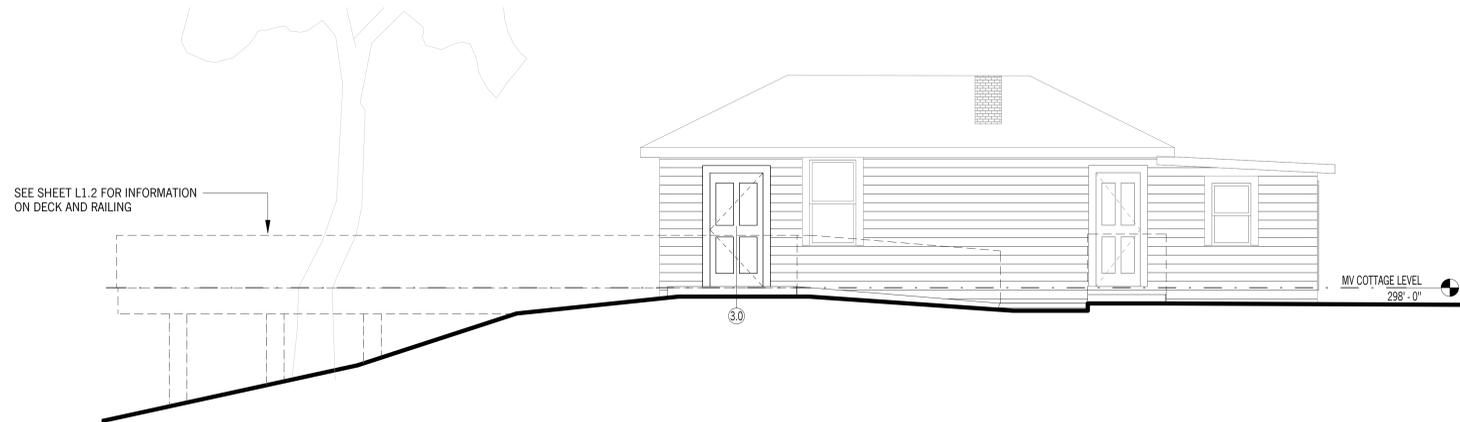
1  
A4.11  
MACVEAGH COTTAGE - EAST ELEVATION  
1/4" = 1'-0"

SEE SHEET L1.2 FOR INFORMATION  
ON DECK AND RAILING

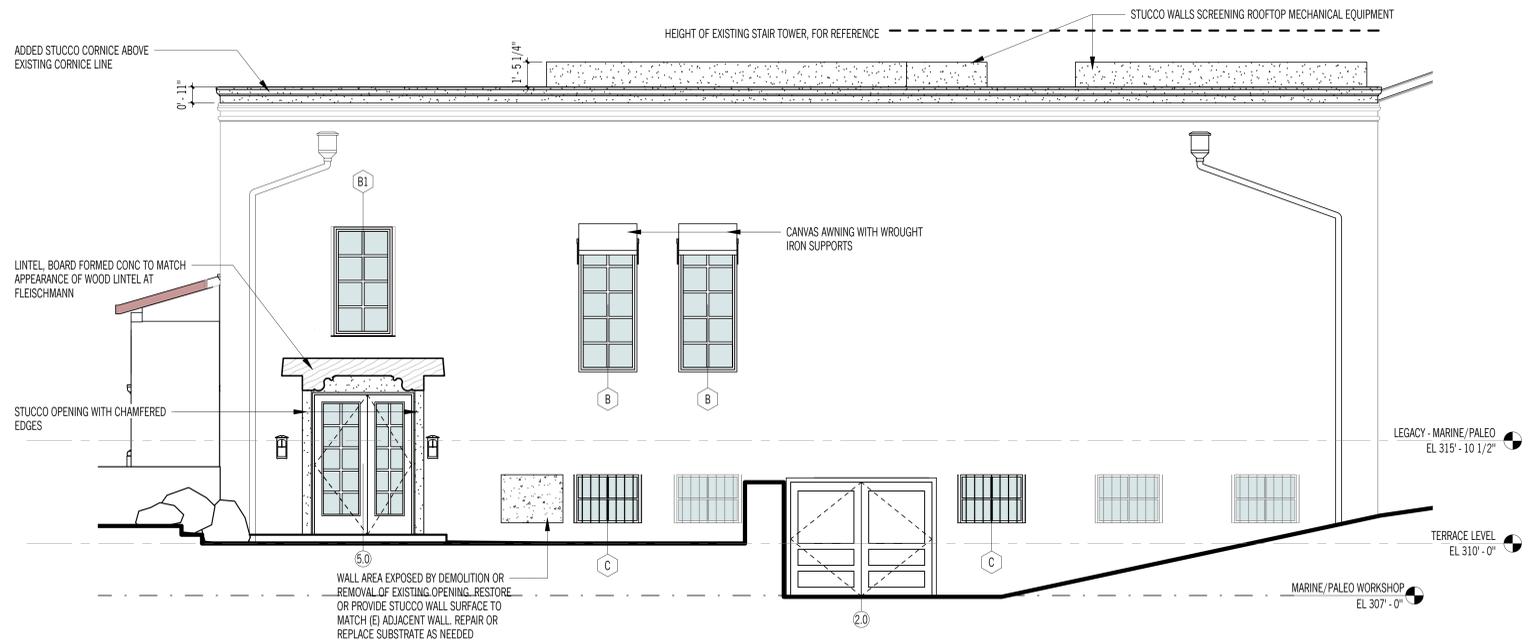
2 ENLARGED SOUTH ELEVATION - MARINE PALEO  
A4.13 1/4" = 1'-0"

LINTEL ABOVE MARINE PALEO EXIT DOOR AND MARINE PALEO WEST ELEVATION WINDOW, SIM TO EXISTING WOOD LINTELS AT FLEISCHMANN AND ORIGINAL QUAD

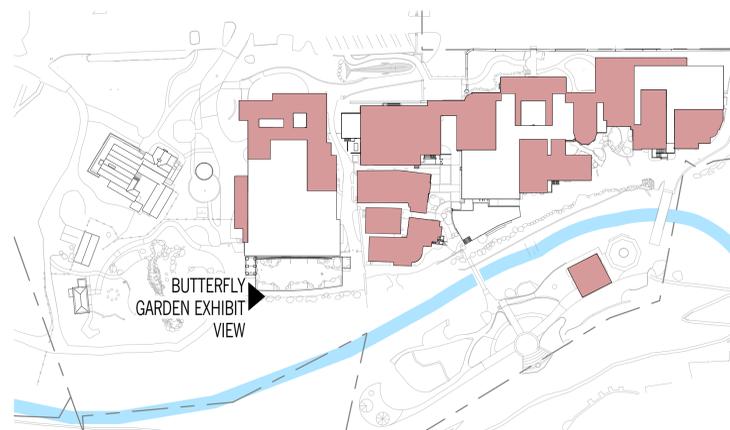
BUTTERFLY GARDEN EXHIBIT - View looking East

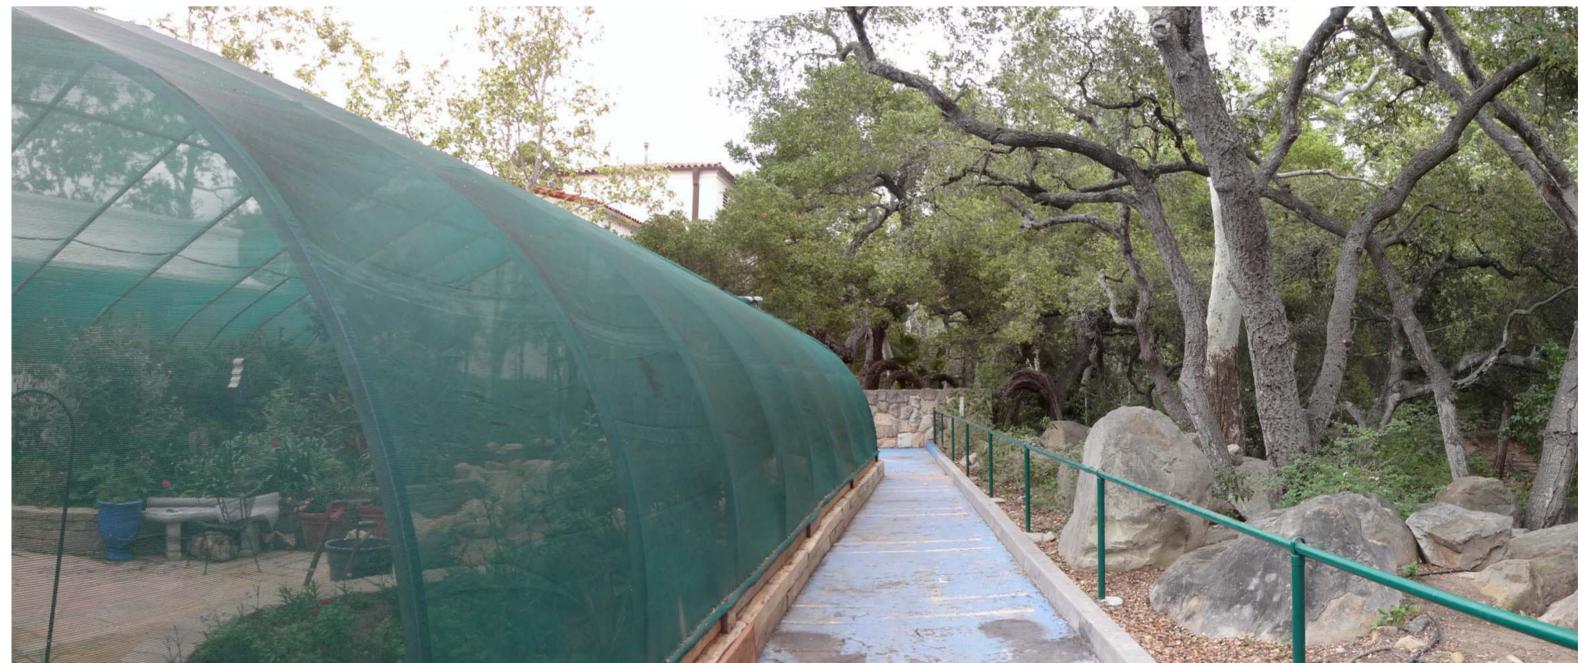
BUTTERFLY EXHIBIT - EXISTING - View looking East

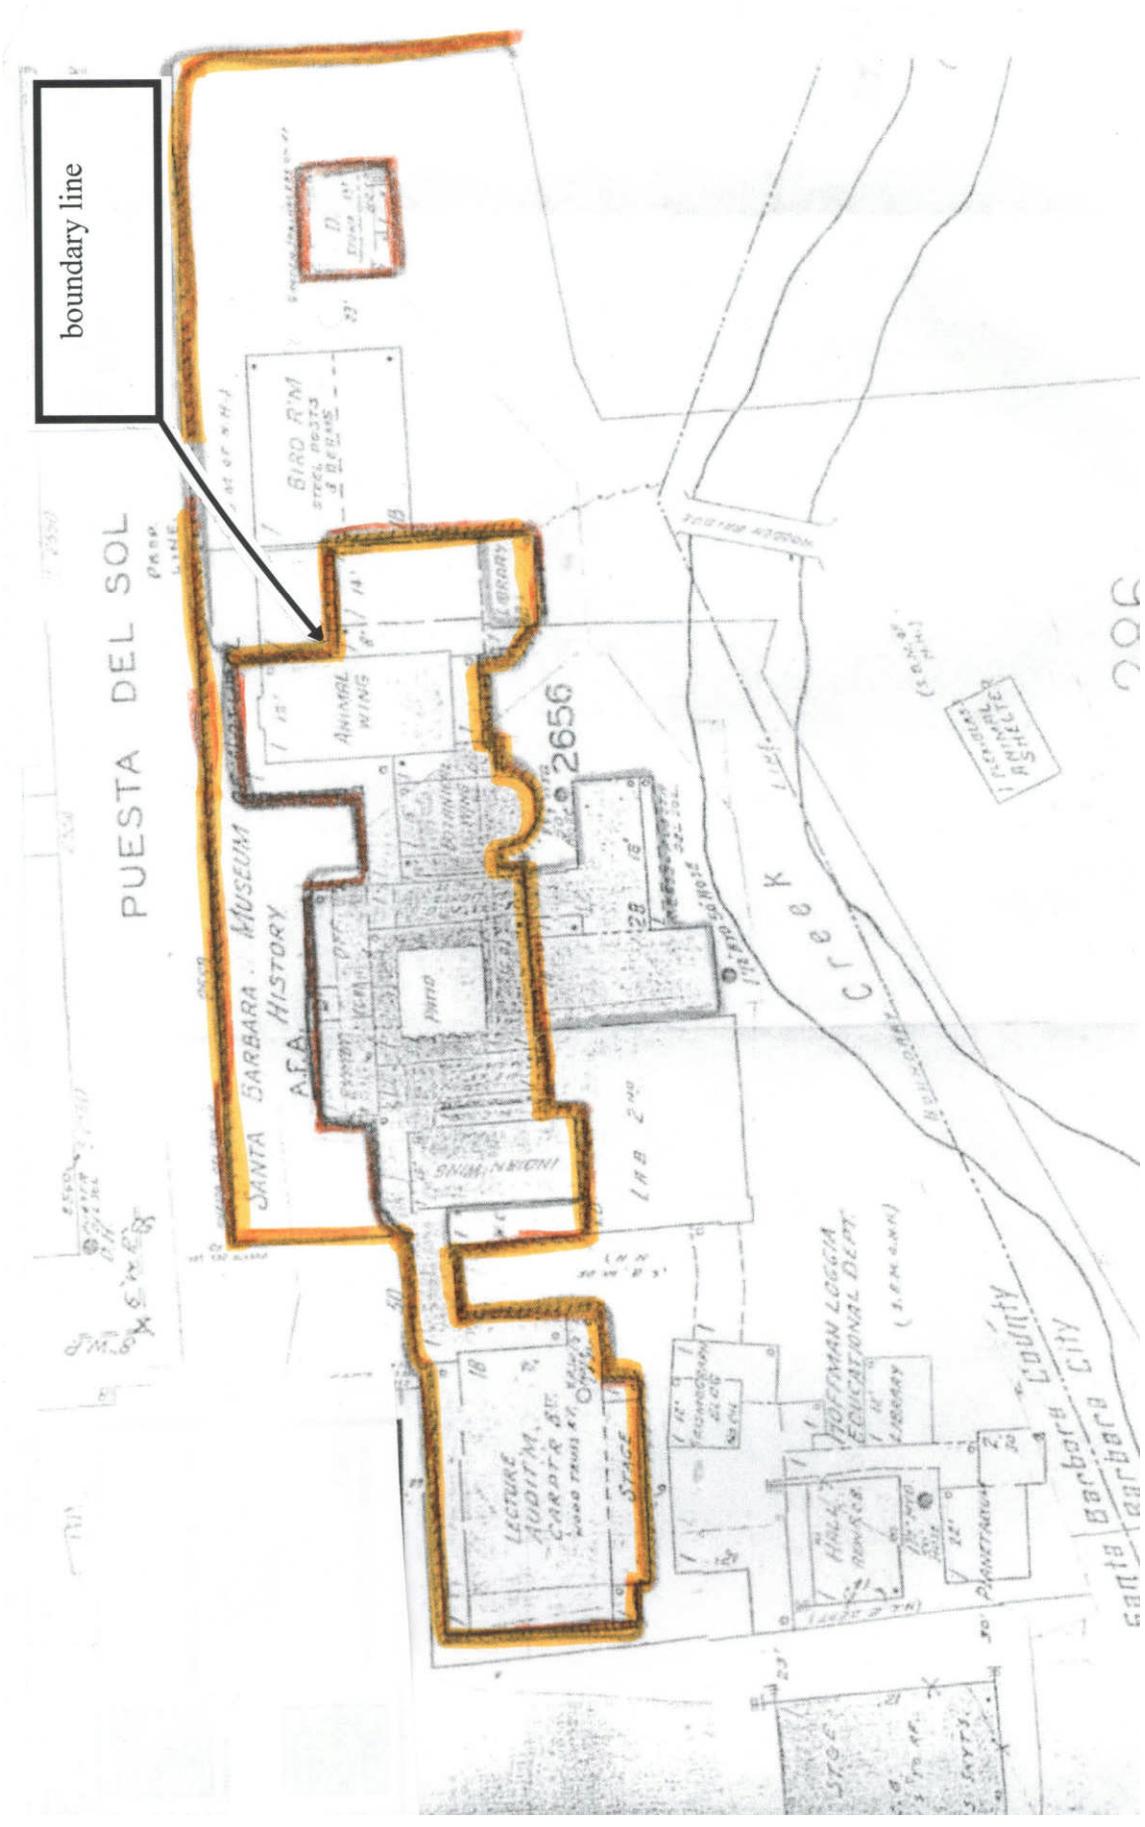
1981 Structure of Merit Designation for Main Museum Complex (outlined in orange)
